PrimeVue
HOME INSPECTIONS

Inspected by Jude Hwang TREC #25266

SUMMARY

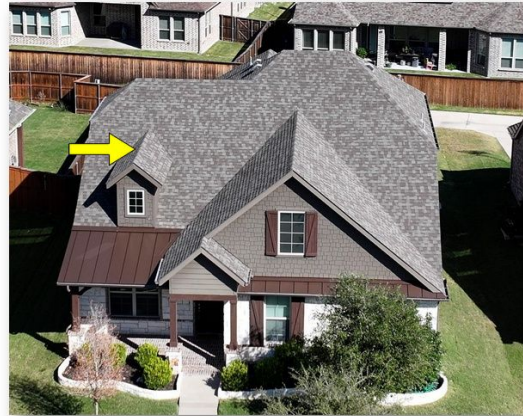
6.

M-Mechanical damage refers to any damage caused Installing shingles or equipment, cleaning gutters, making repairs, or performing construction work of other types can put people on the roof with tools or equipment capable of damaging shingles.

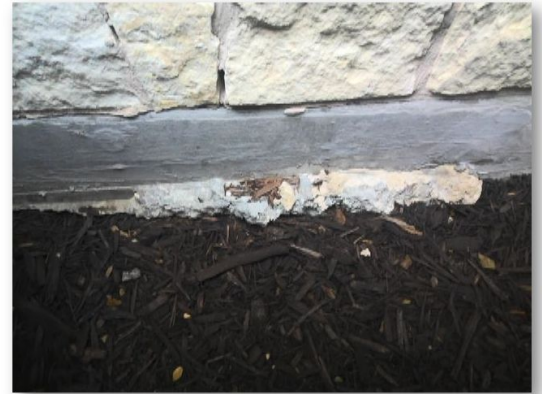
M-The foundation footing is partially exposed at one or more locations. Those areas should be backfilled, leaving 4 to 6 inches of the foundation exposed, and the soil sloped away from the foundation for proper moisture runoff.

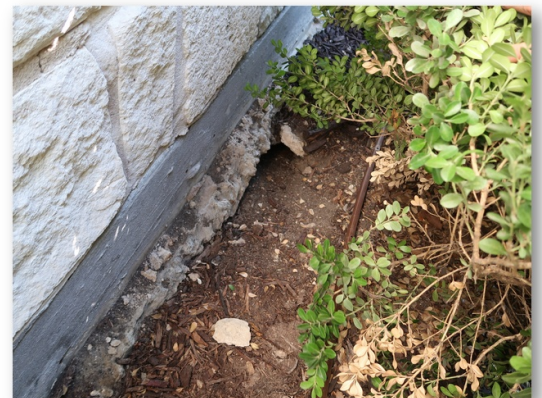
M-Sinkholes are observed around the front of the house. These depressions in the soil indicate poor drainage management, which can lead to water pooling near the foundation. Left

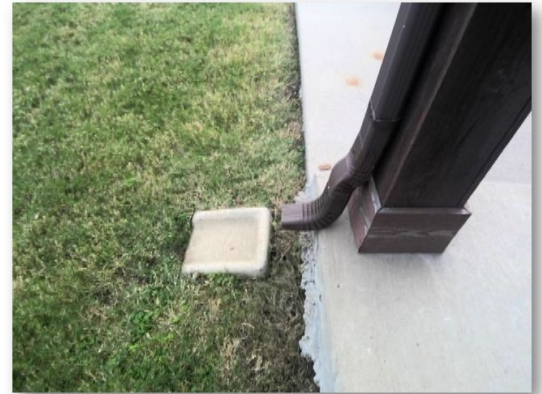
M- A complete gutter system with extensions is recommended on this structure. The gutter system is designed to expedite the drainage of water away from the property. Splash plates located under the down spouts can help direct water away from the foundation and reduce soil erosion, which can reduce the effectiveness of the termite chemicals placed in the soil.

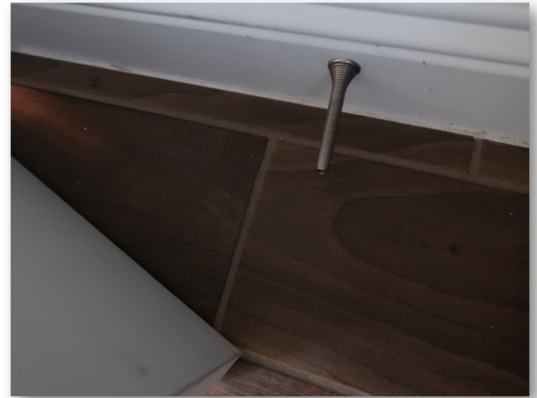
D-An interior doors were missing or pull off a stop. This condition is may result in wall and door damage. A stop be installed to protect the wall.

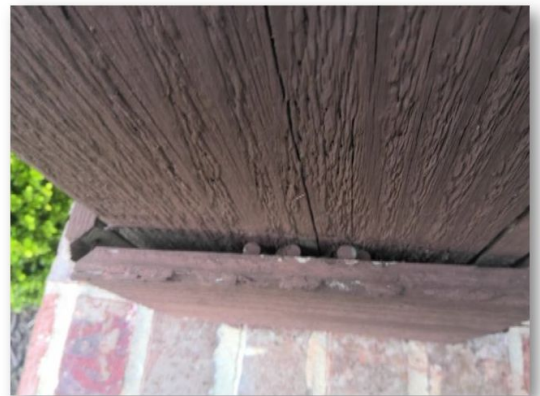
M-The connection at the bottom of the wooden porch column by the front door is separating, with nails visibly inserted. Repairing this area is recommended to ensure stability and prevent further separation.

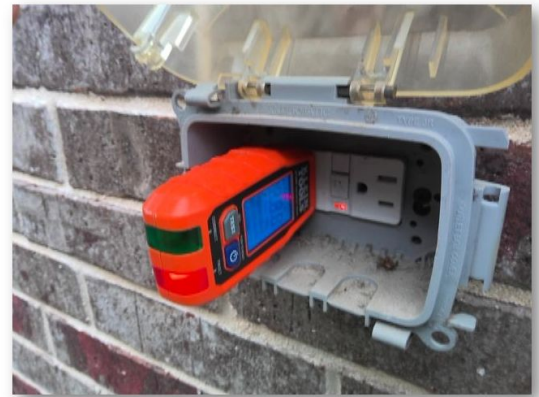
S-An open ground error was detected in the GFCI outlet near the electric meter, which can pose a safety risk. Evaluation and correction by a licensed electrician are recommended to ensure proper grounding and electrical safety.

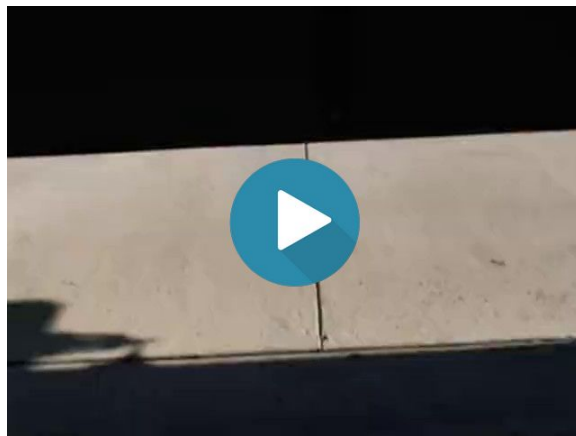
M-To ensure smooth operation of the garage door, it is recommended that the hockey stick part be adjusted to the 1 o'clock position.

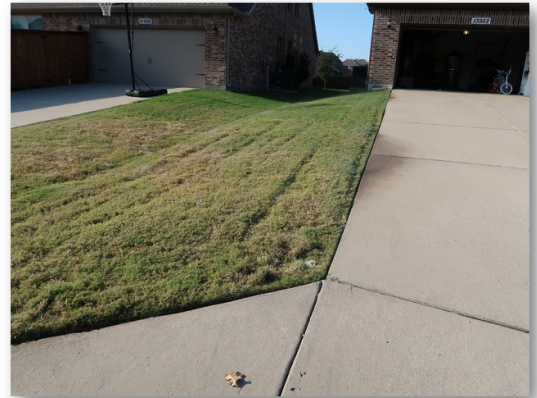
D-In sprinkler zones 2, 4, and 7, one of the heads is damaged, causing water to spray around the lawn area; repair or replacement of the affected sprinkler heads is recommended to ensure efficient water distribution.
