HOME AND TERMITE INSPECTIONS
254-727-0900
1234 DALLAS

Inspected by Jude Hwang TREC #25266

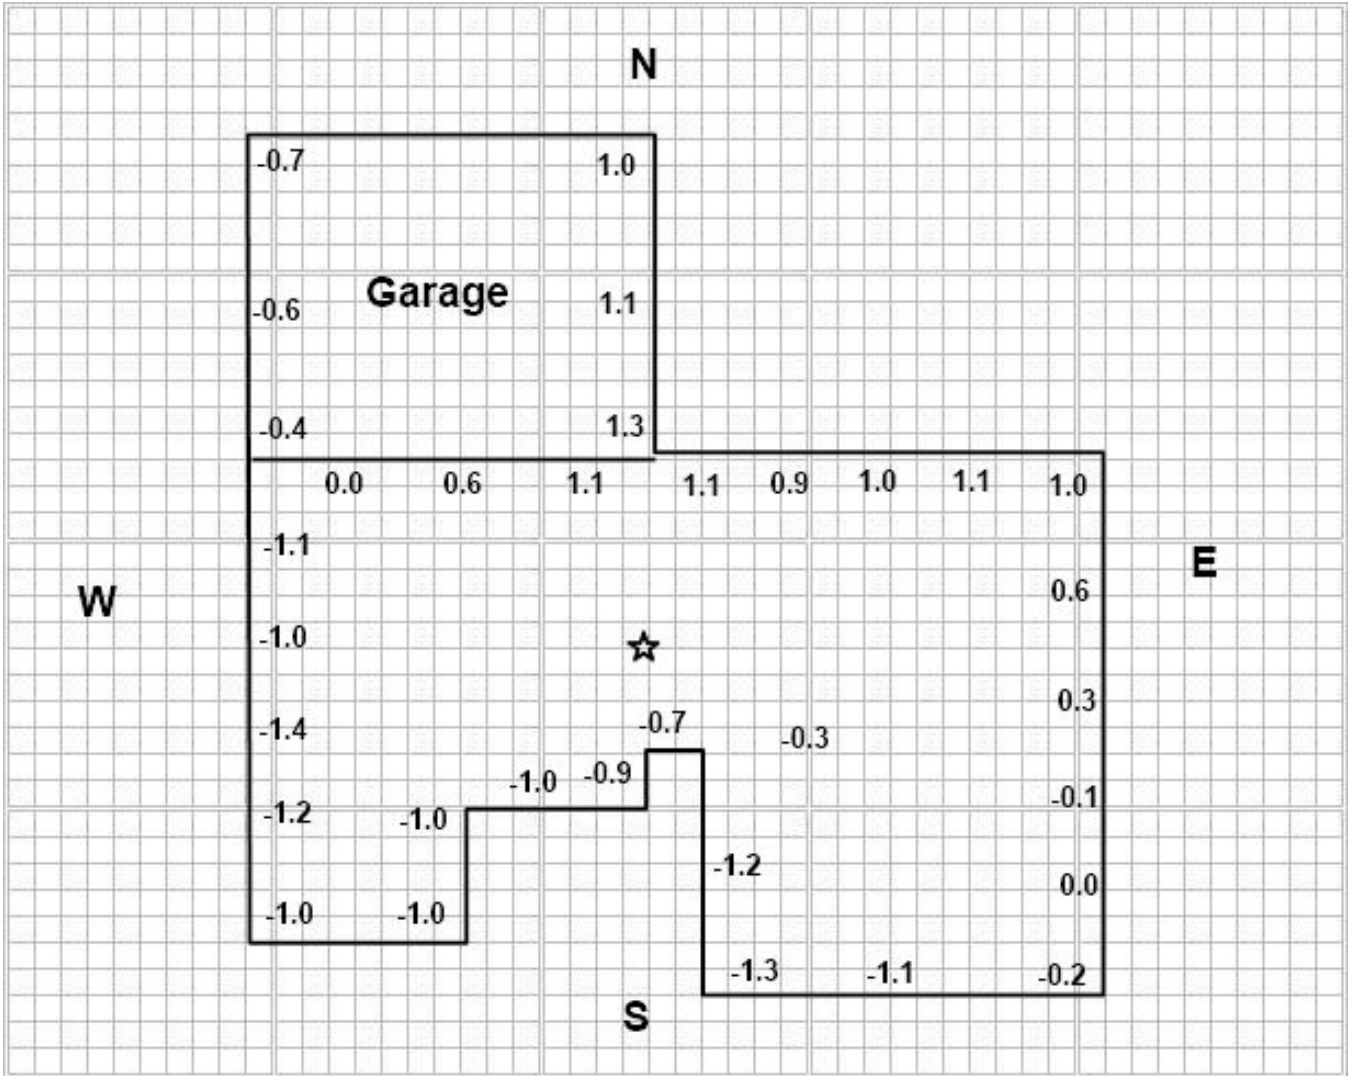
During the foundation elevation test, the area around the southwest corner showed a negative slope. The zero reference point is around the main entrance door. A certified foundation engineering precision evaluation is recommended.

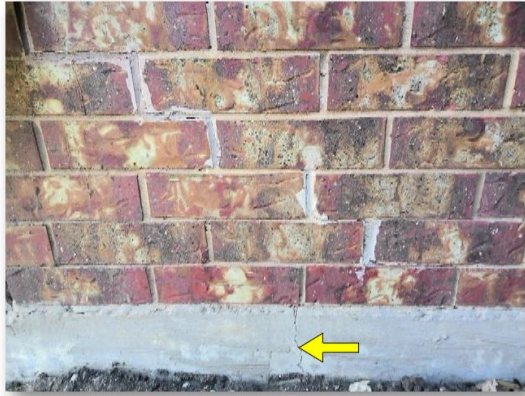
2. Minor cracking was noted at the foundation. This is common as concrete ages and shrinkage surface cracks are normal. Recommend monitoring for more serious shifting/displacement.

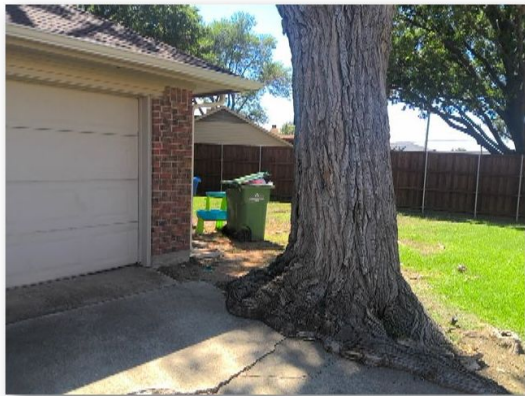
3. [Minor Concerns/Maintenance Items/FYI](#)
Tree(s) in close proximity of the foundation was observed. Client should consider the installation of a root barrier to reduce the possibility of damage to the foundation from tree roots and moisture removal, or have the trees taken down so that they do not damage the property over time.

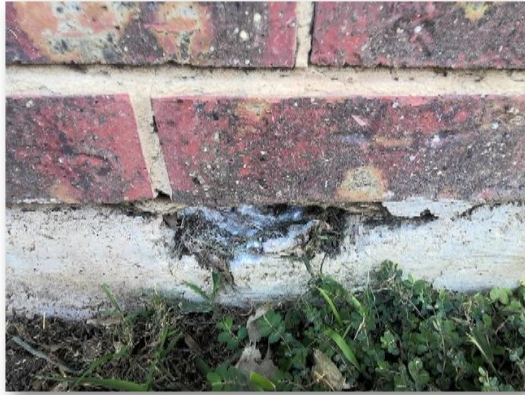
Some exterior corners of the concrete foundation walls were cracked or broken. Exterior corners are high-stress areas and this condition is not unusual in some older homes. The foundation appeared to be adequately supporting the exterior wall structure in these areas.

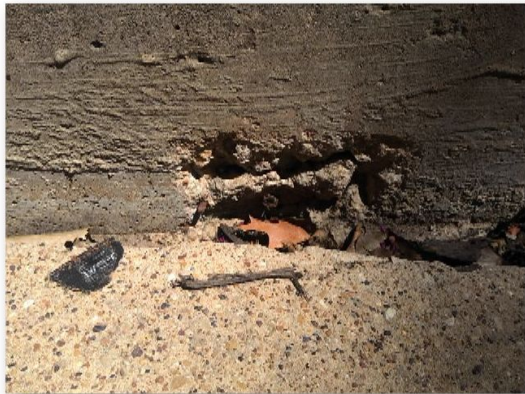
Unfinished foundation hardware, tie rods or snap ties observed at the time of inspection.

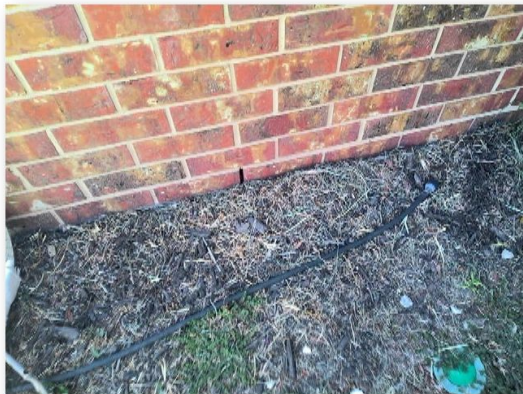
The portions of the concrete foundation wall surfaces minor crack in parge coat.

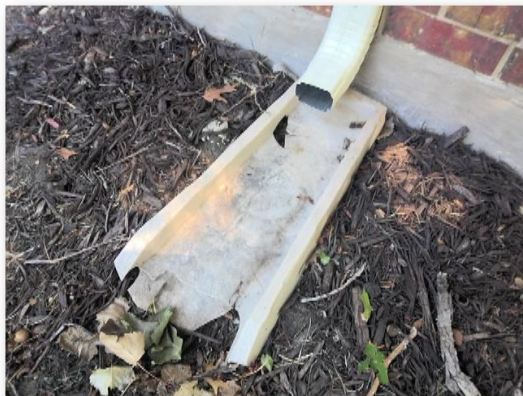
2. Grading and Drainage

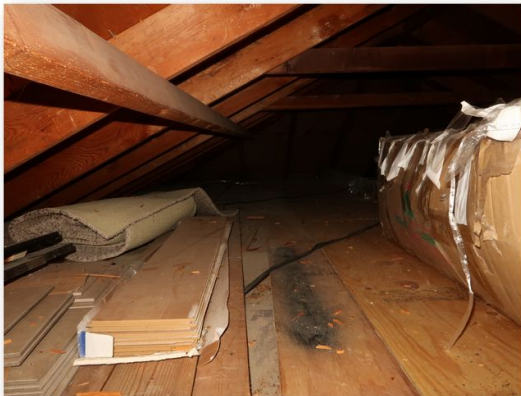
3. Roof Structures and Attics

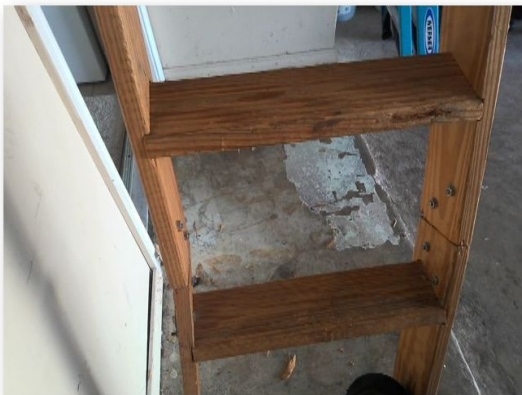
13. Attic staircase should be tighten a hardware. When step on the ladder, unstable balance from stair. **This is safety hazard.**

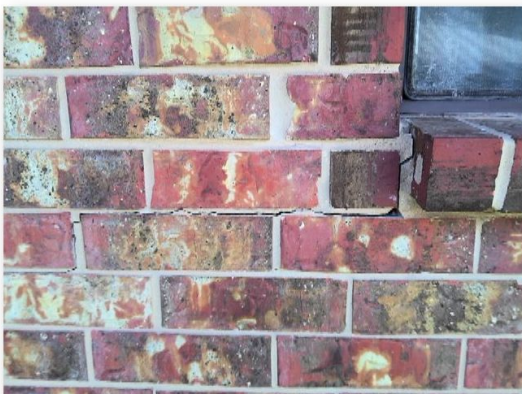
14. One or more common cracks were observed on the brick/stone veneer.

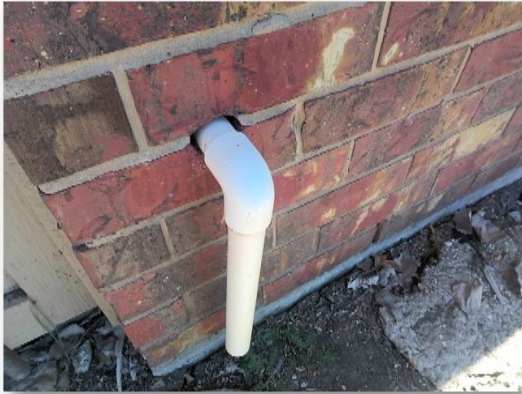
15. Pipes penetrating exterior walls left gaps that needed to be sealed by a qualified contractor with an appropriate sealant to prevent moisture and insect entry.

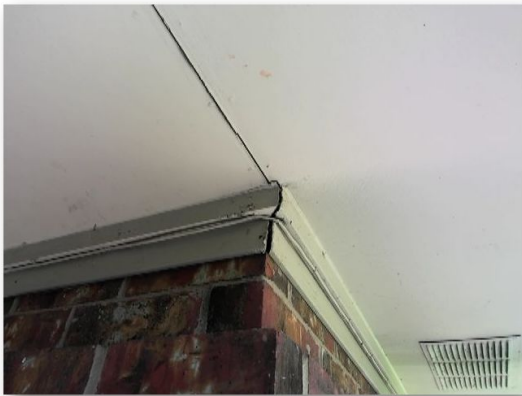
16. **The exterior wall trim had gaps that should be filled** with an appropriate sealant by a qualified contractor to help prevent moisture and insect entry.

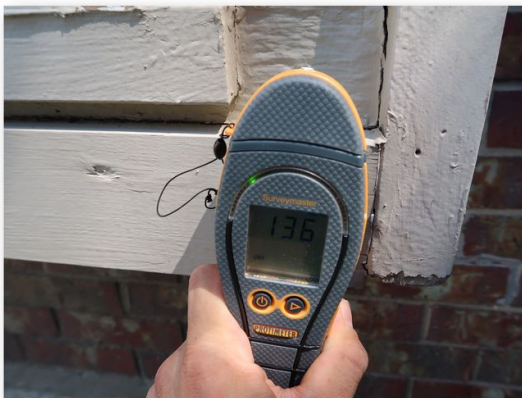
17. Wet and rotten wood draw increases the possibility of insect's invasion.

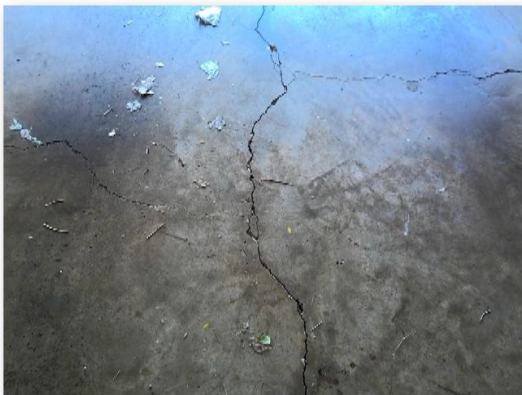
There are several areas where the ceiling and walls of the garage meet that show signs of chipping.

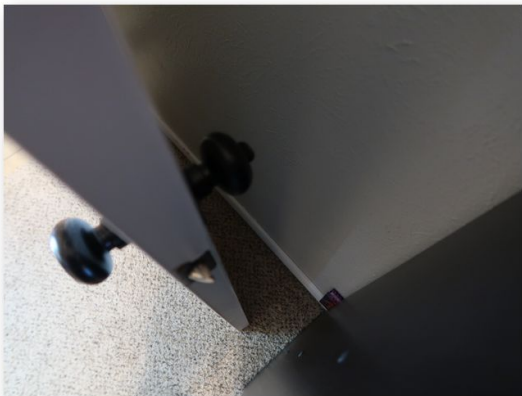
6. Doors (Interior and Exterior)

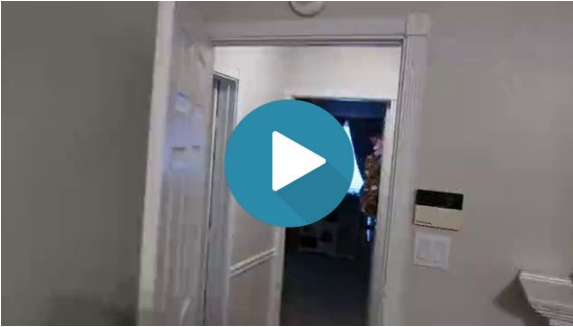
23. The interior door of the master bedroom automatically closes due to the floor being out of level.

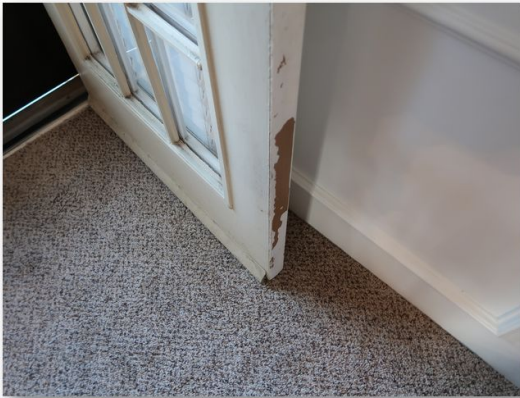
24. The exterior paint on the door is damaged and looks unappealing. It is recommended to adjust the hardware so it does not contact the door case, and then repaint the door.

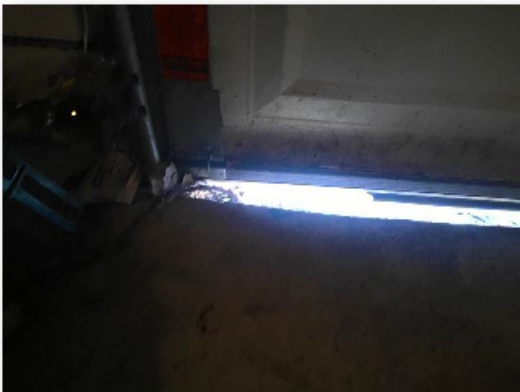
26. Garage door was observed penetrations had gaps indicate at time of inspection

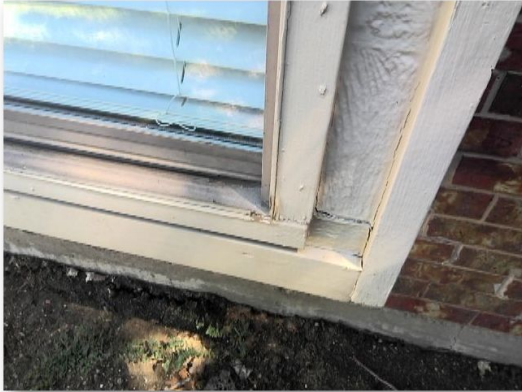
27. Windows and trim outside the house require caulking to prevent possible moisture damage

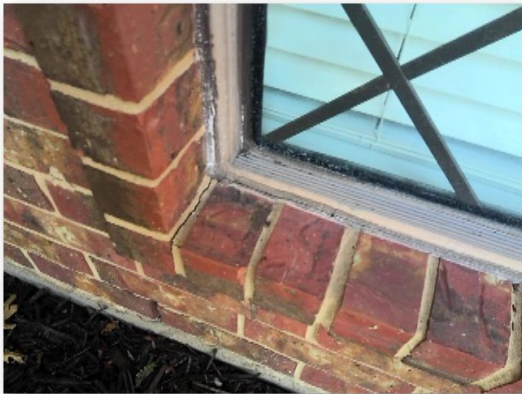
28. Outside window brick wall was observed hairline crack, require patch to prevent possible moisture damage

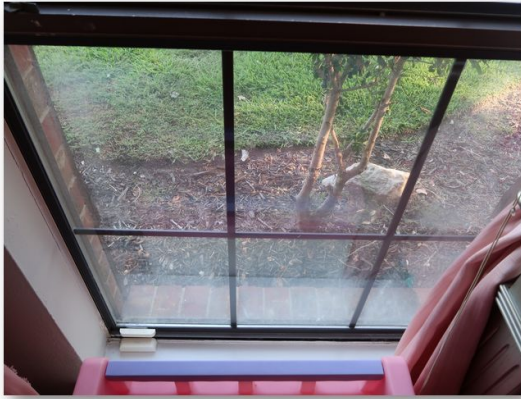
30. Front room windows are missing screen observed.

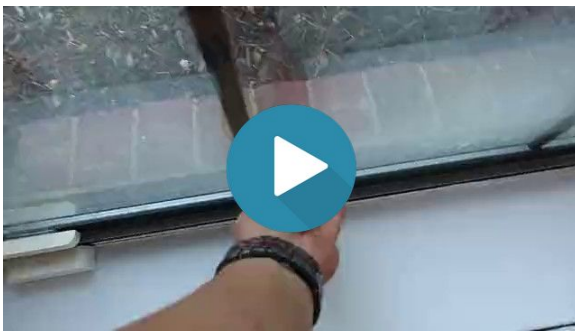
31. Windows are old, most window were difficult to operate and needed maintenance.

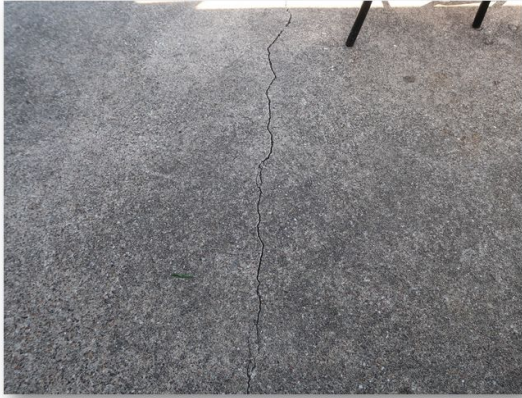
36. There are tile cracks and hairline cracks in the floors of the front porch and backyard patio.

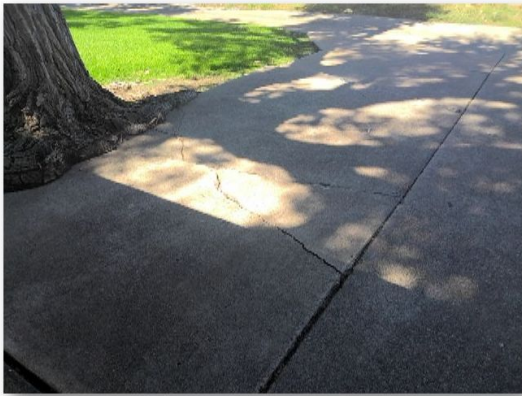
37. The driveway at the back of the house shows significant cracking due to tree roots.

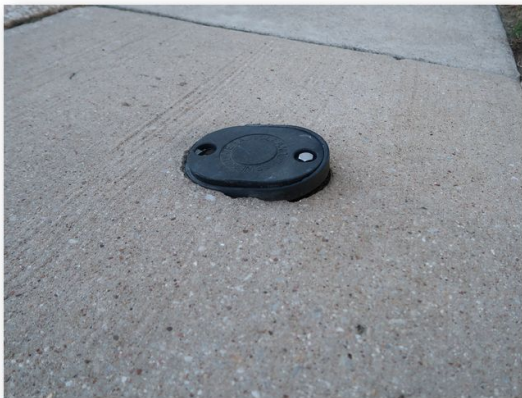
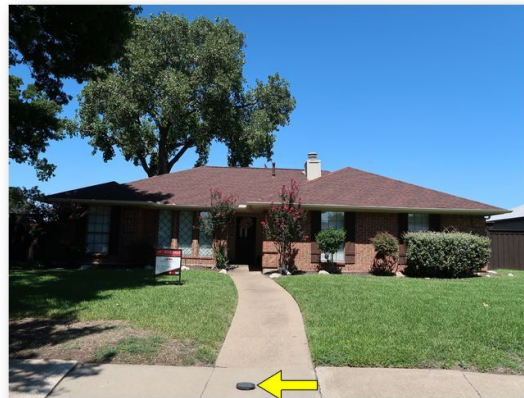
38. The city sewer line cover is protruding above the walkway floor.

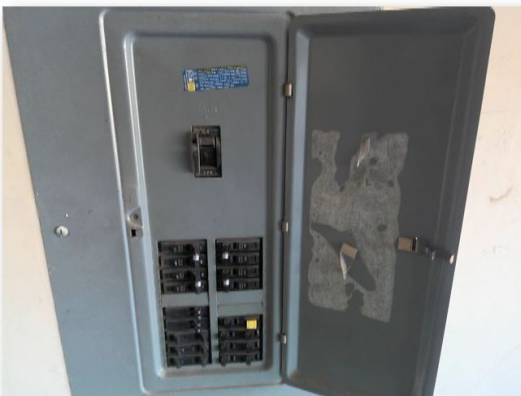
41. Various minor issues have been found in the electrical panel. An evaluation by a licensed electrician is needed.

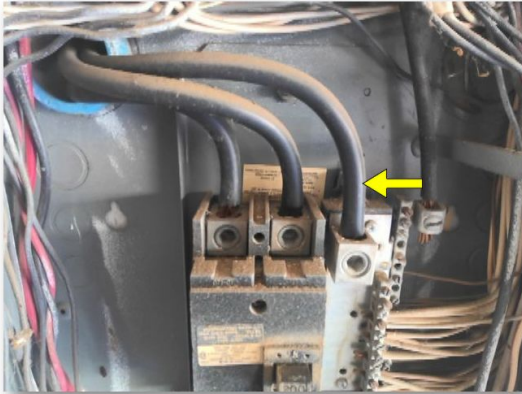
43. The main neutral line does not have a white marking for identification.

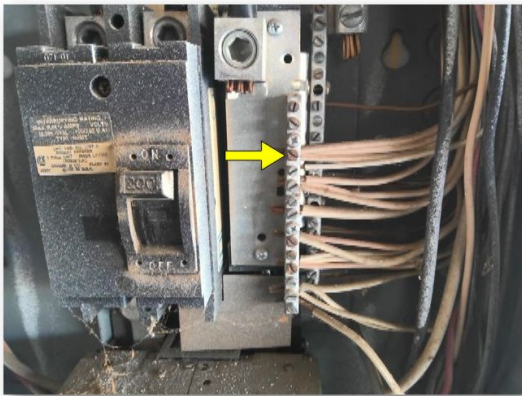
44. Components in this service panel were corroded,

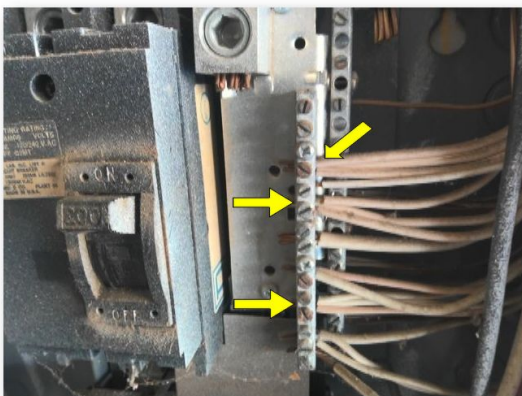
45. There are double tapped neutral conductors in the electric service panel.

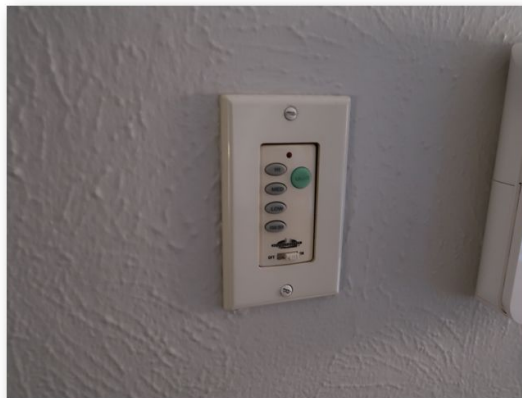
- Ceiling fans inoperable or in need of repair

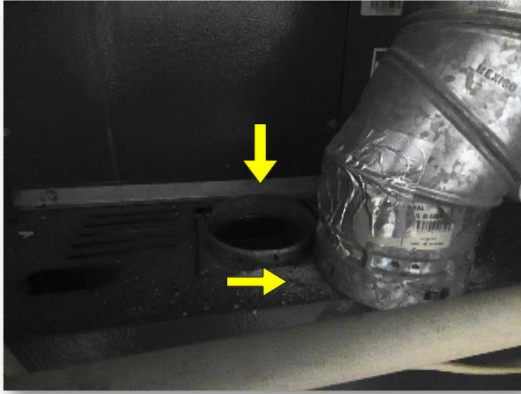
12. Heating Equipment

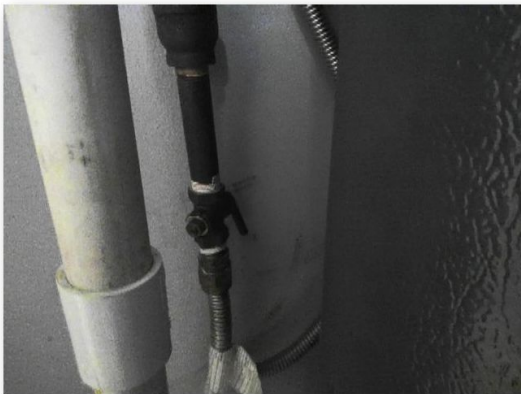
▲Significant/Major Concerns
The furnace combustion exhaust vent was separated.

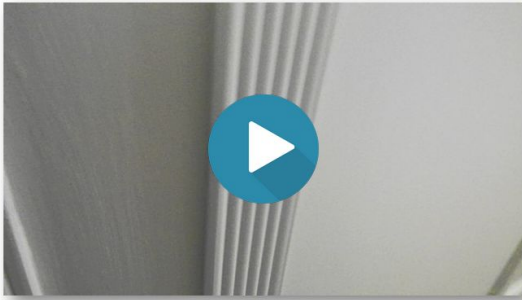
51. **When the furnace is operating and the blower is running, the noise is excessively loud.**

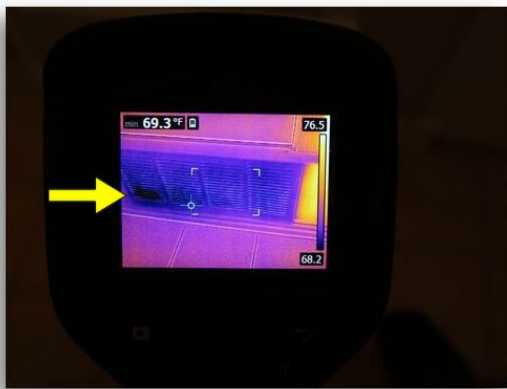
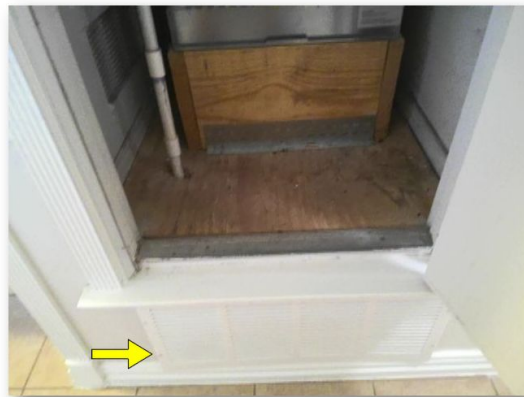
52. Moisture was detected by an infrared camera near the lower condensate drain line of the furnace return.

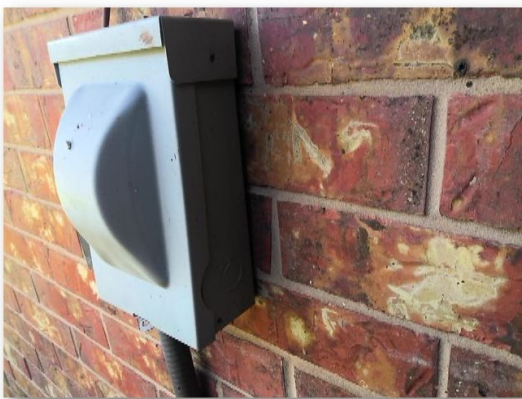
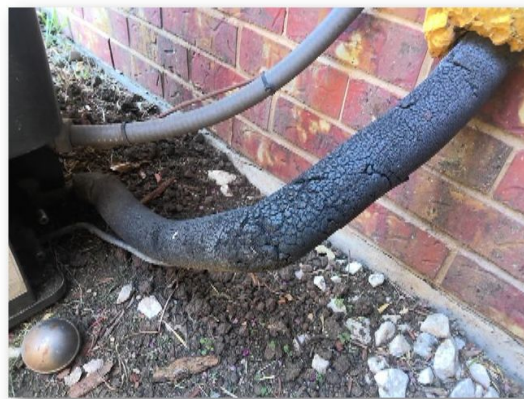
53. The insulation on the suction line of the outdoor AC unit is old and heavily worn. Replacement is recommended. Additionally, silicone sealing is needed around the area between the exterior wall and the fuse case.

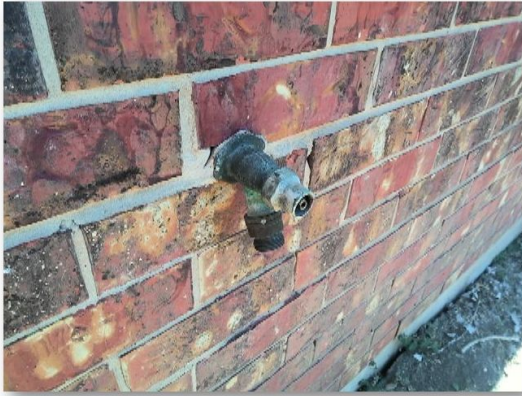
54. One of exterior faucet missing the handle.

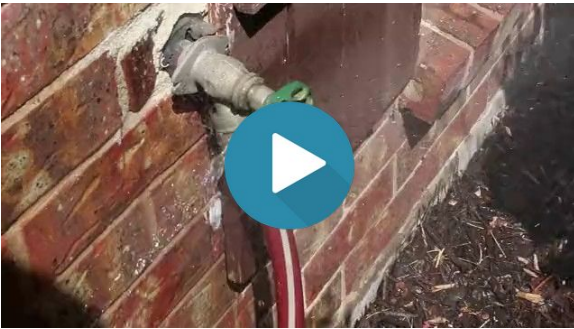
55. An exterior faucet near the front of the home was leaking.

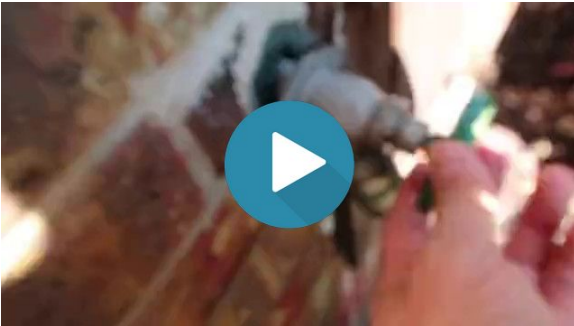
56. One of the exterior hose bibs is severely loose. It should be secured to prevent damage to the pipe.

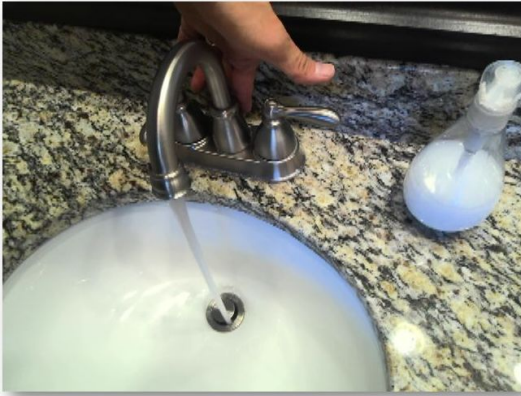
15. Drains, Wastes, and Vents

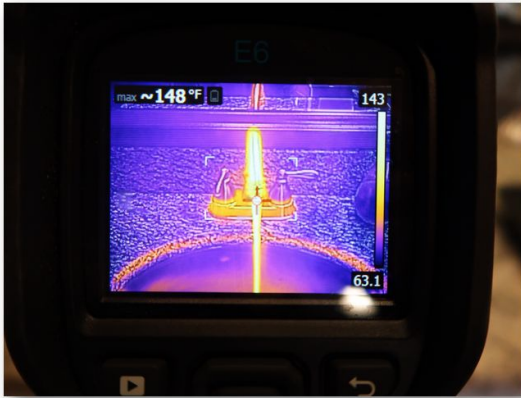
60. **The water temperature is generally set too high.** The recommended maximum temperature is 120°F to prevent the risk of burns, especially to children's hands.

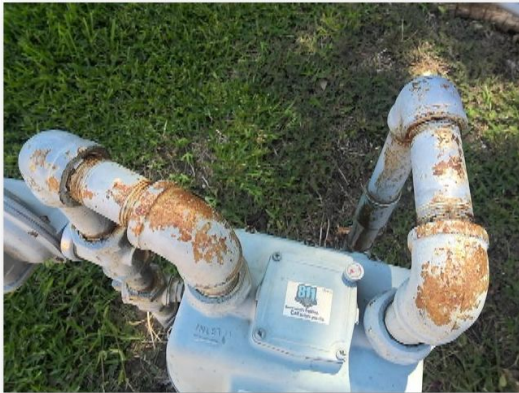
61. Gas pipes at the meter exhibited corrosion.

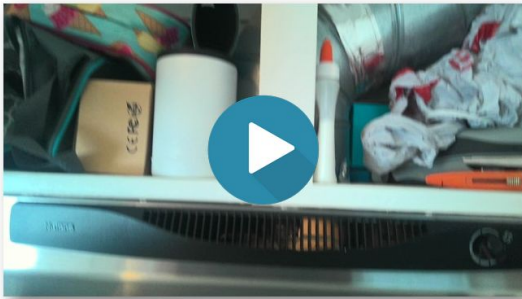
19. Range Hood and Exhaust Systems

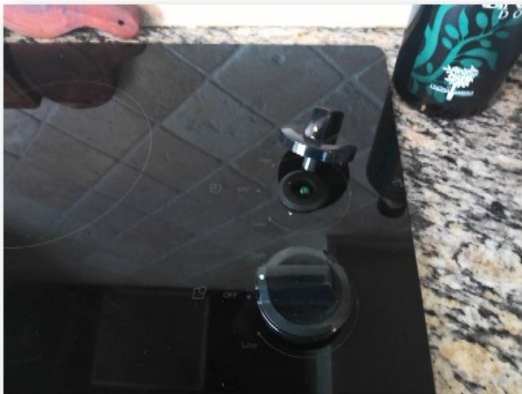
20. Ranges, Cooktops, and Ovens

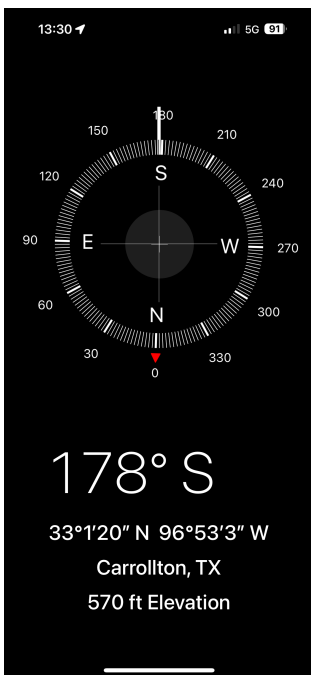
House Direction of Front

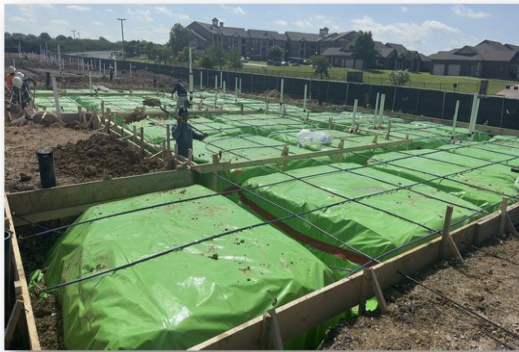
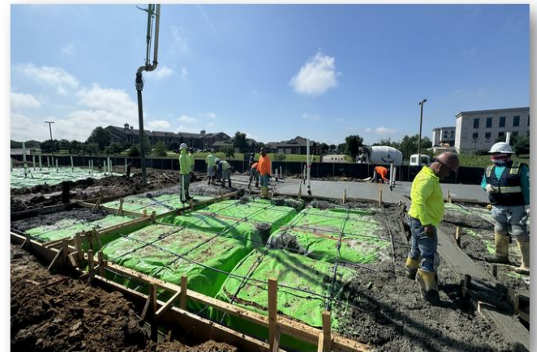
Foundation construction included a post-tensioned slab-on-grade. Post-tensioning is a method in which cables embedded in the concrete floor slab are placed under permanent tension by stretching them. This places the entire concrete slab under compression, which improves its performance. Care must be taken during any renovations not to damage cables by drilling or cutting into the concrete slab or shooting steel pins into concrete with a powder-actuated tool. This condition can be dangerous and may cause serious or fatal injury.

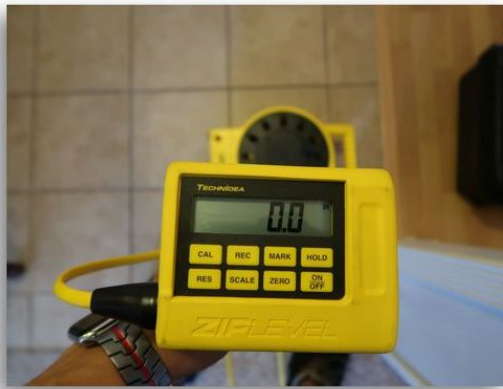
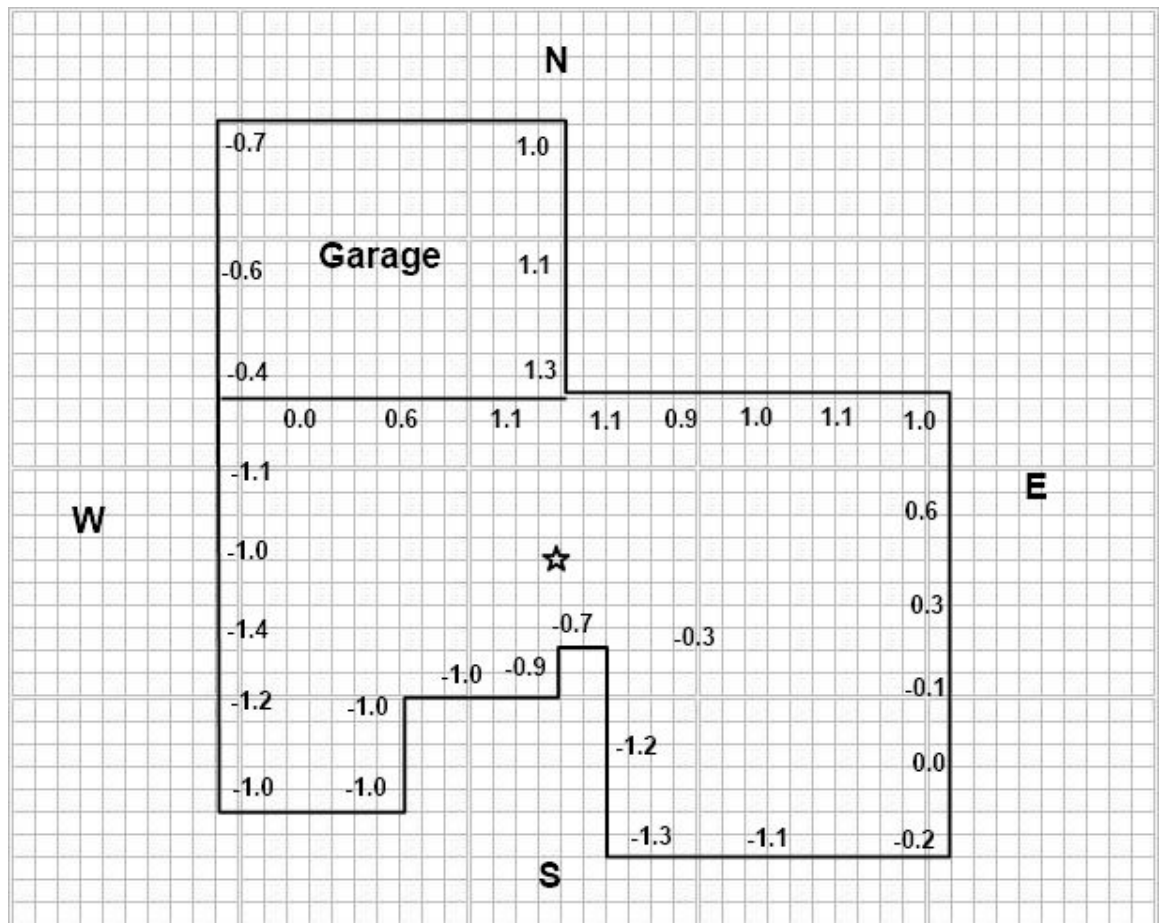
During the foundation elevation test, the area around the southwest corner showed a negative slope. The zero reference point is around the main entrance door. A certified foundation engineering precision evaluation is recommended.

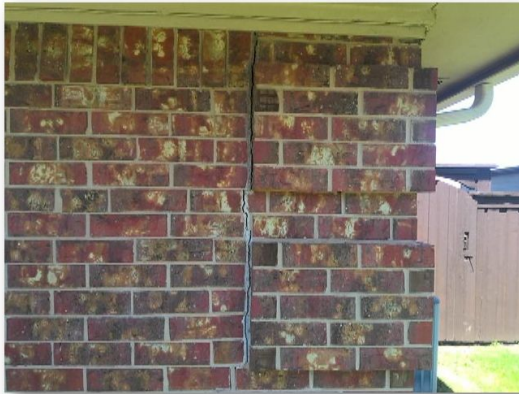
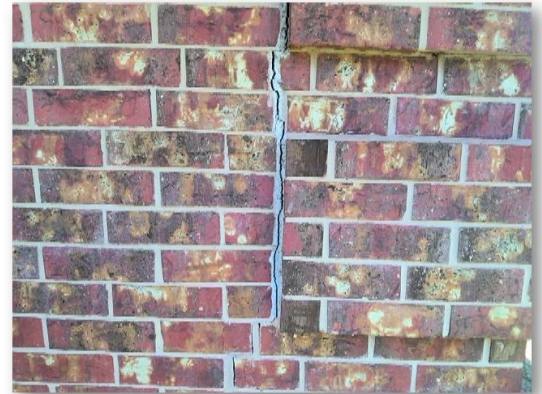
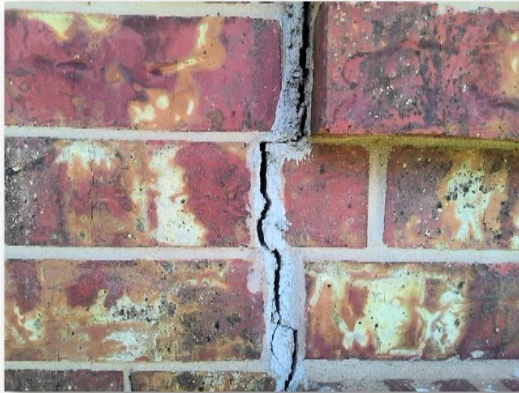
Disclaimer: The attached elevations are provided for informational purposes only and should not be used for serious negotiations. PrimeVue Home Inspections inspectors are not qualified professional engineers and do not attempt to imitate one. If you have concerns about the foundation's life expectancy, insurability, or potential for future problems, a professional engineer should be consulted.

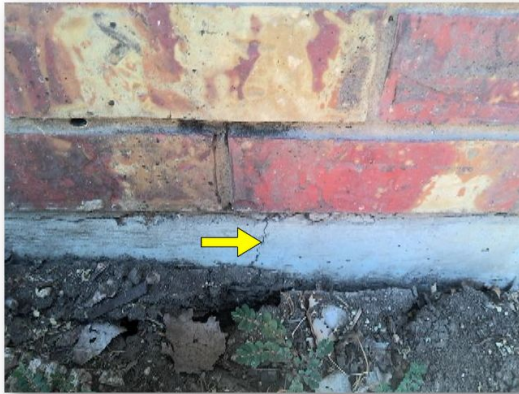
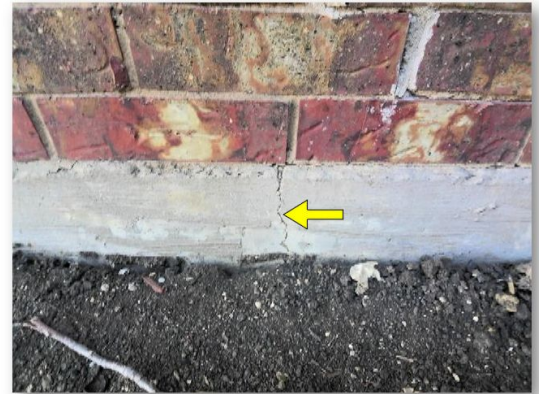
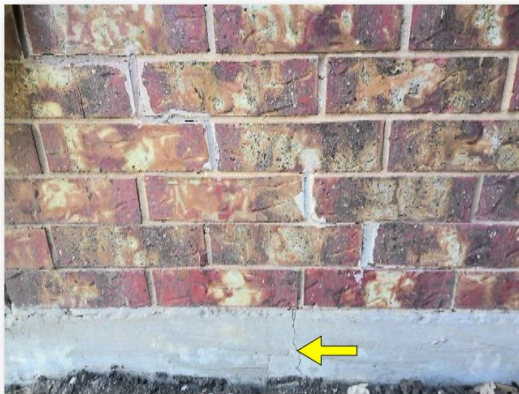
Minor cracking was noted at the foundation. This is common as concrete ages and shrinkage surface cracks are normal. Recommend monitoring for more serious shifting/displacement.

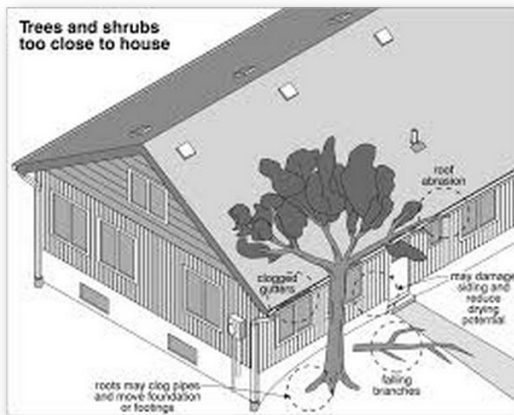
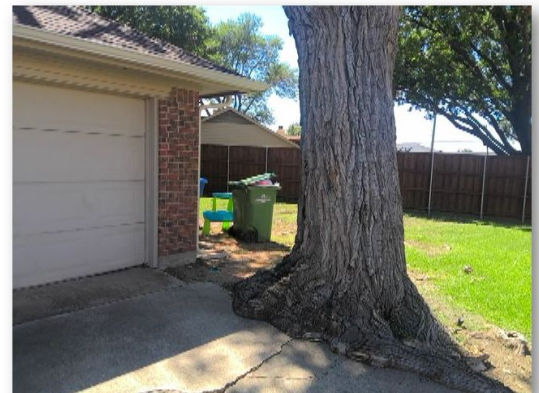
Minor Concerns/Maintenance Items/FYI

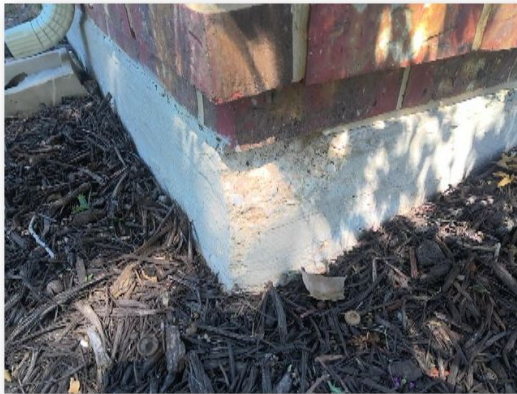
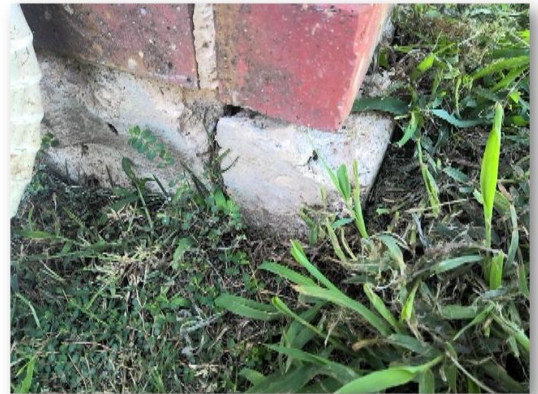
and moisture removal, or have the trees taken down so that they do not damage the property over time.

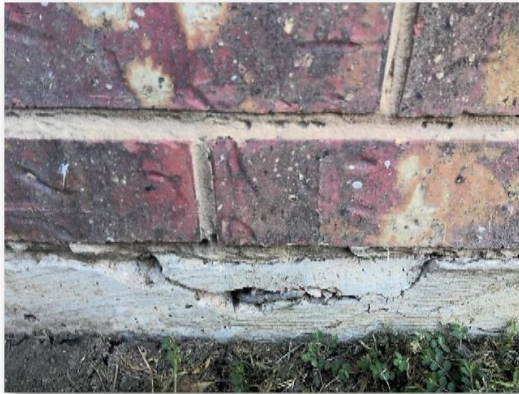
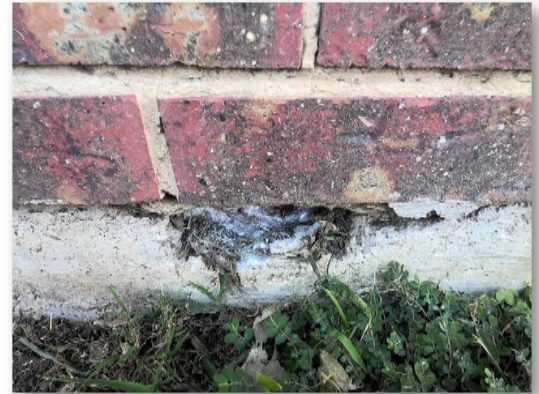
Minor Concerns/Maintenance Items/FYI

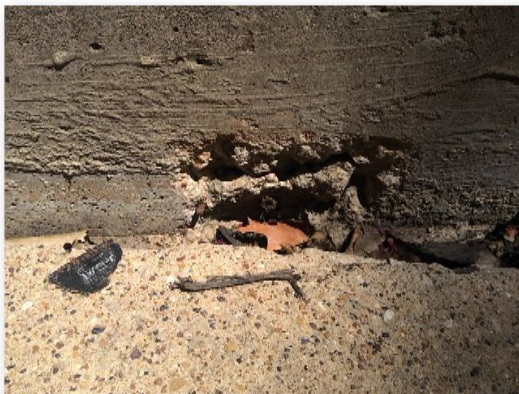
Minor Concerns/Maintenance Items/FYI

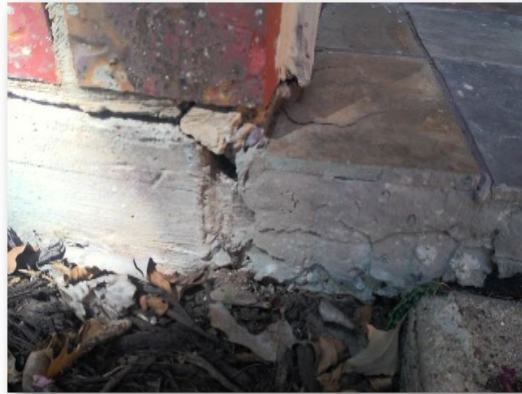
Minor Concerns/Maintenance Items/FYI

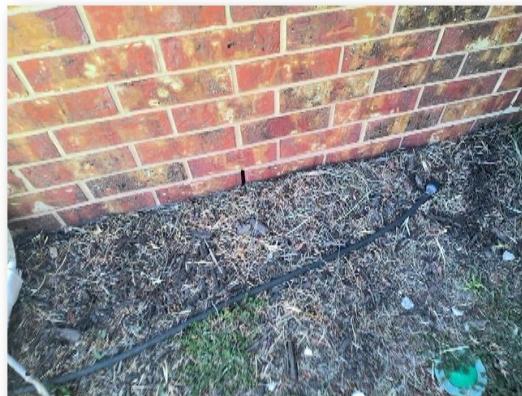
Minor Concerns/Maintenance Items/FYI

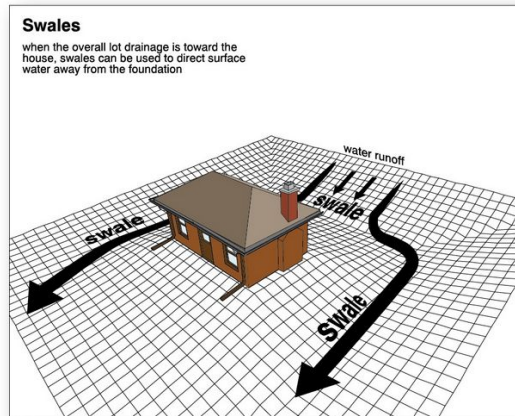
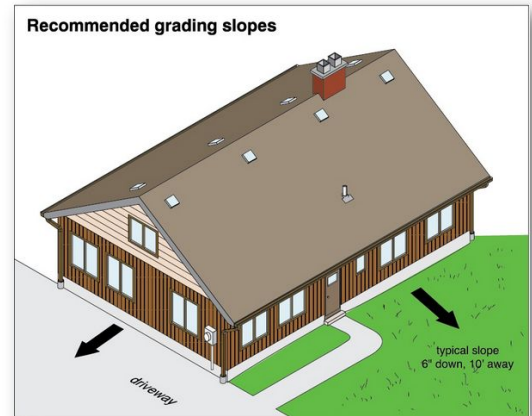
Proper drainage is critical to the performance of the foundation. All grades should slope away from the structure at a rate of 6 inches for every 10 feet.

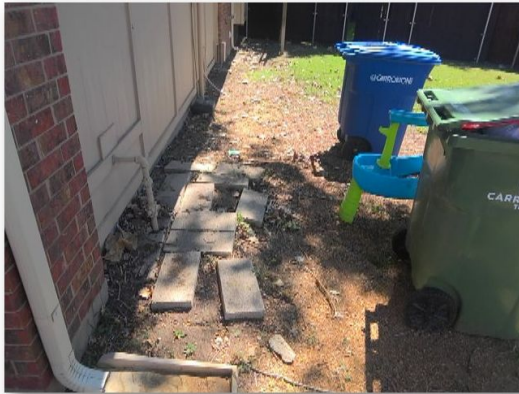
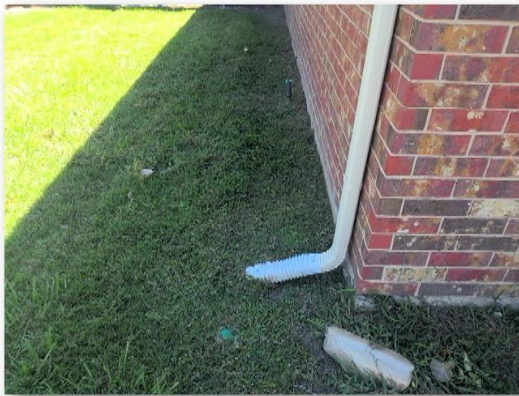
Missing Splash Gaurd

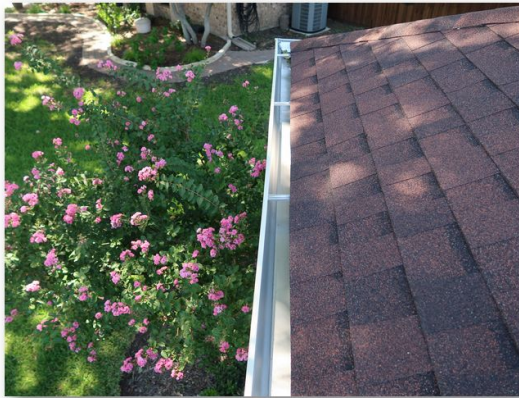
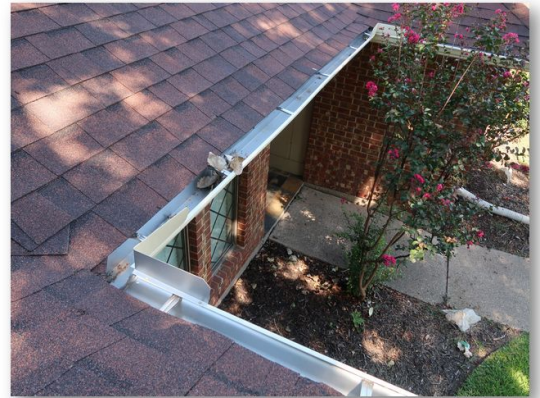
The items listed below are the Inspectors observations of deficiencies and/or exceptions if any associated with the **gutter & downspout system** that were noted on this structure at the Time of the Inspection:

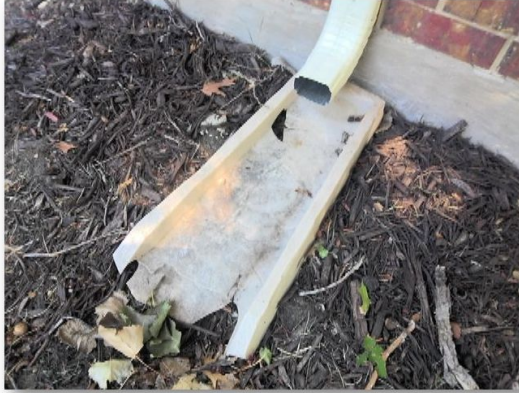
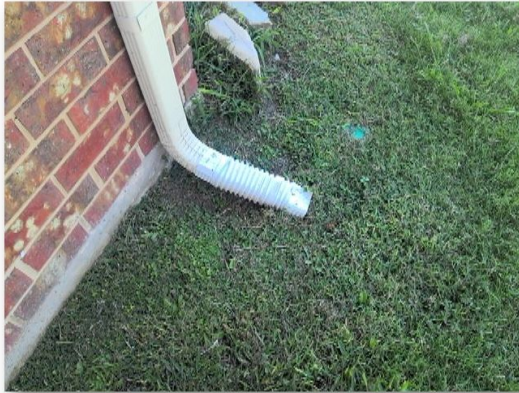
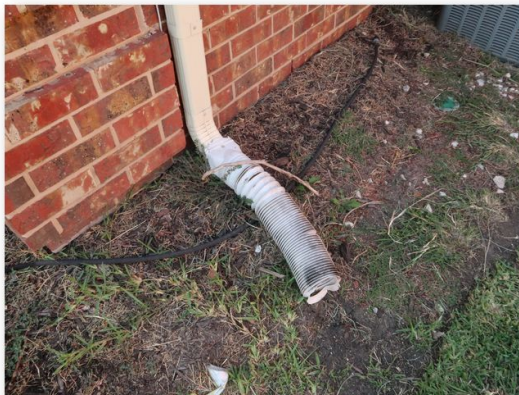
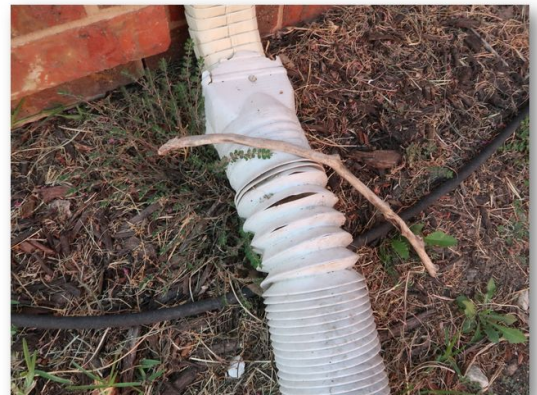
The gutters of this house appear to have been recently replaced, but overall, the condition of the splash guards is poor or they are missing. Additionally, damage was found at the time of inspection where the downspouts meet the ground. Overall, the rainwater drainage system requires maintenance.

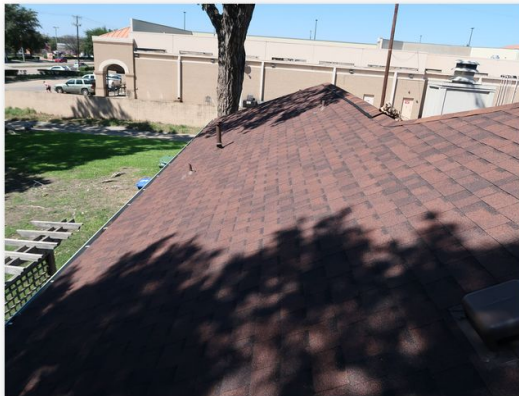
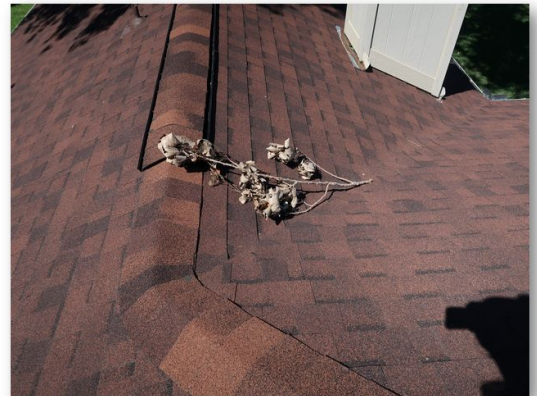
The items listed below are the Inspectors observations of deficiencies and/or exceptions if any associated with the **Roofing Material** that were noted on this structure at the time of the Inspection:

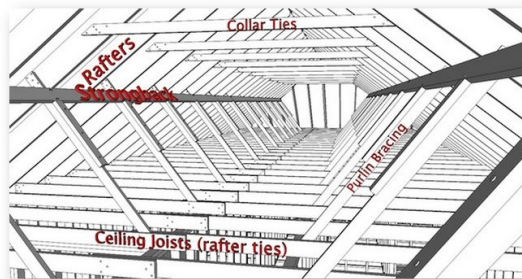
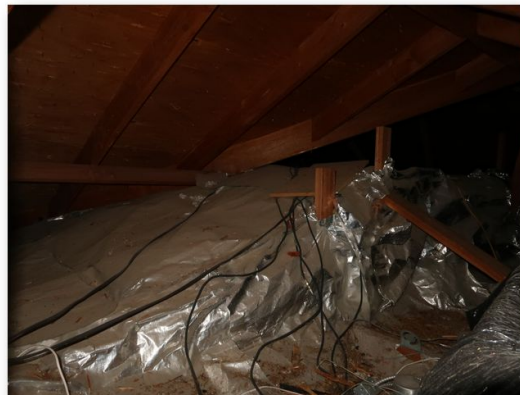
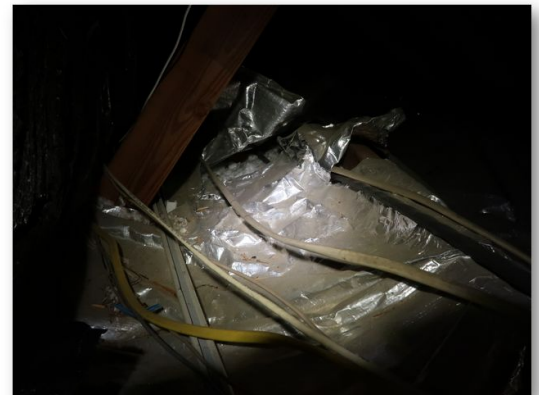
At the time of the Inspection it was the Inspectors opinion that your Roofing and Attic structure appeared to be in Operable Condition.

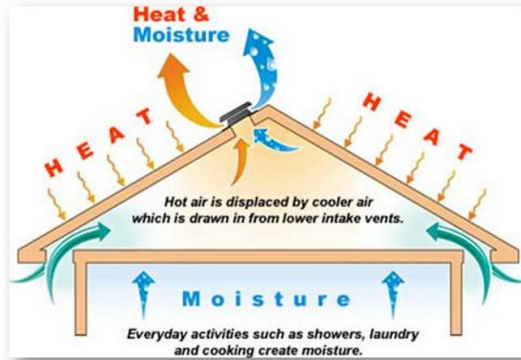
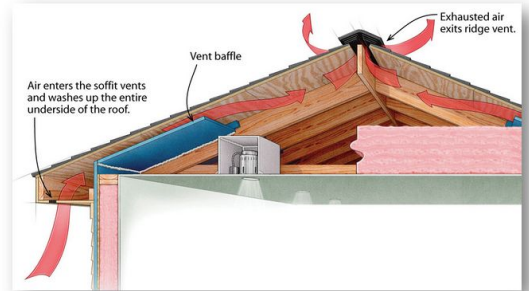
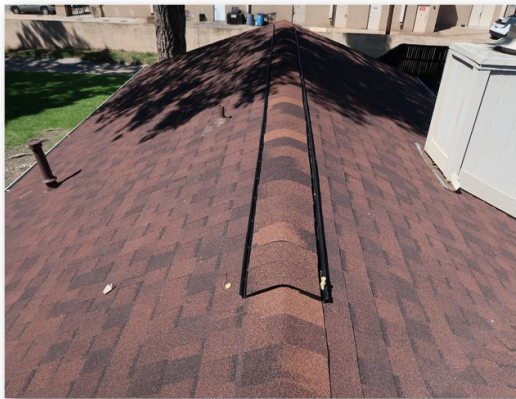
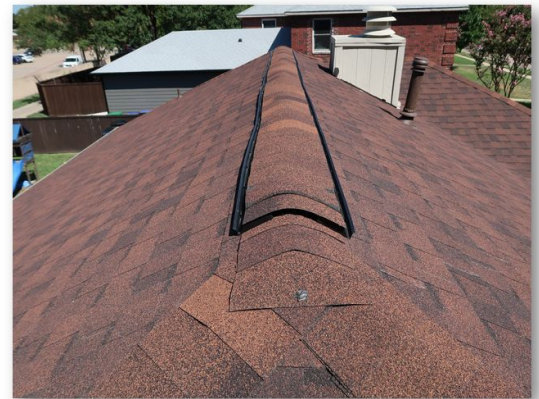
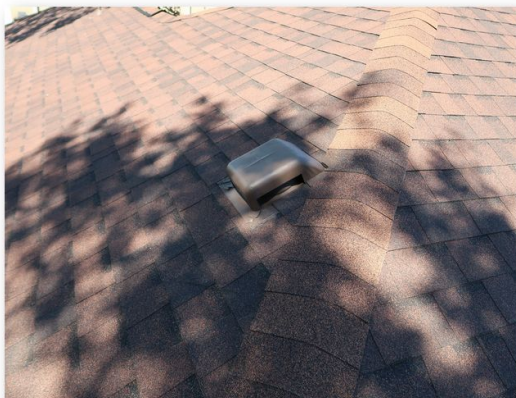
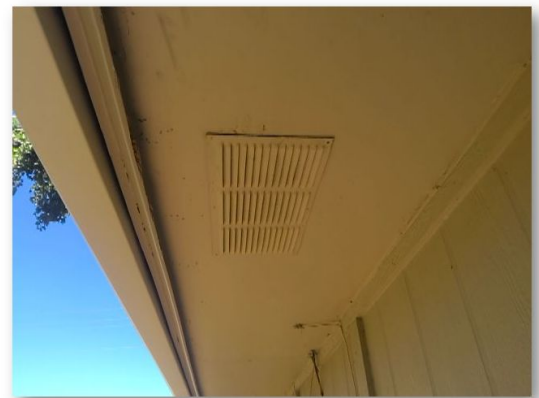
The items listed below are the Inspectors observations of deficiencies and/or exceptions if any associated with the Roof Structure and Attics that were noted on this structure at the time of the Inspection:

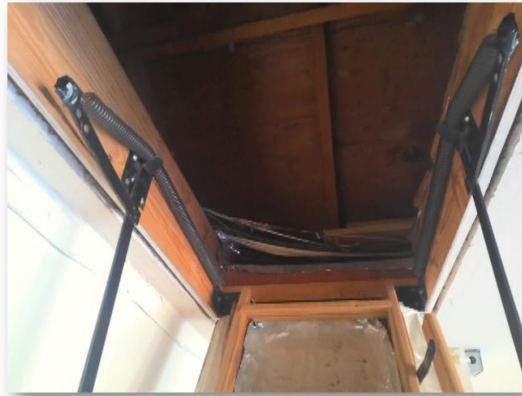
The pull-down ladder access is positioned in reverse, making it difficult to access the attic.

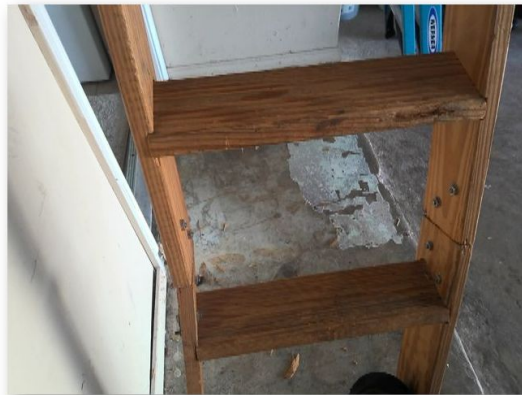
Attic staircase should be tighten a hardware. When step on the ladder, unstable balance from stair. **This is safety hazard.**

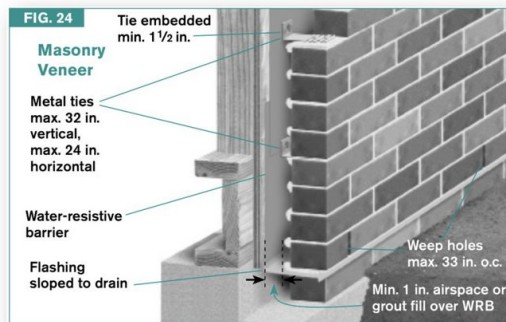
- Siding Materials: Brick Stone Wood Wood byproducts Stucco
 Vinyl Aluminum Asbestos Fiber Cement Board Other

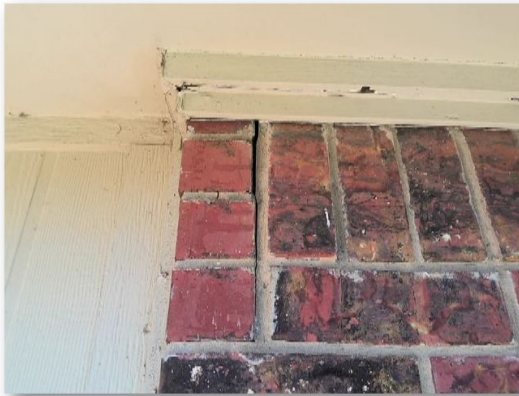
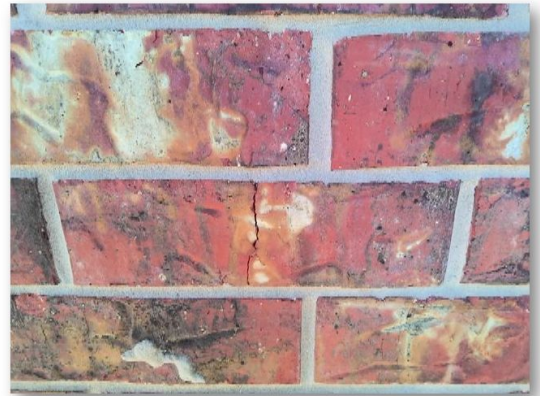
The items listed below are the Inspectors observations of deficiencies and/or exceptions if any associated with the **Exterior Wall** that were noted on this structure at the Time of the Inspection:
