HOME AND TERMITE INSPECTIONS
254-727-0900
1234 DALLAS

Inspected by Jude Hwang TREC #25266

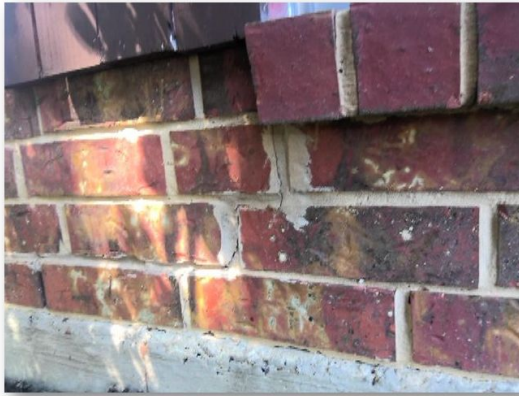
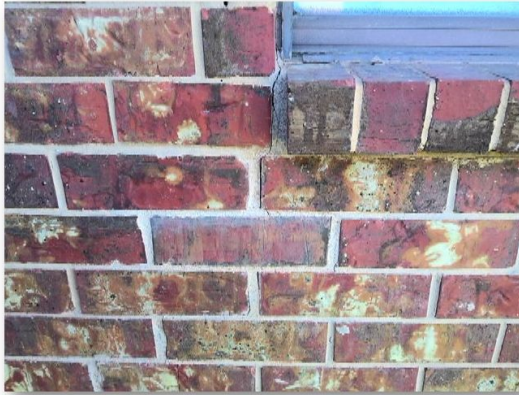
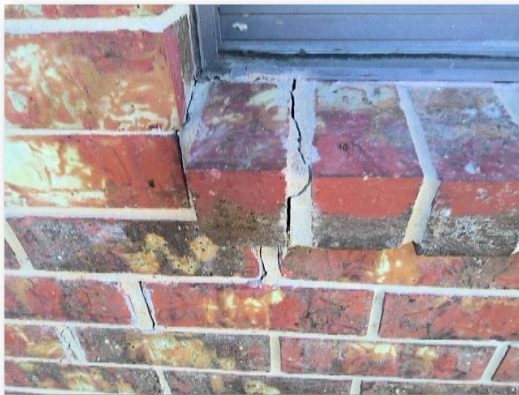
One or more common cracks were observed on the brick/stone veneer. This may be due to normal settling and/or thermal movement of the building materials. These areas should be sealed to prevent moisture penetration and monitored for further signs of movement.

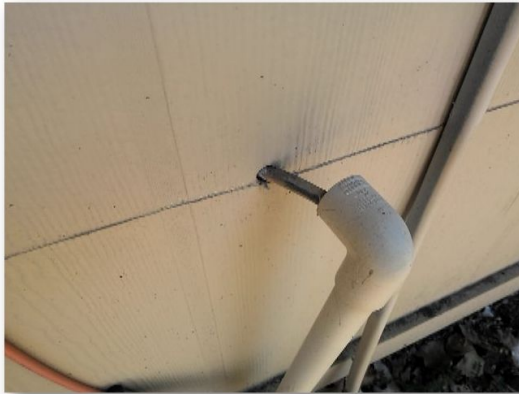
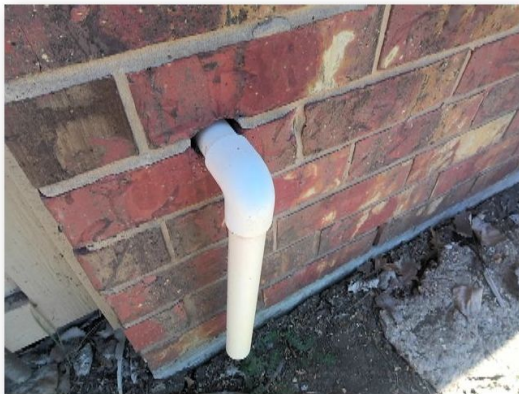
Pipes penetrating exterior walls left gaps that needed to be sealed by a qualified contractor with an appropriate sealant to prevent moisture and insect entry.

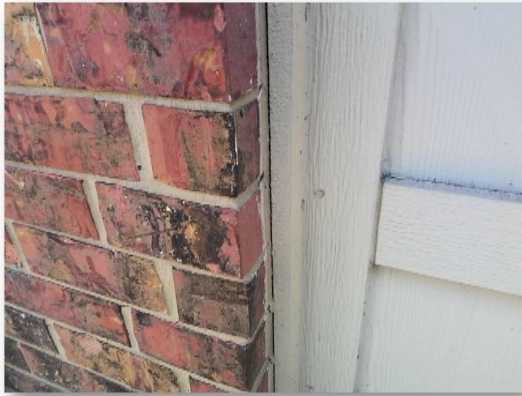
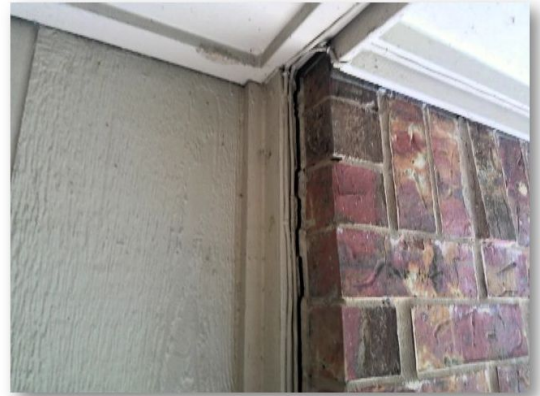
I	NI	NP	D
---	----	----	---

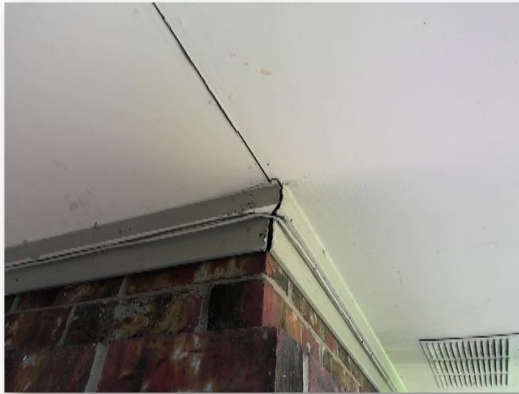
The exterior wall trim had gaps that should be filled with an appropriate sealant by a qualified contractor to help prevent moisture and insect entry.

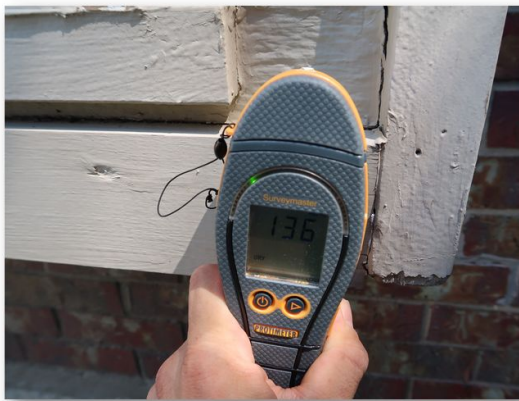
Wet and rotten wood draw increases the possibility of insect's invasion. By repairing these areas you reduce the possibility of infestation. When replacing this wood we recommend using a man made material such as a James Hardi board. It more resistant to moisture and insects.

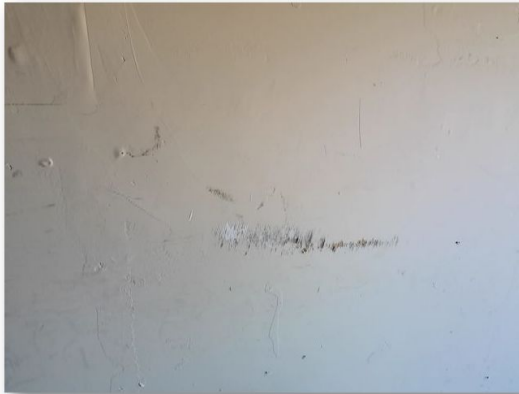
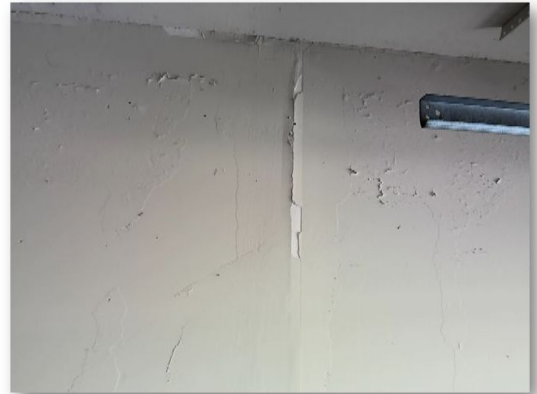
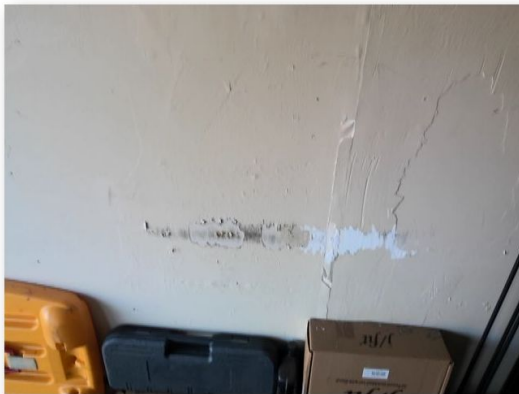
Drywall patches installed in the garage were poorly executed. Drywall seams visible in the walls of the garage were typical of poor installation.

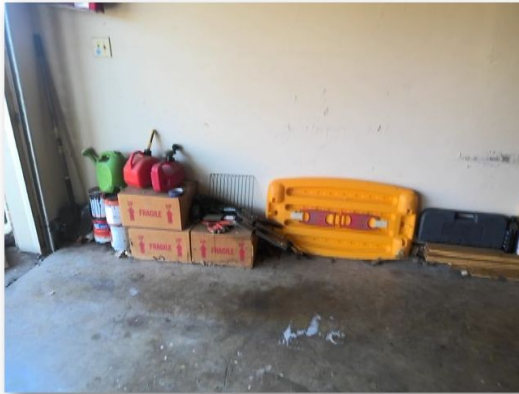
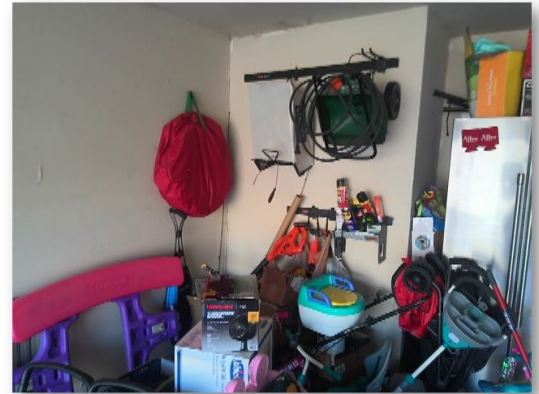
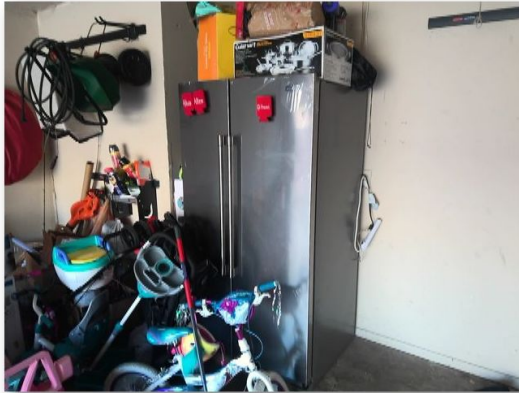
During the inspection of the property, it was noted that some of the garage space was obstructed by the owner's personal items. The presence of these items limited the ability to fully assess the condition and functionality of the garage.

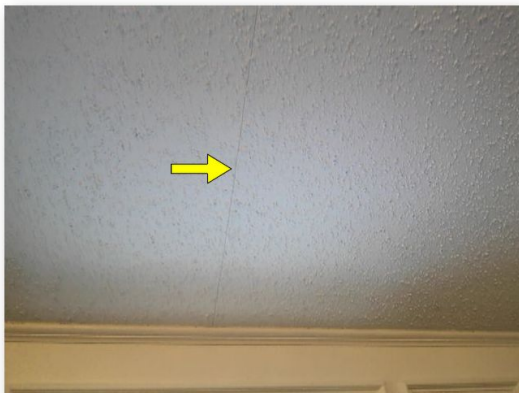
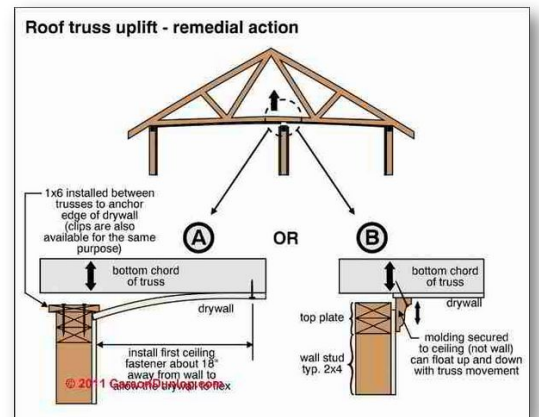
In the Inspectors opinion the **Ceilings** appeared to be in **Operable Condition** on the Day of this Inspection.

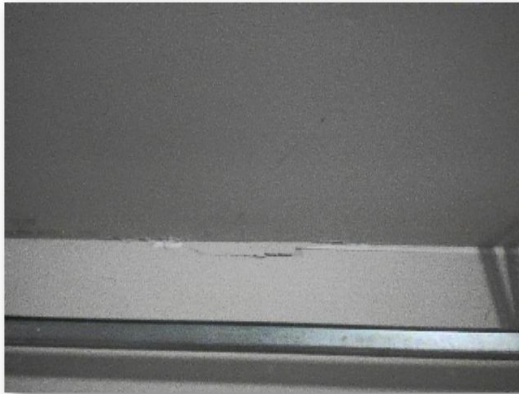
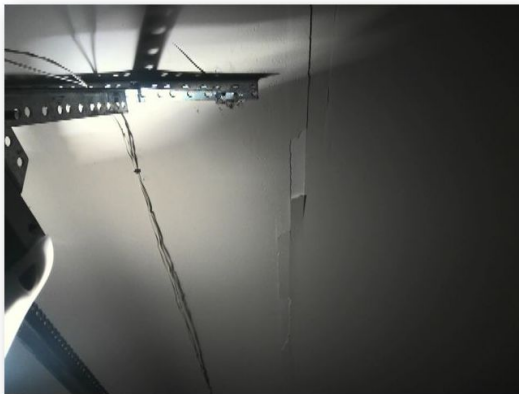
There are several areas where the ceiling and walls of the garage meet that show signs of chipping. Patching is needed, and since this could be due to structural movement, ongoing monitoring is recommended.

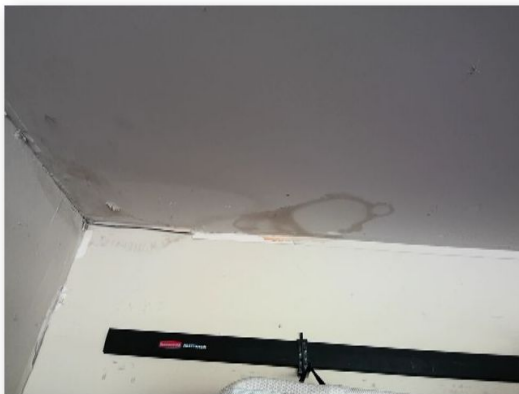
Water stains were discovered on the garage ceiling, but an infrared camera scan indicated no moisture retention.

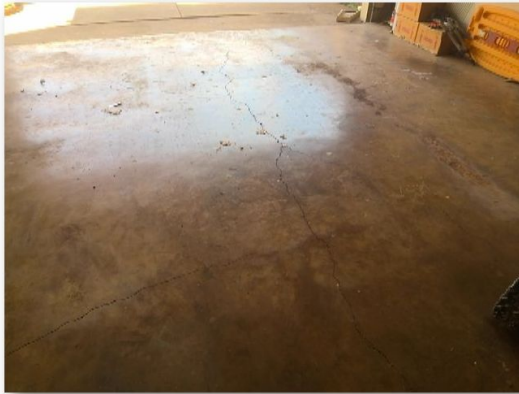
The following observations, deficiencies and/or exceptions if any associated with the **Garage Floor** that were observed on this house are noted below

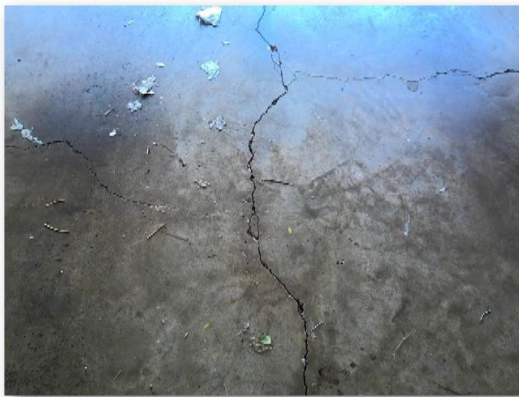
The garage floor appears to have cracks that exceed the standard threshold, likely due to the influence of the roots from the large tree in front.

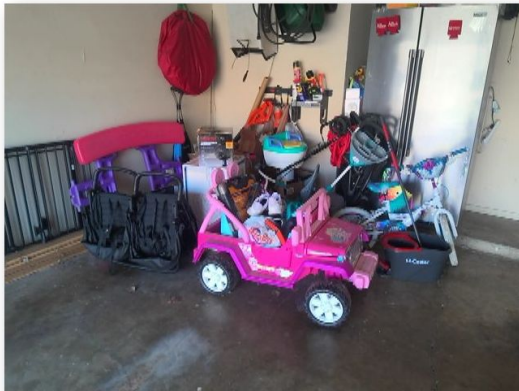
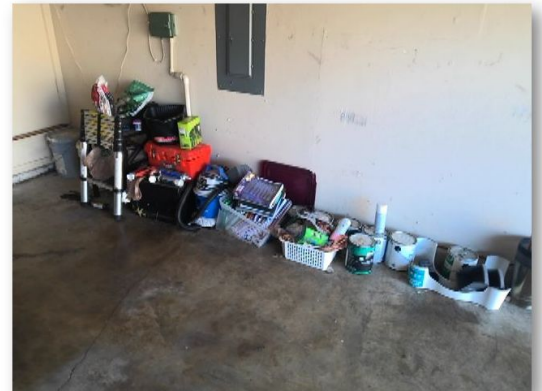
During the inspection of the property, it was noted that the some of garage space was

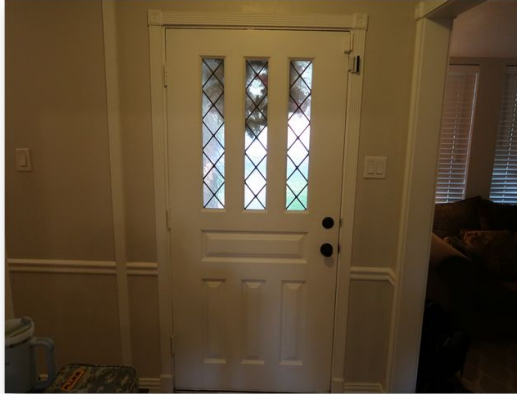
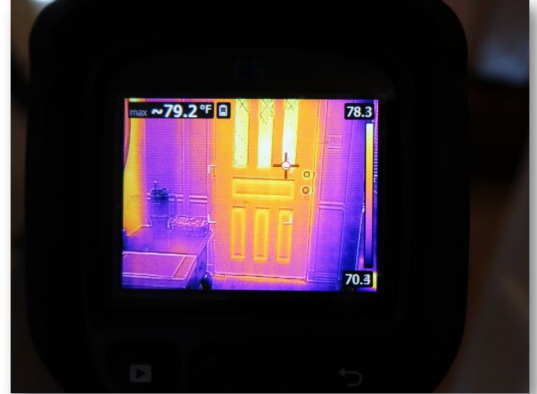
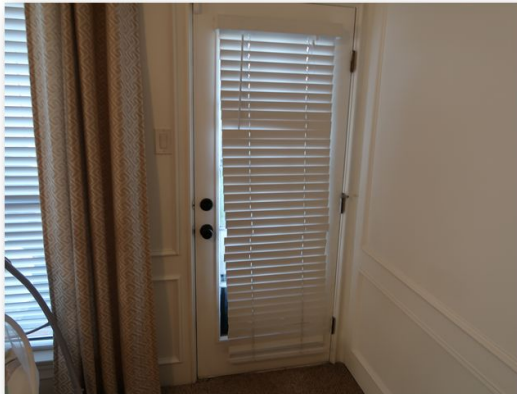
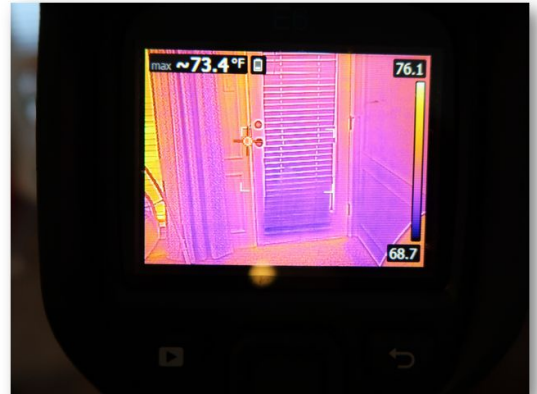
At the time of the Inspection the **Interior and Exterior Doors** appeared to be in **Operable Condition**.

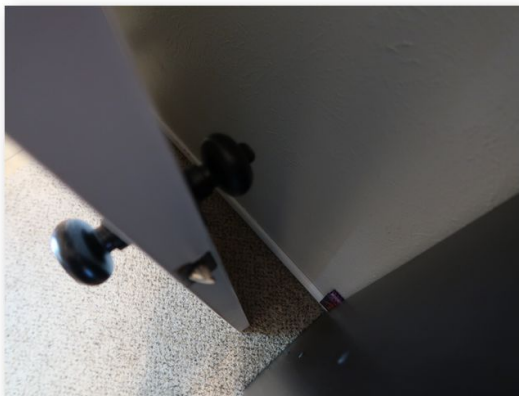
An interior doors were missing a stopper. This condition is may result in wall and door damage. A stop be installed to protect the wall.

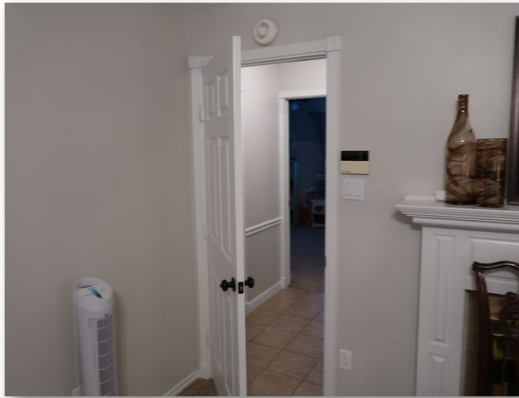
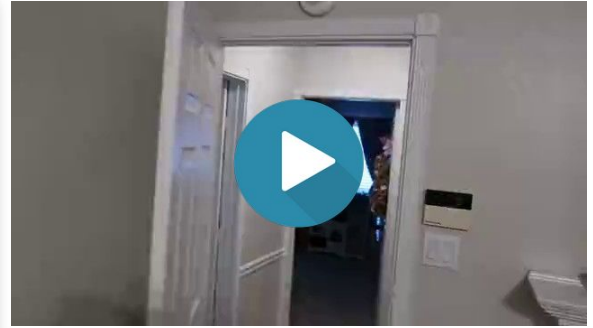
The interior door of the master bedroom automatically closes due to the floor being out of level. This could be related to structural movement. However, this issue can be corrected with door hardware adjustments.

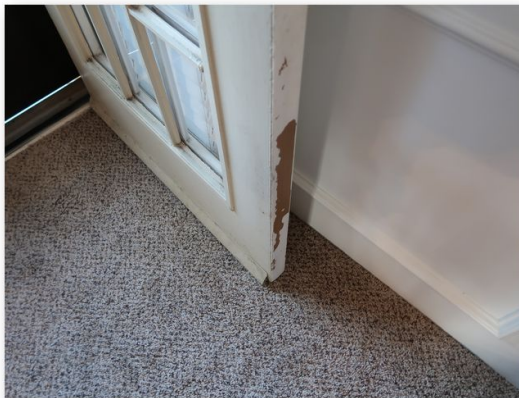
The exterior paint on the door is damaged and looks unappealing. It is recommended to adjust the hardware so it does not contact the door case, and then repaint the door.

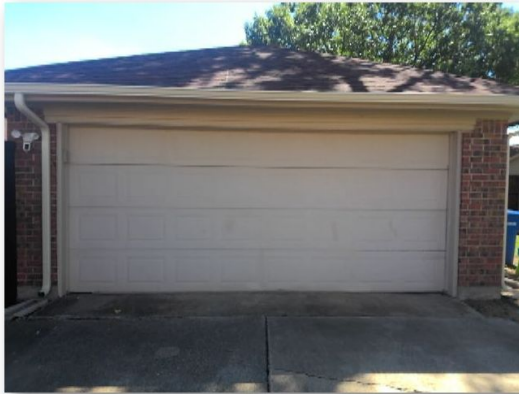
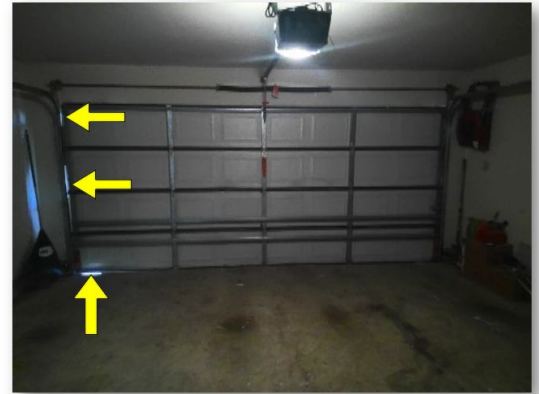
The items listed below are the Inspectors observations of deficiencies and/or exceptions if any associated with the **Doors** that were noted on this structure at the Time of the Inspection:

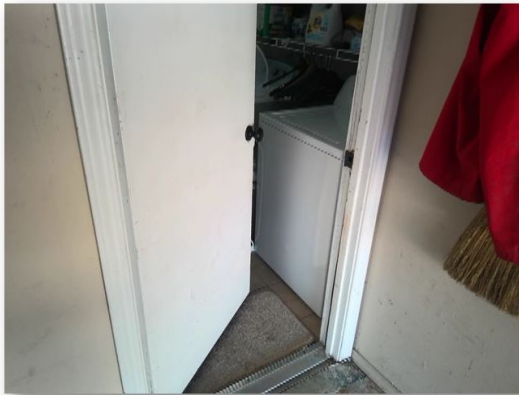
The door in the wall between the garage and the home living space did not have operable self closing or automatic-closing device installed as is required by modern safety standards. Self- or automatic-closing doors are designed to slow the spread of fire starting in the garage and to prevent toxic exhaust fumes from entering indoor air. An operable self- or automatic-closing device should be installed by a qualified contractor.

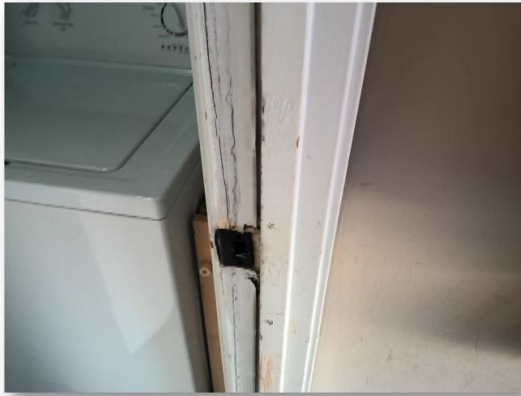
The surface of the door case between the garage and living space requires maintenance.

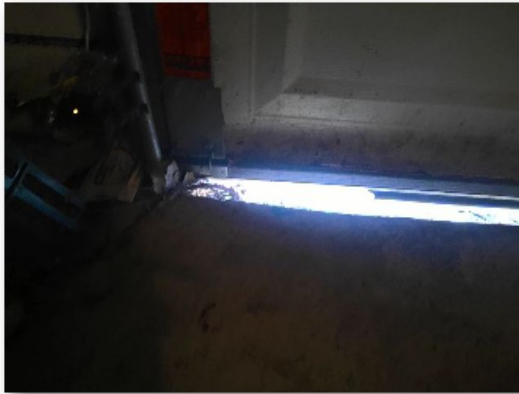
Garage door was observed penetrations had gaps indicate at time of inspection that should to be sealed by a qualified contractor with an appropriate weather seal to prevent moisture, vermin and insect entry. Correction should be made as necessary by a builder.

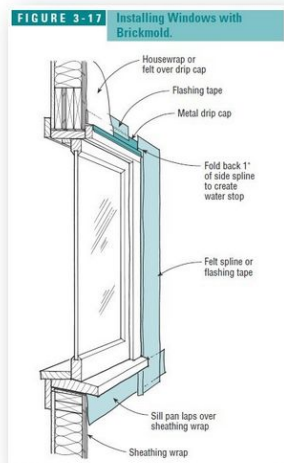
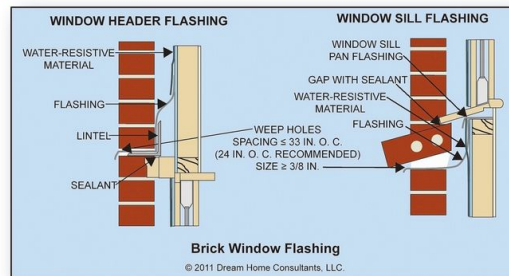
- When components of the exterior window sill are loose, damaged, or deteriorated, maintenance is required. This helps prevent moisture from intruding into the home materials and exterior wall structure and prevents the development of microbial growth, such as mold. All work should be performed by a qualified contractor.

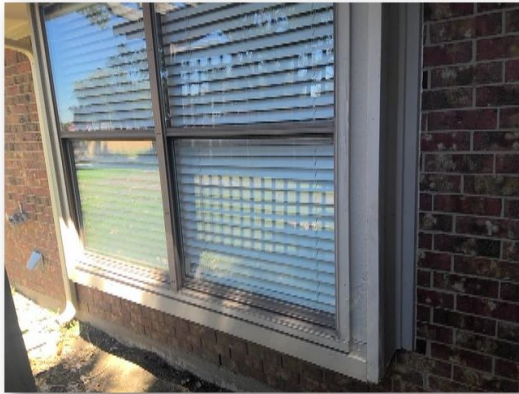
The items listed below are the Inspectors observations of deficiencies and/or exceptions if any associated with the **Windows and screens** that were noted on this structure at the Time of the Inspection:

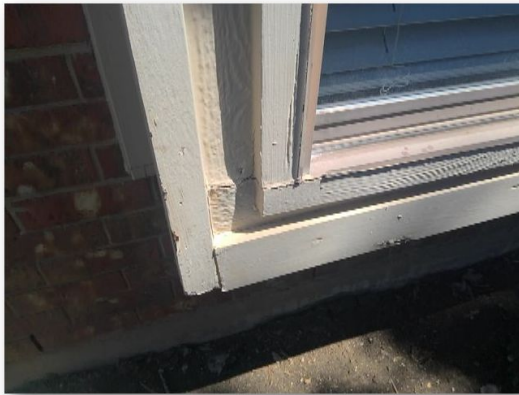
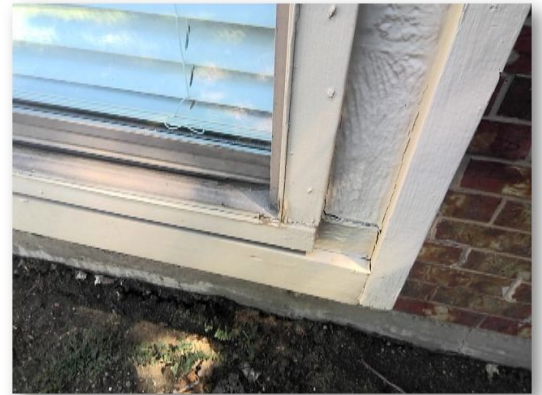
Windows and trim outside the house require caulking to prevent possible moisture damage

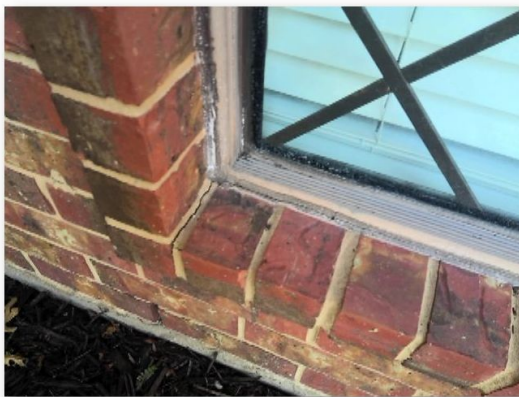
Outside window brick wall was observed hairline crack, require patch to prevent possible moisture damage

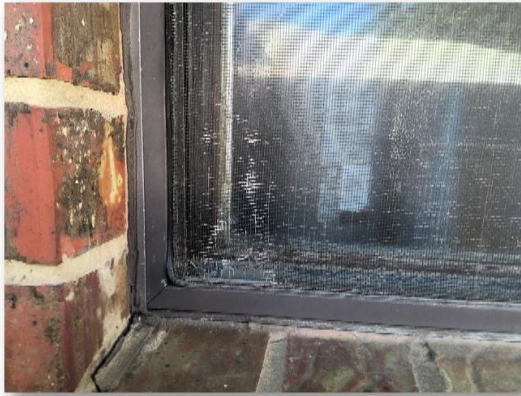
East wall Window screen was damaged

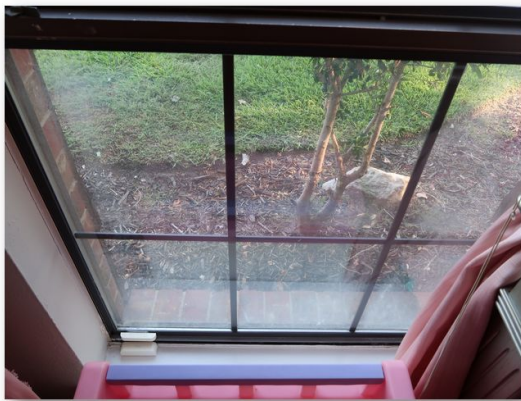
Front room windows are missing screen observed. An evaluation and work as necessary should be performed by a qualified contractor.

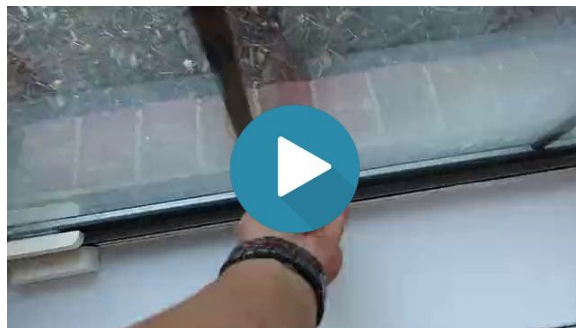
Windows are old, most window were difficult to operate and needed maintenance. Should consult with a qualified contractor to discuss options and costs for repair or replacement.

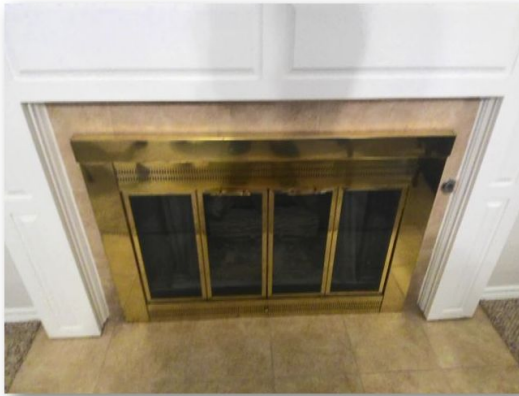
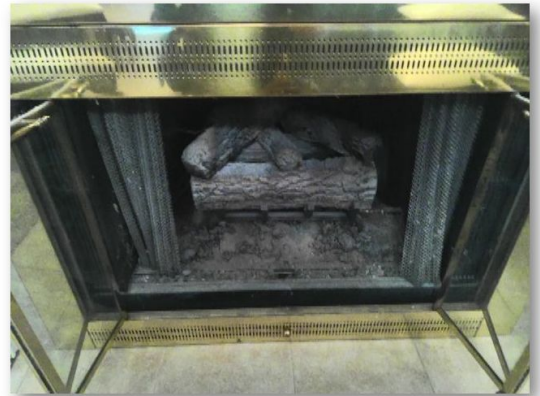
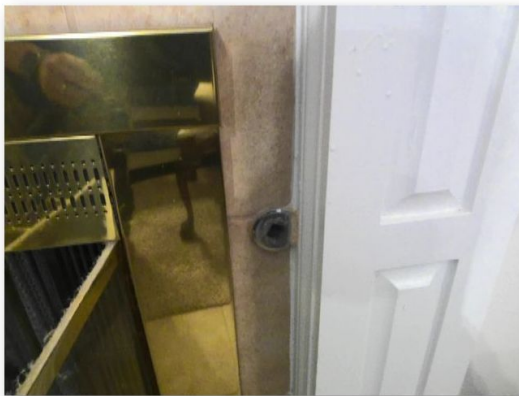
At the time of the Inspection the Inspectors opinion was that the interior/exterior **Fireplace and Chimney** appeared to be in **Acceptable Condition**.

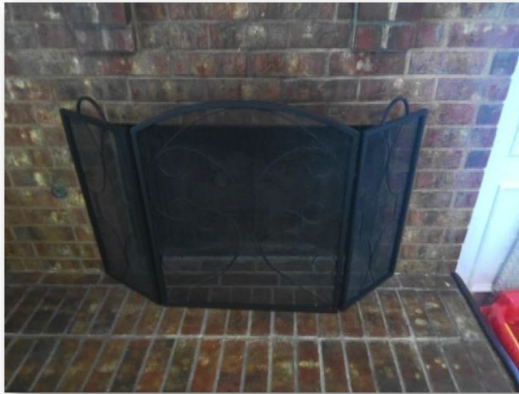
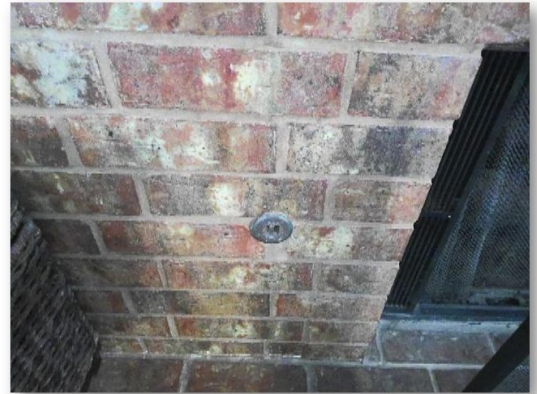
The items listed below are the Inspectors observations of deficiencies and/or exceptions if any associated with the **fireplace and chimney** that were noted on this structure at the Time of the Inspection:

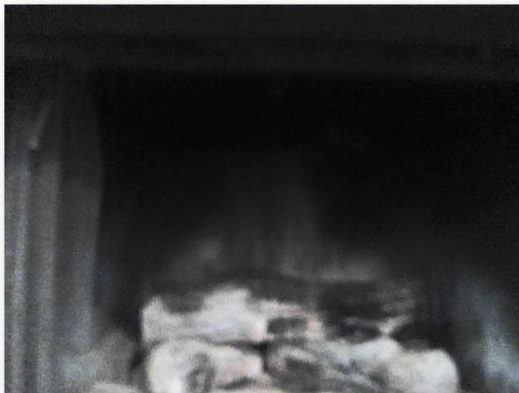
The firebox of the fireplace in the living room needed cleaning.

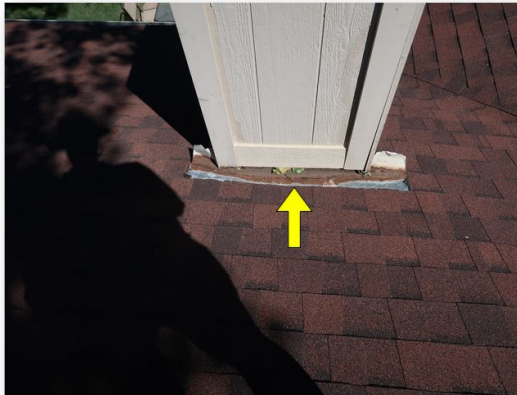
The chimney had no cricket. A cricket is a small roof built on the uphill side of the chimney to prevent roof drainage from pooling and causing damage from roof leakage.

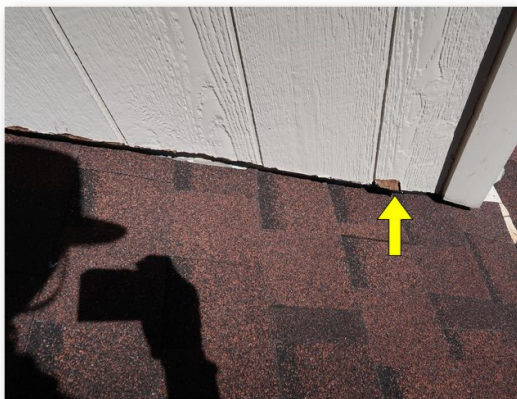
There is paint chipping on the chimney sidewall, and paint is peeling around the rain cover.

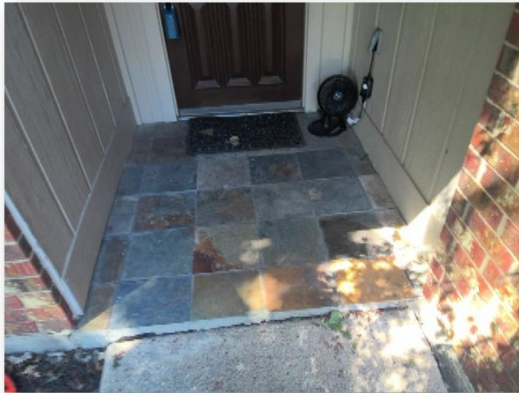
The items listed below are the Inspectors observations of deficiencies and/or exceptions if any associated with the **porches and patio** that were noted on this structure at the Time of the Inspection:

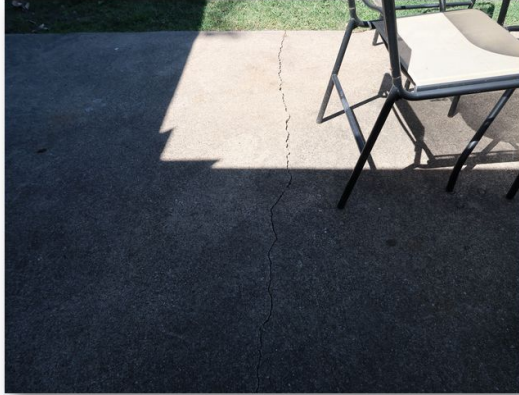
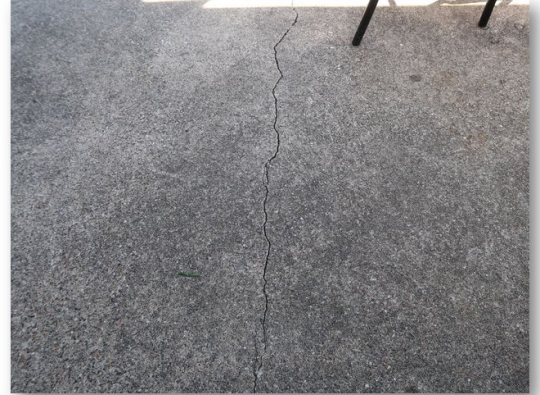
There are tile cracks and hairline cracks in the floors of the front porch and backyard patio.

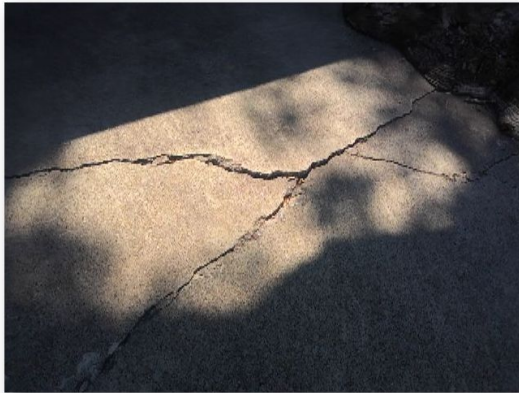
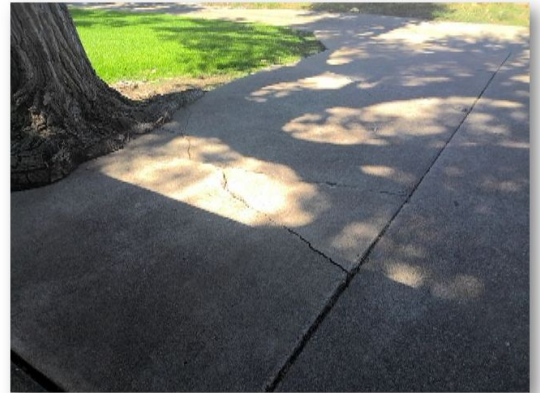
The driveway at the back of the house shows significant cracking due to tree roots.

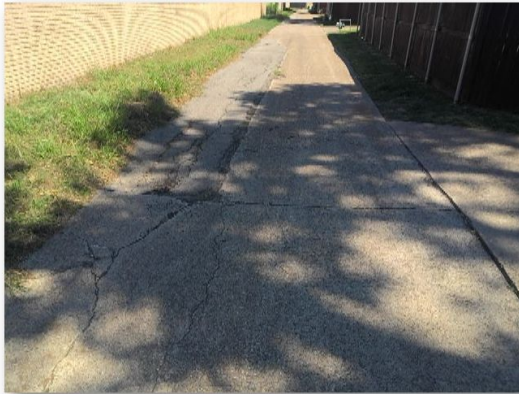
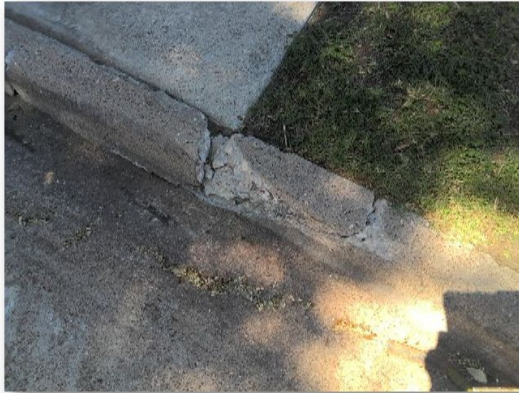
Notable cracks are evident in both the walkway floor and the curbing.

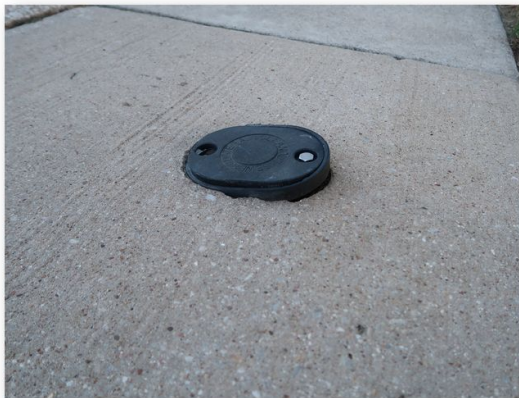
The city sewer line cover is protruding above the walkway floor. This poses a tripping hazard for children and pedestrians. The cover should be adjusted to be flush with the floor as soon as possible, as it is a safety hazard.

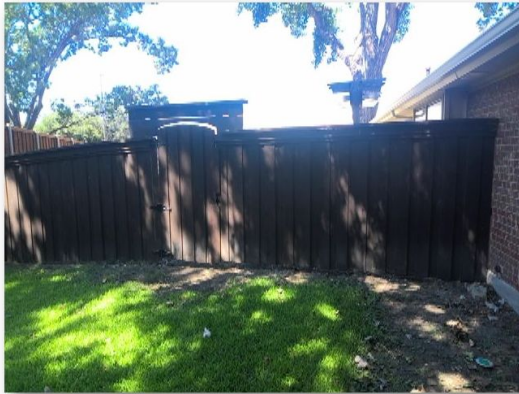
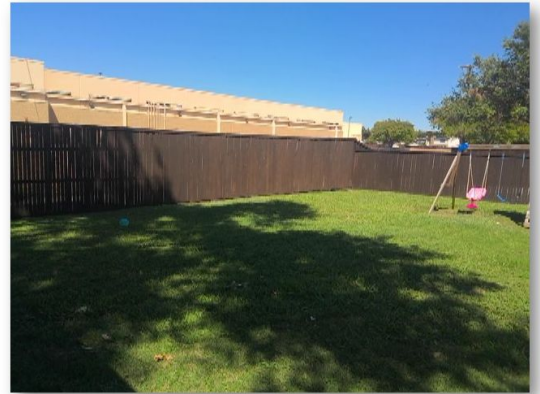
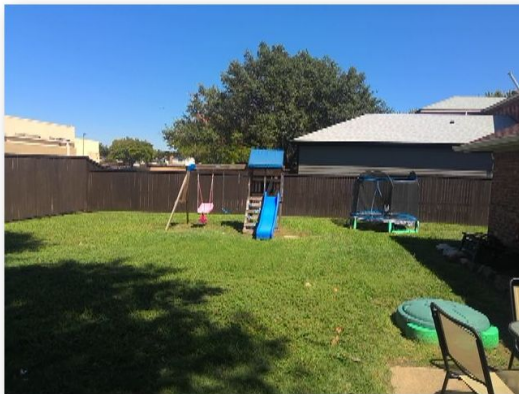
The items listed below are the Inspectors observations of deficiencies and/or exceptions if any associated with the **Fence/s** that were noted on this structure at the Time of the Inspection:

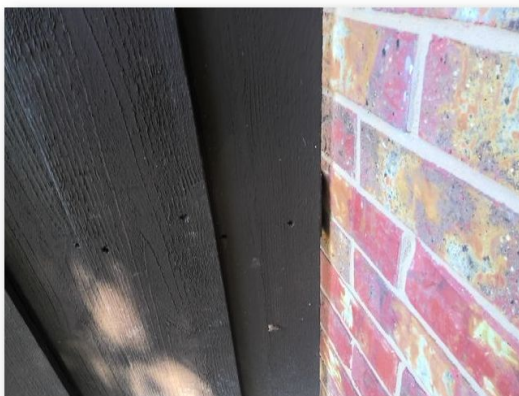
The wood fence is in contact with the exterior wall of the structure. This condition is conducive to wood-destroying insects (WDI). It is recommended to install the wood fence with a gap of approximately 1/2" from the exterior wall.

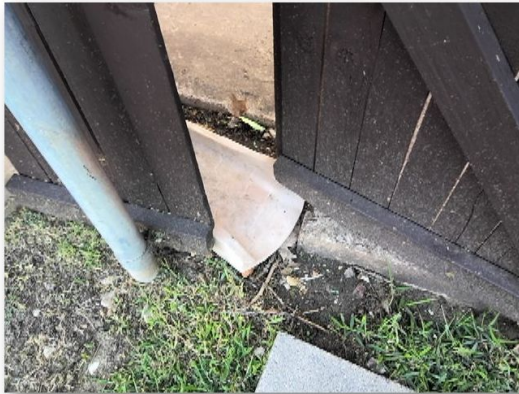
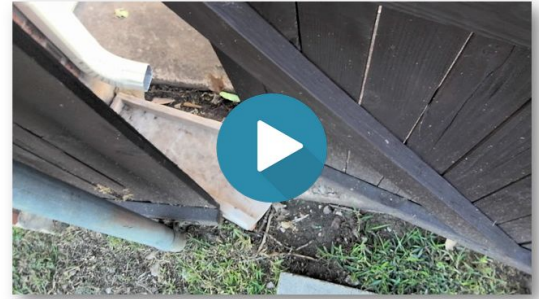
The fence door is obstructed by the downspout splash guard, interfering with its operation. This issue needs to be resolved.

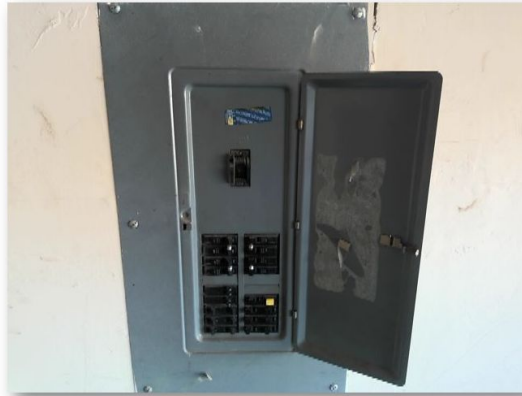
In the Inspectors opinion is the **Main Electrical System** appeared to be in **Acceptable Condition at time of Inspection.**

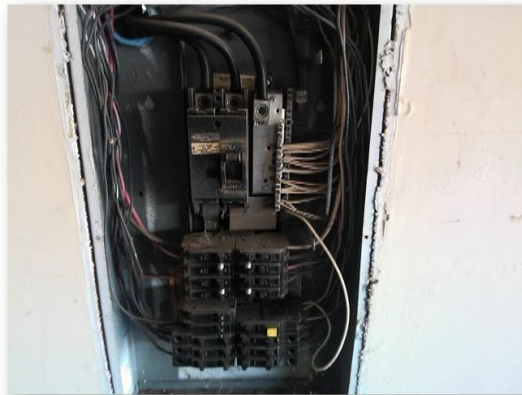
Various minor issues have been found in the electrical panel. An evaluation by a licensed electrician is needed.

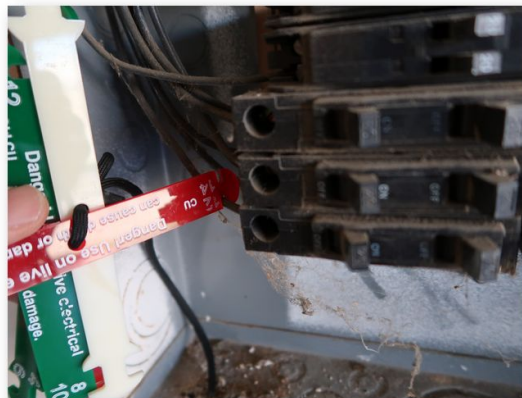
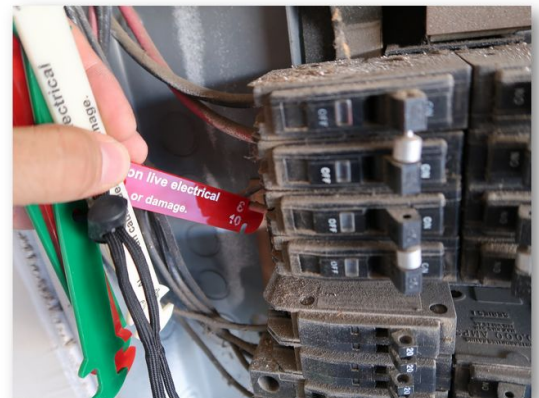
Whenever a defect and/or deficiency of any kind is noted in the electrical system, we recommend that a qualified, licensed electrician repair and/or service the entire system and/or part.

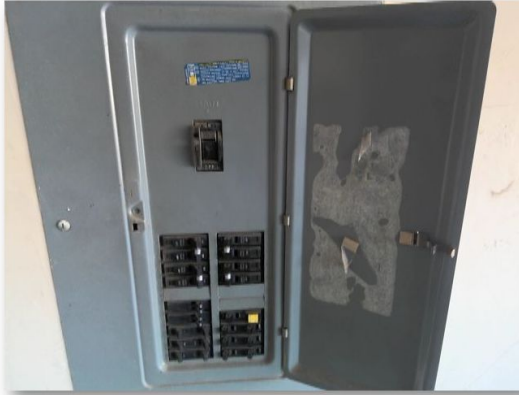
The Circuit Directory label identifying individual electrical circuits was missing from the service panel. The service panel should contain a clearly-marked label identifying individual circuits so that in an emergency, individual circuits can be quickly shut off. Branch circuits should be traced and identified with a properly marked Circuit Directory label installed by a qualified electrical contractor.

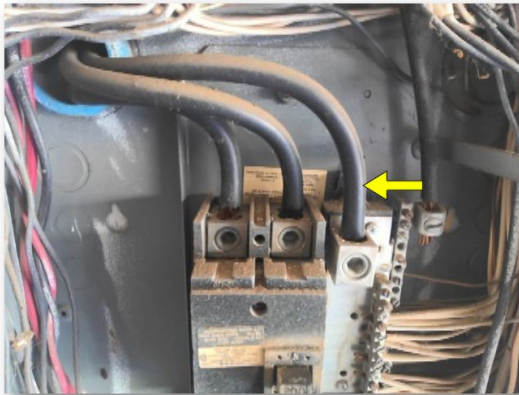
The main neutral line does not have a white marking for identification.

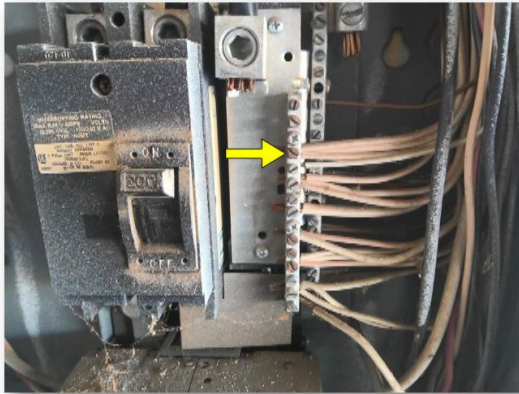
Components in this service panel were corroded, indicating that moisture has been entering the panel. Corrosion can deteriorate electrical connections, a potential fire hazard. The panel interior should be serviced by a qualified electrical contractor.

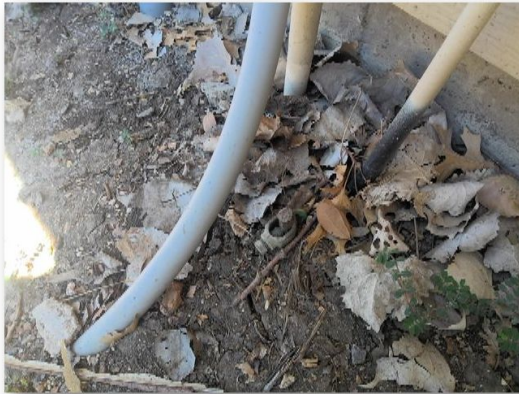
The electrical service was grounded to a driven rod. Driven rods have length requirements that cannot be confirmed once the rod has been installed. Confirming an effective service grounding would require the services of a qualified electrical contractor using special instruments.

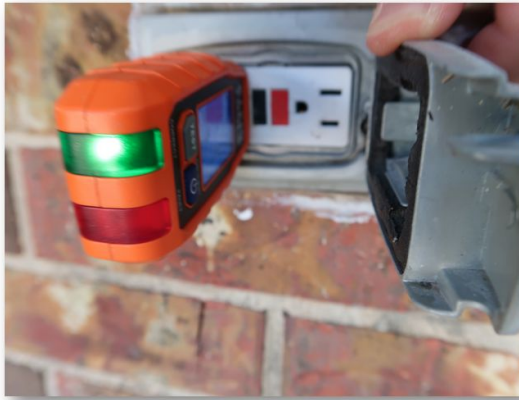
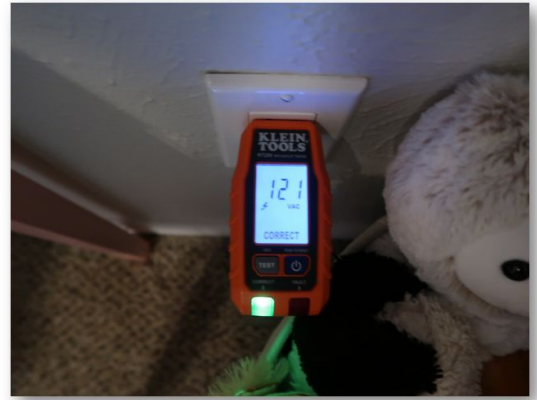
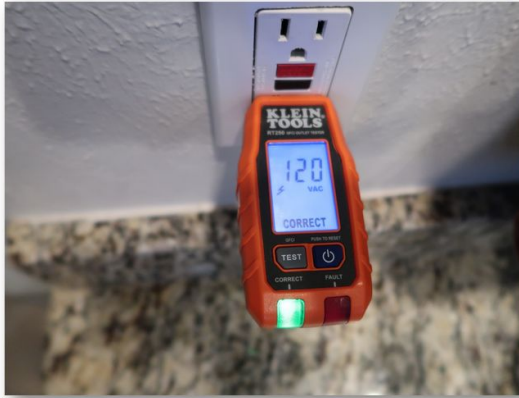
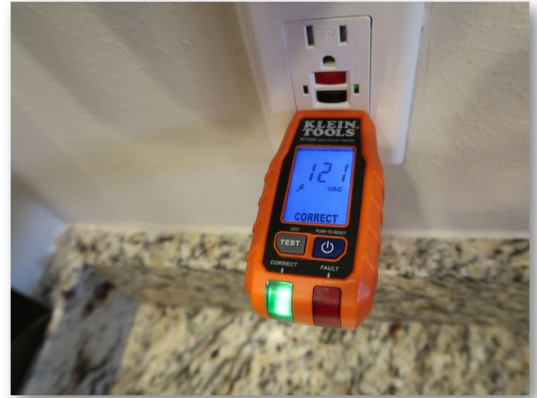
Whenever a defect and/or deficiency of any kind is noted in the electrical system, we recommend that a qualified, licensed electrician repair and/or service the entire system and/or part.

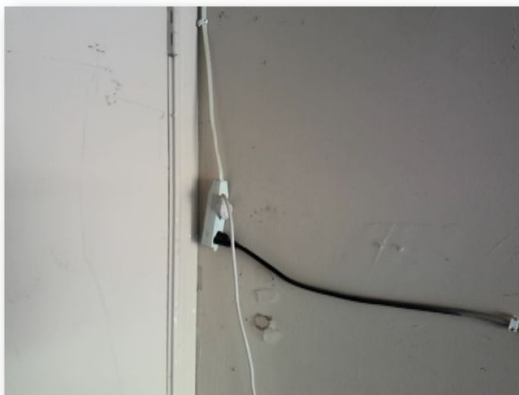
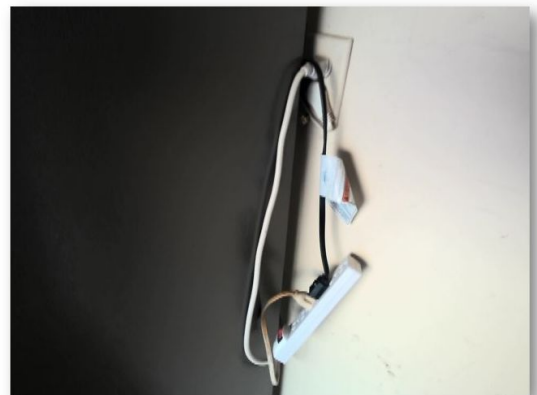
The items listed below are the Inspectors observations of deficiencies and/or exceptions if any associated with the **Branch Service** that were noted on this structure at the Time of the Inspection:

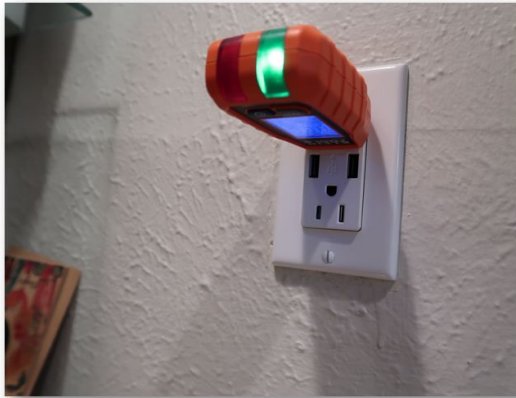
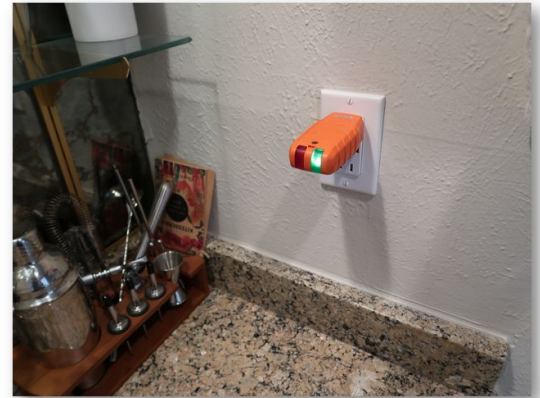
Electrical receptacles in the wet bar was installed upside down, with the ground holes above the neutral and hot slots. This condition sometimes indicates a switched receptacle.

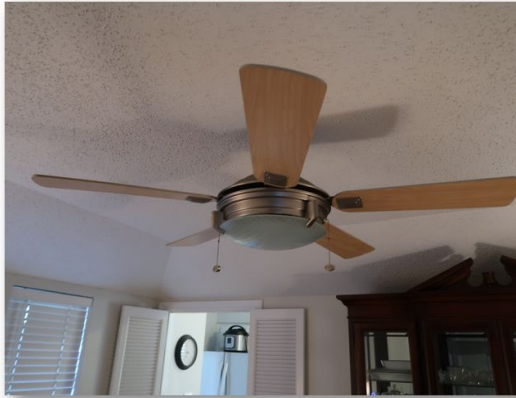
Ceiling fans inoperable or in need of repair

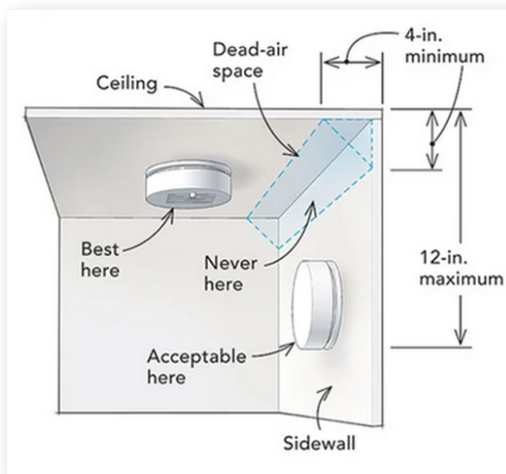
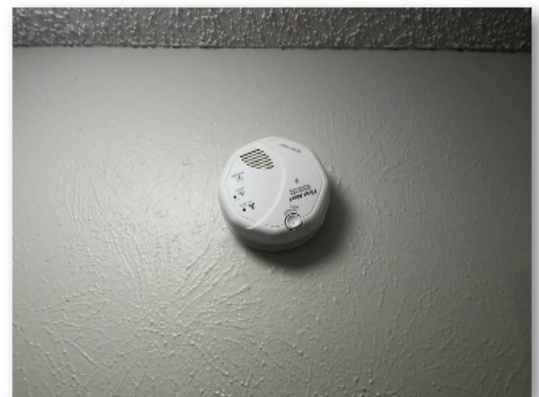
The items listed below are the Inspectors observations of deficiencies and/or exceptions if any associated with the Smoke & Fire Alarms that were noted on this structure at the Time of the Inspection:

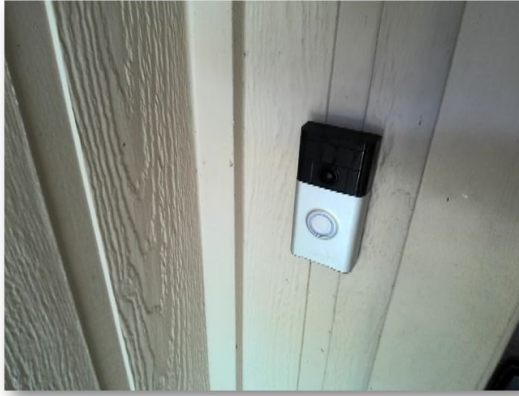
The items listed below are the Inspectors observations of deficiencies and/or exceptions if any associated with the **doorbell and chime** that were noted on this structure at the Time of the Inspection:

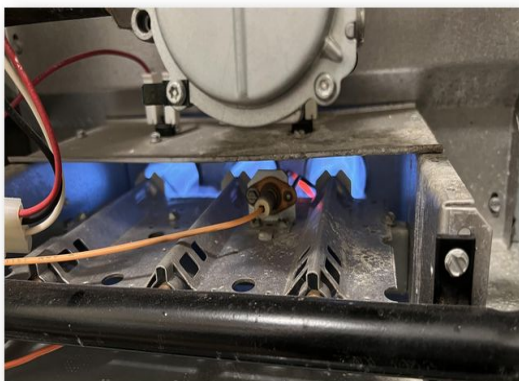
On the day and time of the inspection it is my opinion that the **Gas Furnace** appeared to be in **Operable Condition**.

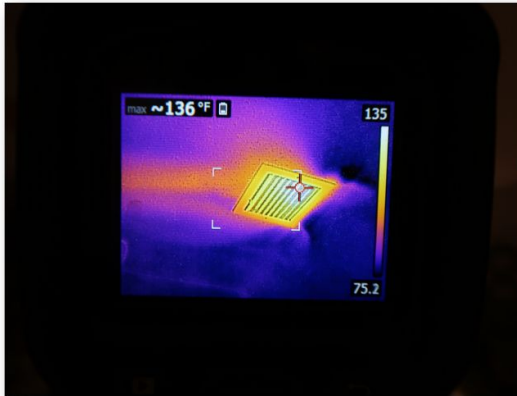
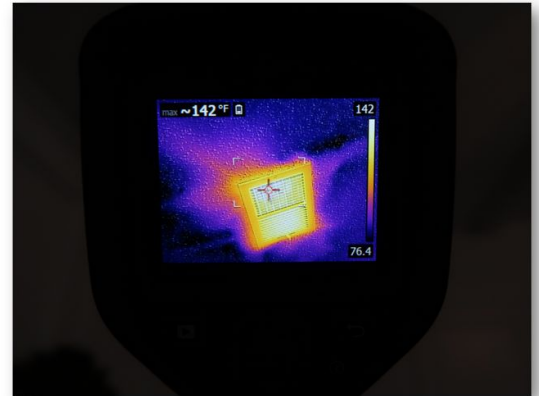
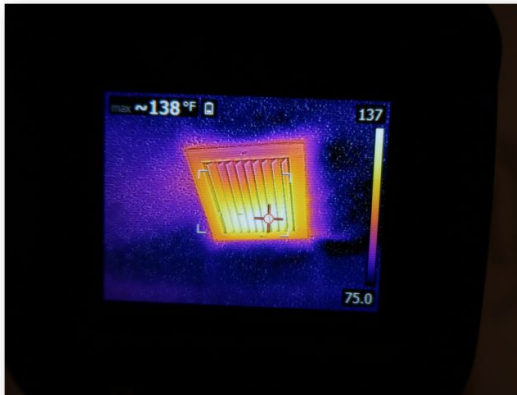
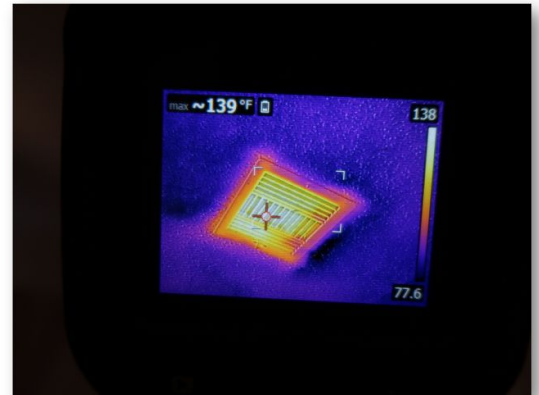
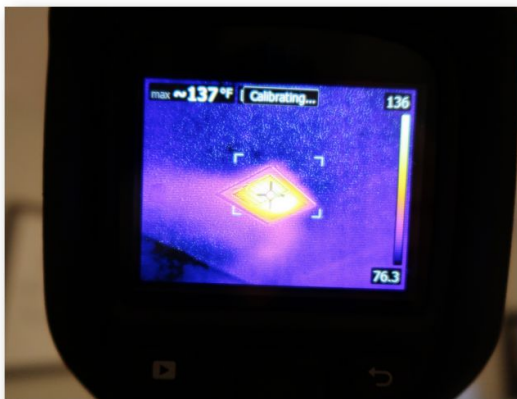
The items listed below are the Inspectors observations of deficiencies and/or exceptions if any associated with the **Gas Furnace** that were noted on this structure at the Time of the Inspection:

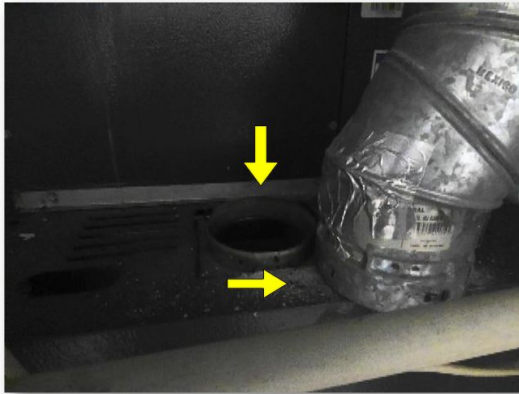
▲Significant/Major Concerns

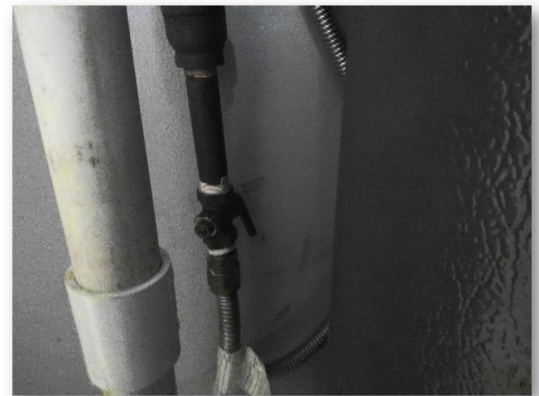
The direction of the gas line valve handle supplying the furnace is reversed, making it difficult to operate. It needs to be replaced. Additionally, the gas line sediment trap is missing.
