HOME AND TERMITE INSPECTIONS
254-727-0900
1234 DALLAS

Inspected by Jude Hwang TREC #25266

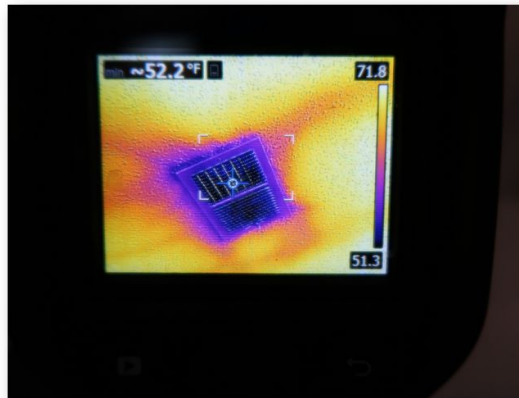
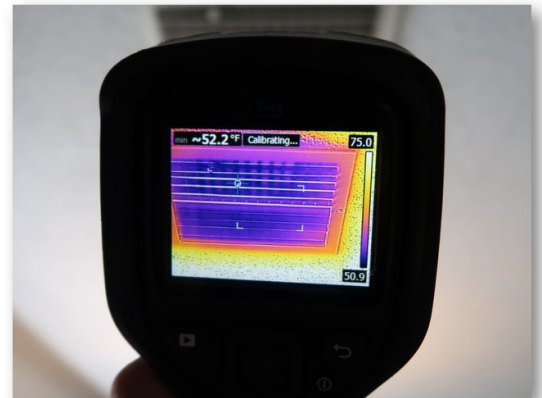
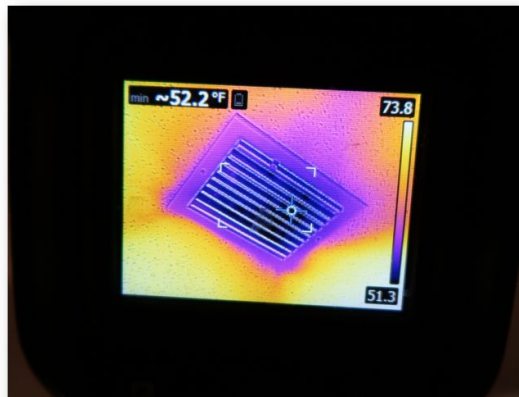
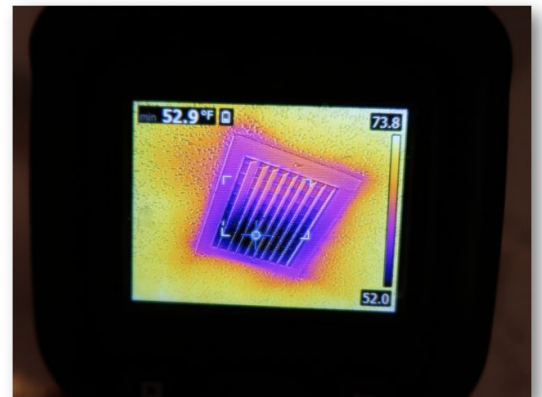
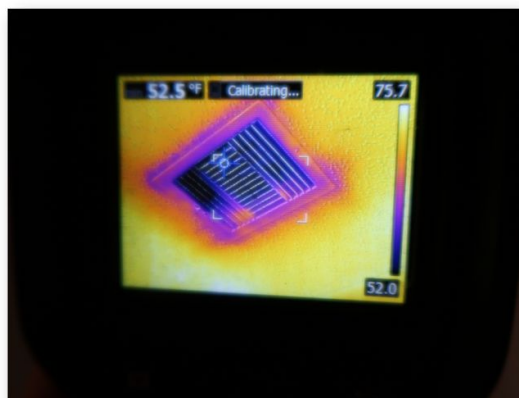
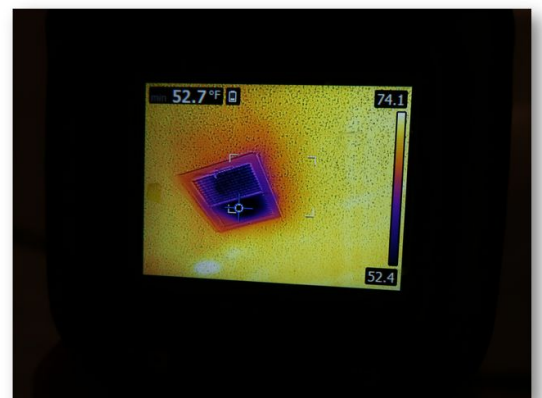
Supply Air Temp: 52 °F Return Air Temp: 69°F Temp. Differential: 17 °F

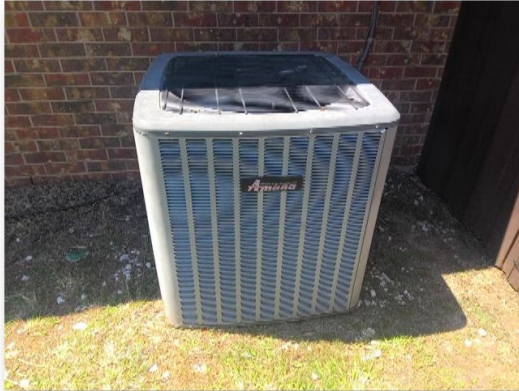
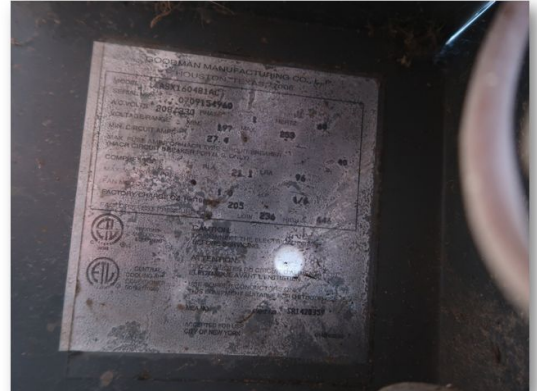
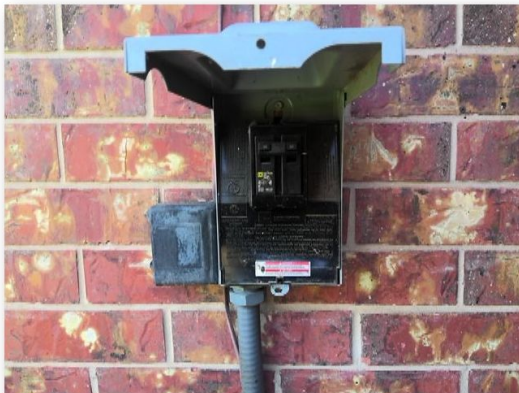
It is recommended that the unit be serviced now as well as annually. Having the coils cleaned allows the unit to perform as intended and avoids costly repairs.

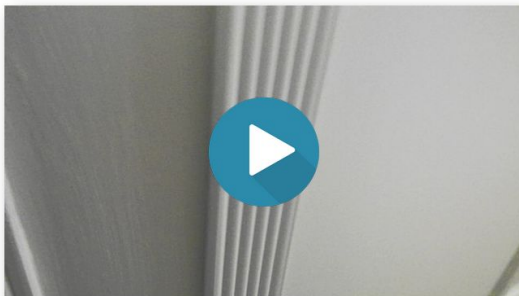
The items listed below are the Inspectors observations of deficiencies and/or exceptions if any associated with the **Cooling System** that were noted on this structure at the Time of the Inspection:

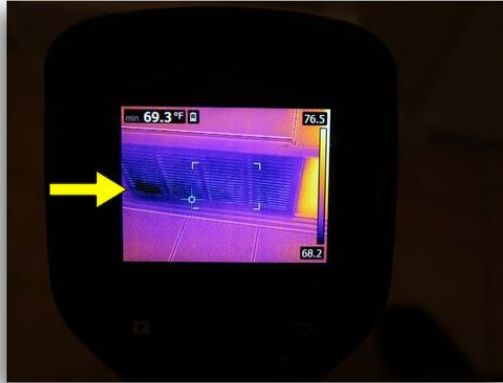
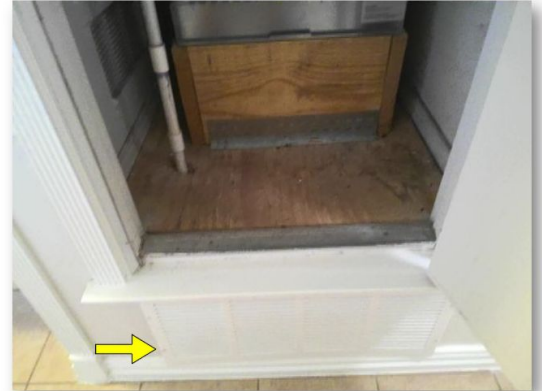
Moisture was detected by an infrared camera near the lower condensate drain line of the furnace return. A check by an HVAC professional is needed.

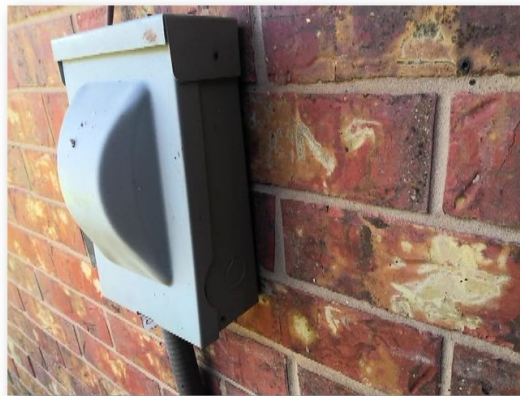
The insulation on the suction line of the outdoor AC unit is old and heavily worn. Replacement is recommended. Additionally, silicone sealing is needed around the area between the exterior wall and the fuse case.

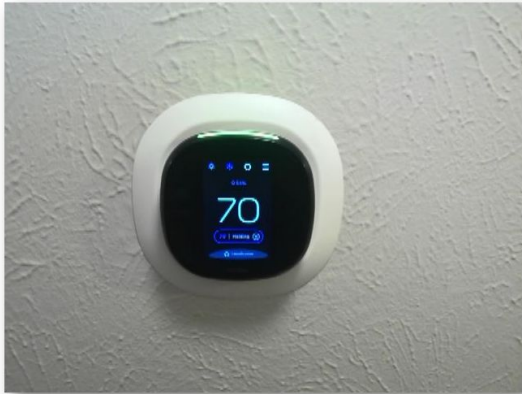
I	NI	NP	D
---	----	----	---

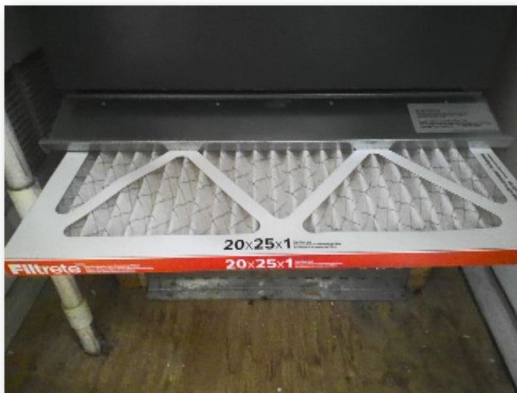
The **Supply & Return & Duct system** appeared to be in **Operable Condition** and appears to have equal distribution.

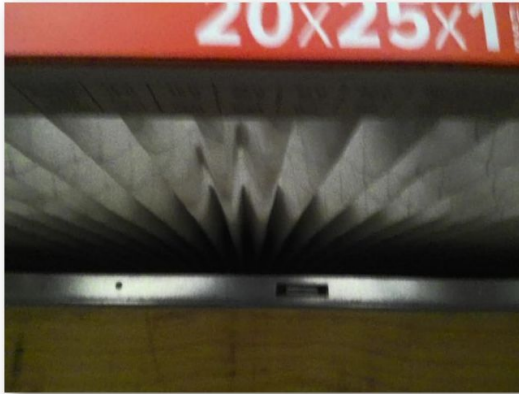
Air Filter Location : The air filter for this furnace was located bottom a sliding panel in the return air duct at the furnace.

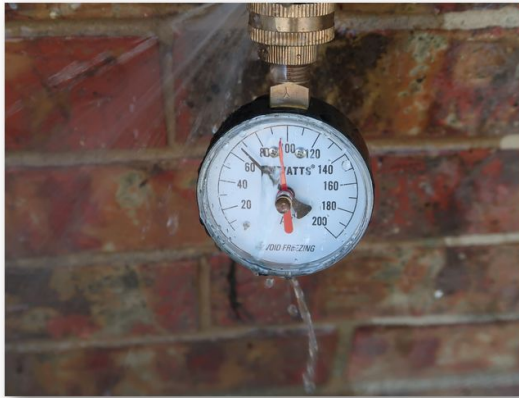
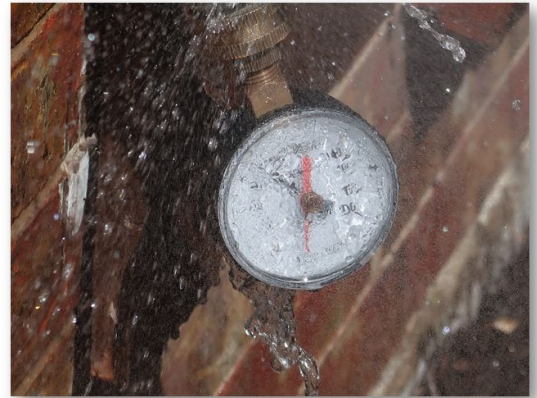
I	NI	NP	D
---	----	----	---

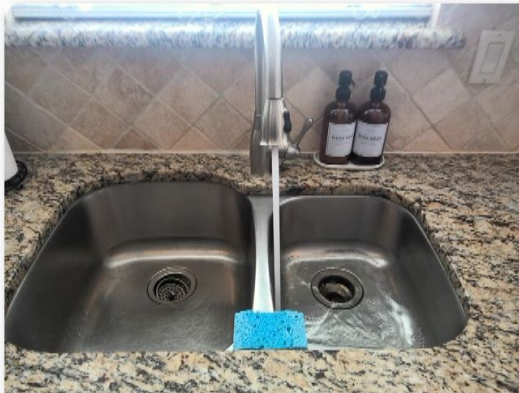
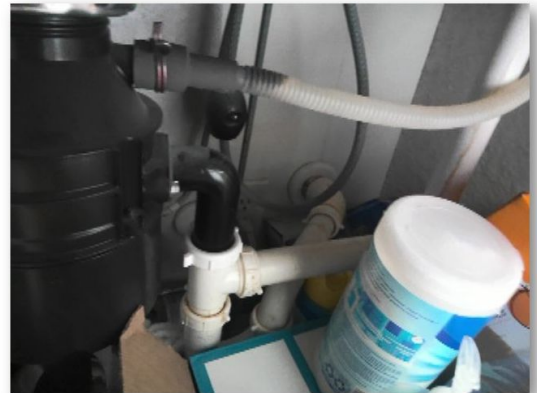
The **Kitchen and or Utility Sinks Plumbing Fixtures** appeared to be in **Operable Condition** on the day of the Inspection

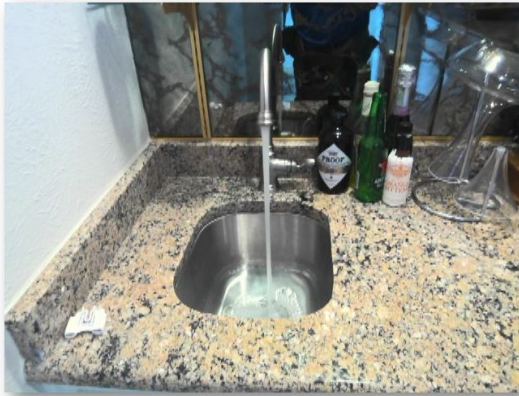
I	NI	NP	D
---	----	----	---

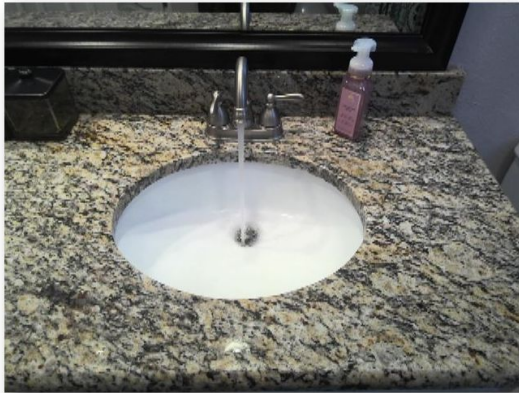
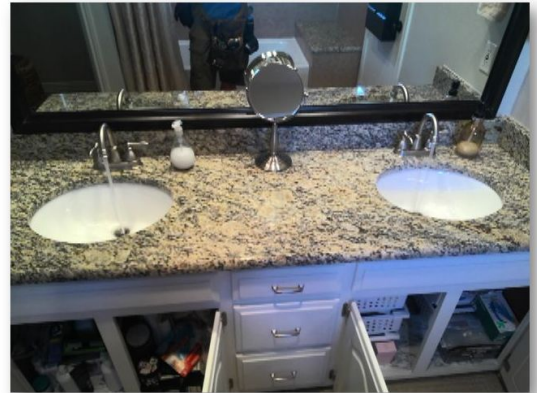
The **Bathrooms Plumbing Fixtures** appeared to be in **Operable Condition** on the day of the Inspection

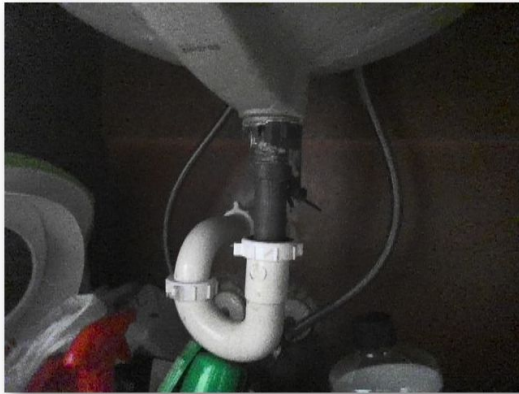
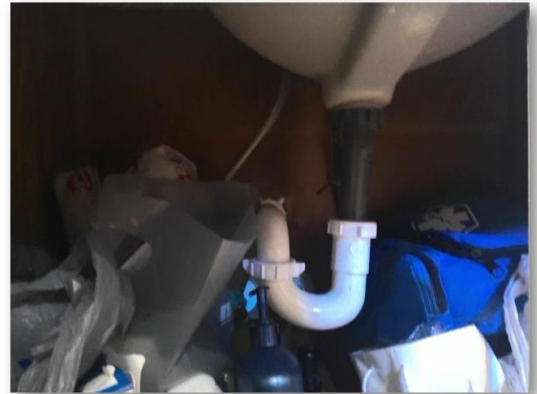
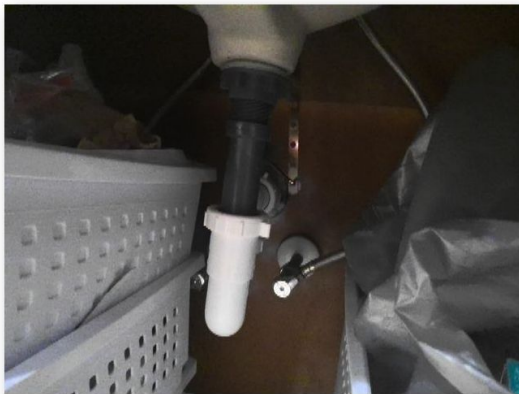
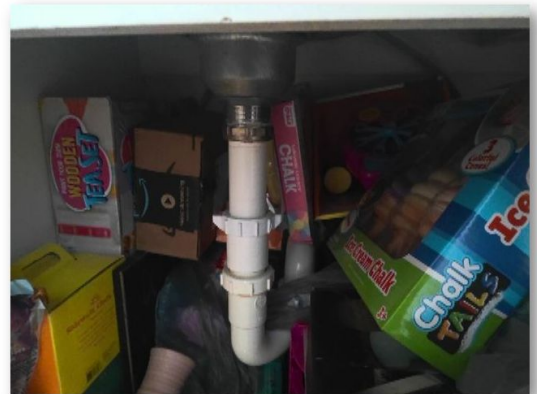
I	NI	NP	D
---	----	----	---

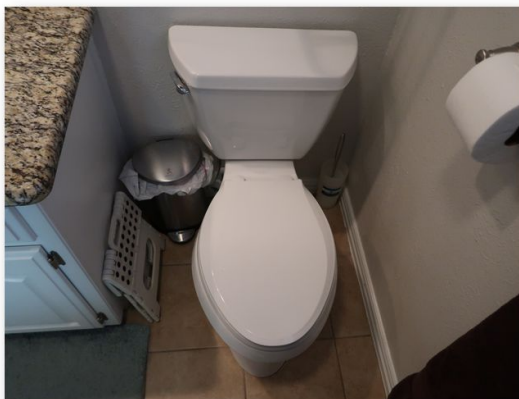
Comments: The Commodes Plumbing Fixtures appeared to be in **Operable Condition** on the day of the Inspection

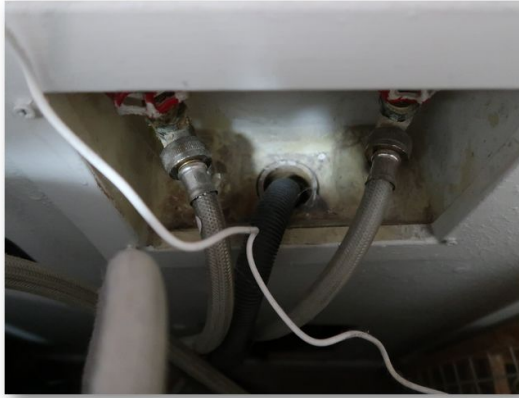
The **Laundry Fixtures** appeared to be in **Operable Condition** on the day of the Inspection

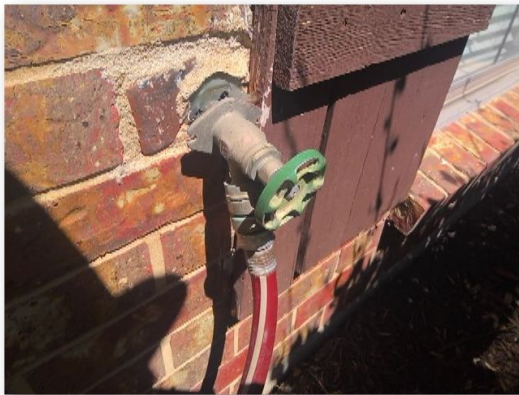
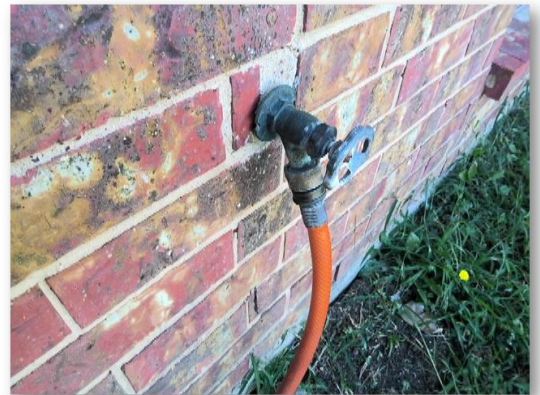
The items listed below are the Inspectors observations of deficiencies and/or exceptions if any associated with the **Exterior Faucets** that were noted on this structure at the Time of the Inspection:

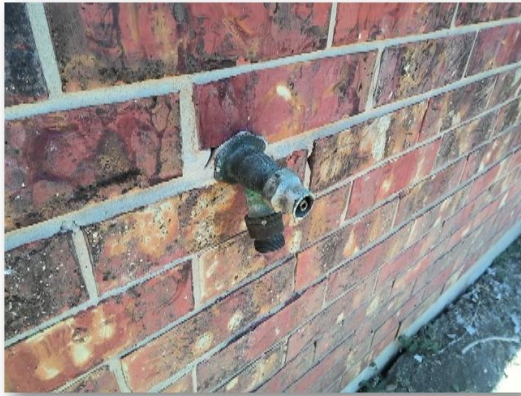
One of exterior faucet missing the handle.

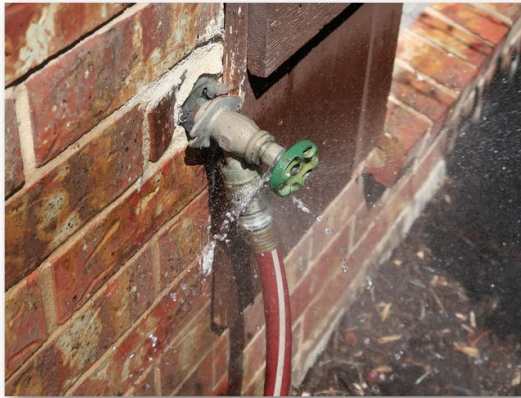
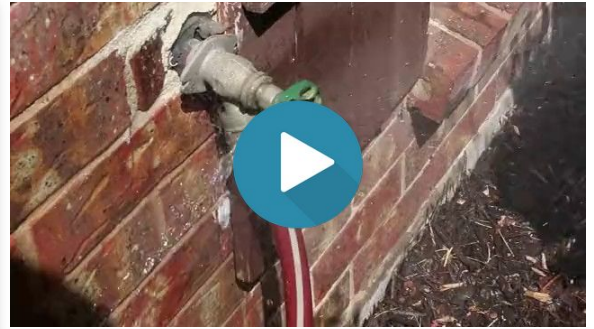
An exterior faucet near the front of the home was leaking. Leakage can result in a significant amount of wasted water each month. This leak should be fixed by a qualified plumbing contractor.

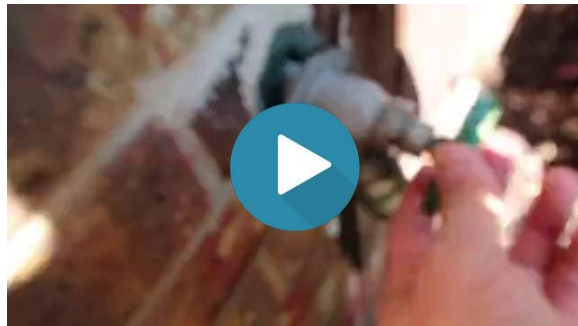
One of the exterior hose bibs is severely loose. It should be secured to prevent damage to the pipe.

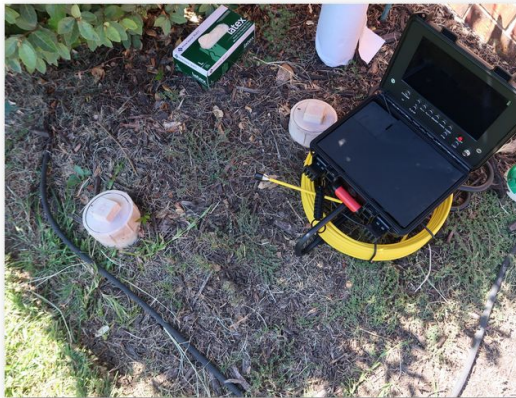
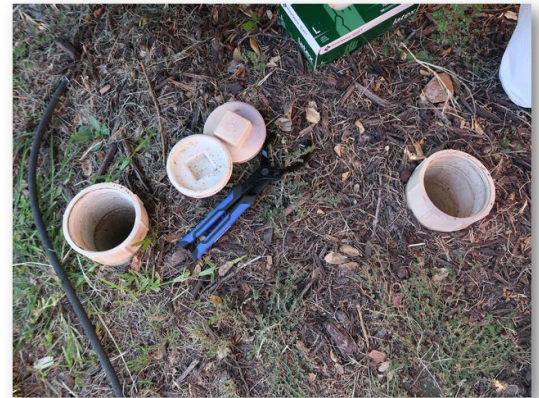
As an add-on service, a sewer scope inspection was conducted, and the video is attached. No abnormalities were observed during the inspection.

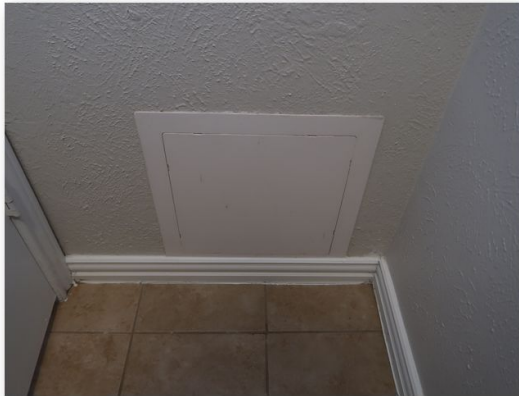
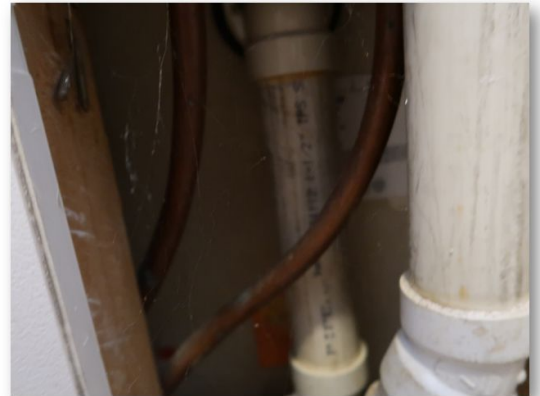
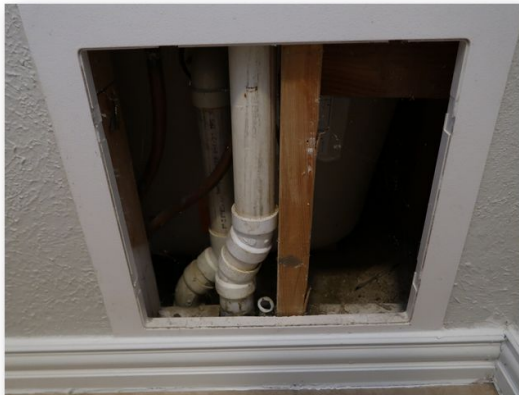
The items listed below are the Inspectors observations of deficiencies and/or exceptions if any associated with the plumbing drains & vents that were noted on this structure at the Time of the Inspection:

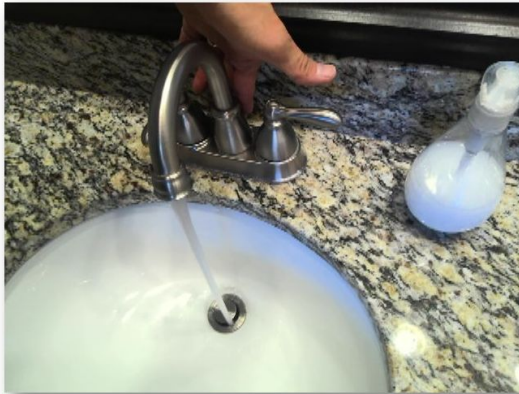
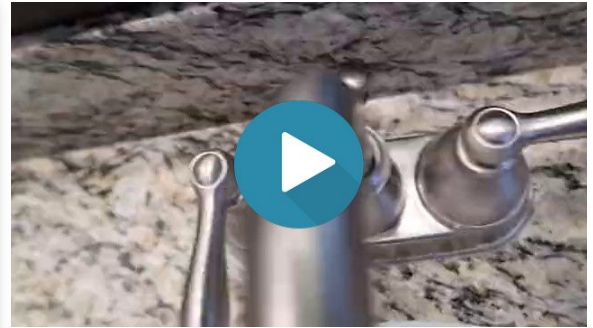
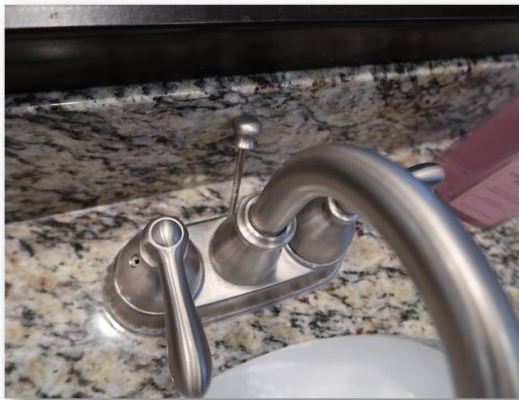
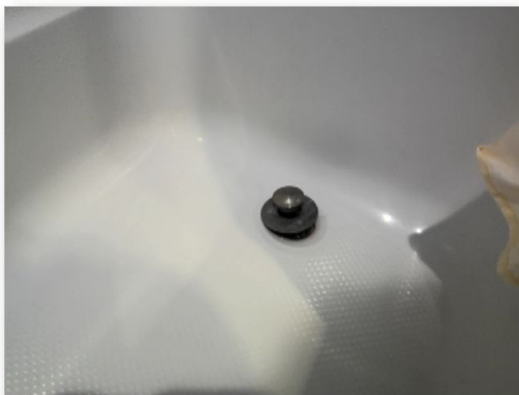
Several sinks and bathtubs have drain stoppers that are not functioning properly. Repairs are needed to ensure the drain stoppers work smoothly.

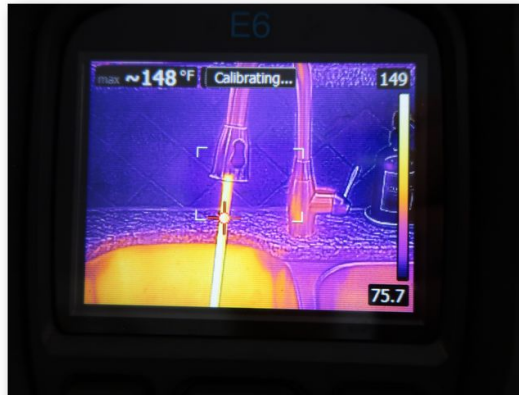
Water Temp: 145~148°F Recommended Hot Water setting should between 115°F – 120°F

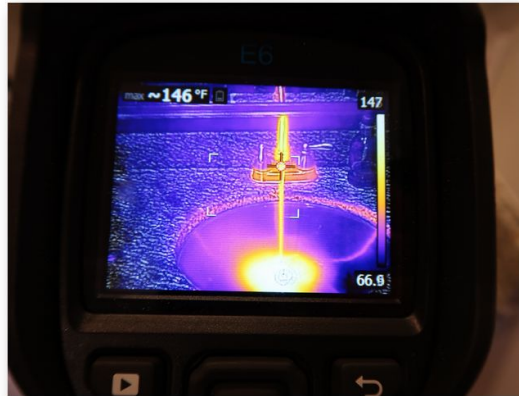
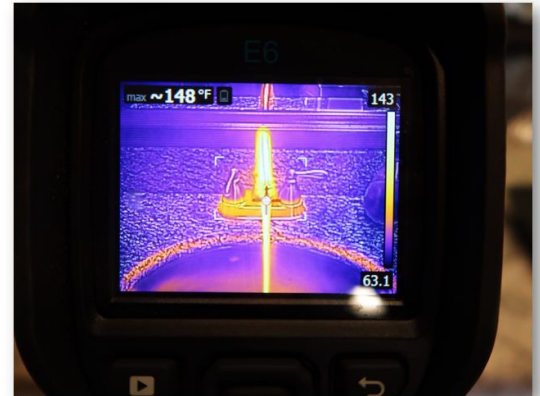
The water temperature is generally set too high. The recommended maximum temperature is 120°F to prevent the risk of burns, especially to children's hands.

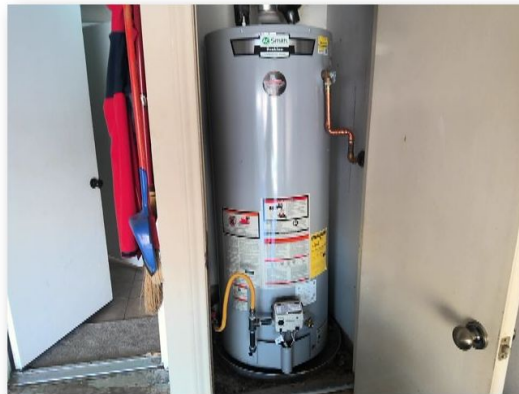
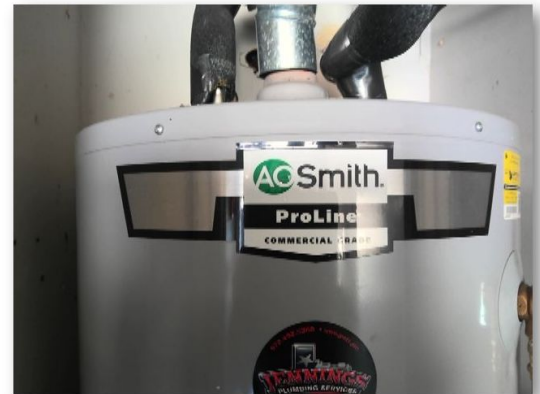
The **Water Heater** appeared to be in **Acceptable Condition** on the Day of the Inspection.

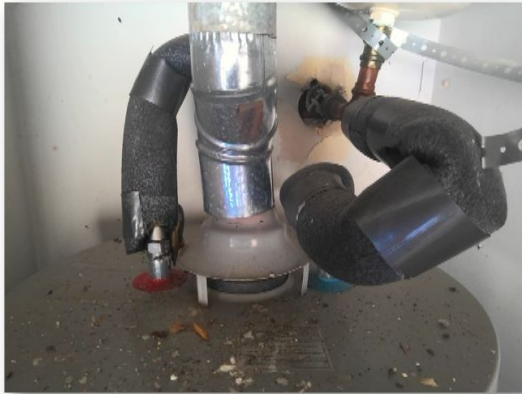
Water heater Temperature and Pressure Relief Valve

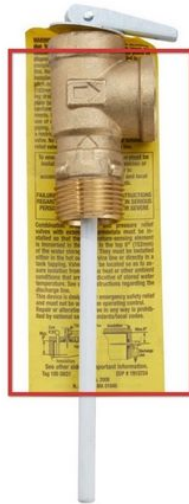
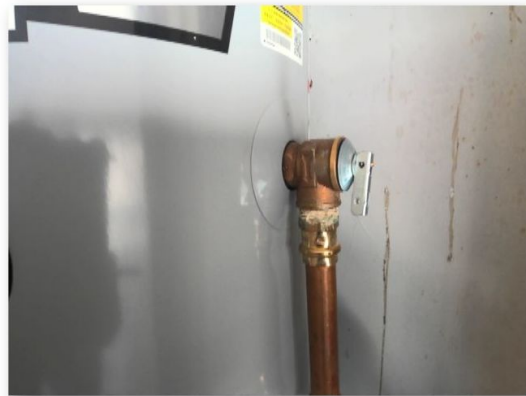
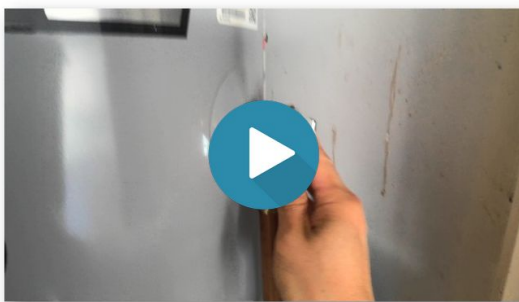
The **Temperature and Pressure Relief Valve** appeared to be in **Operable Condition** on the Day of the Inspection.

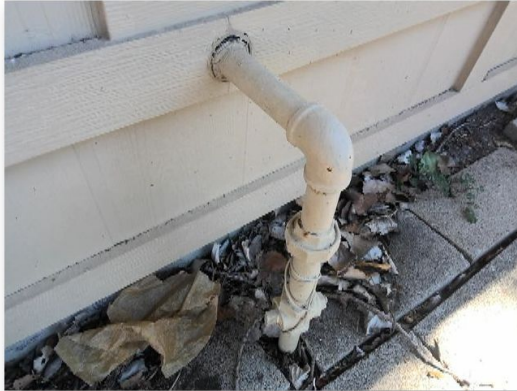
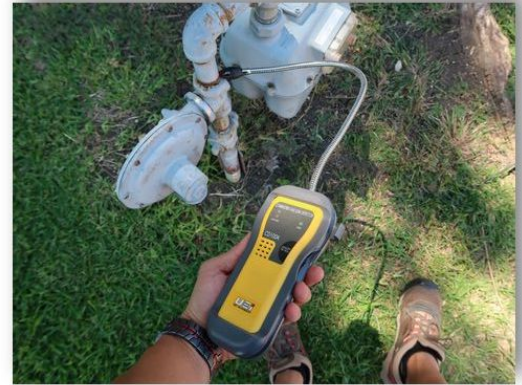
Visible sediment traps not present at some or all of the gas lines connected to appliances.

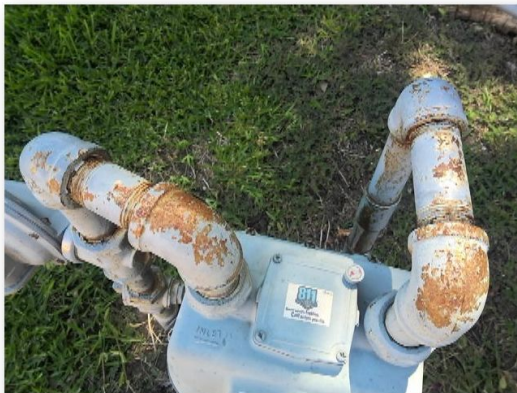
The items listed below are the Inspectors observations of deficiencies and/or exceptions if any associated with the **Gas Distribution System & components** that were noted on this structure at the Time of the Inspection:

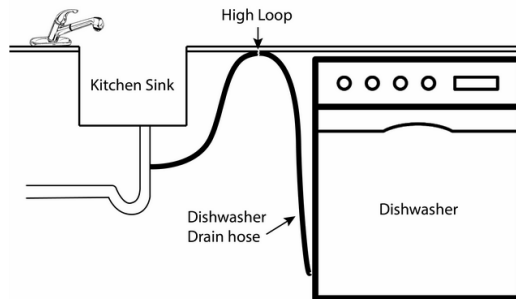
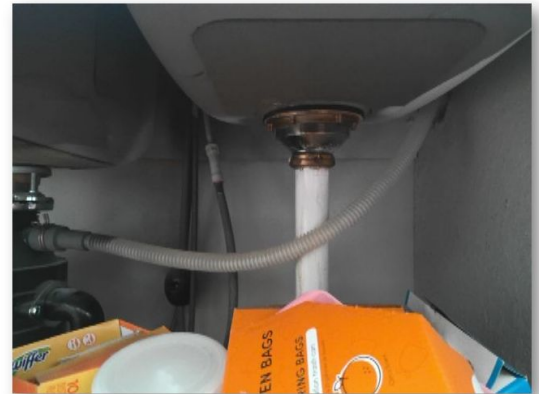
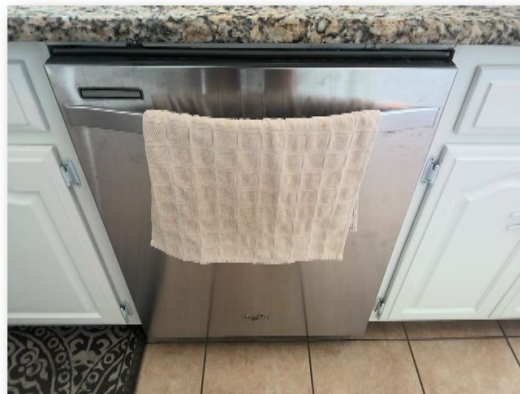
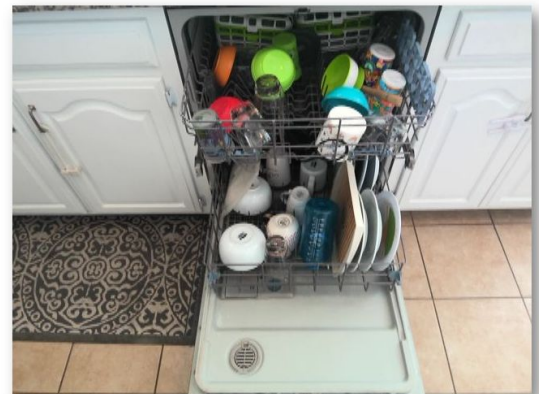
The Inspector observed no deficiencies in the condition and Operable Condition of the dishwasher. It was operated through a cycle.

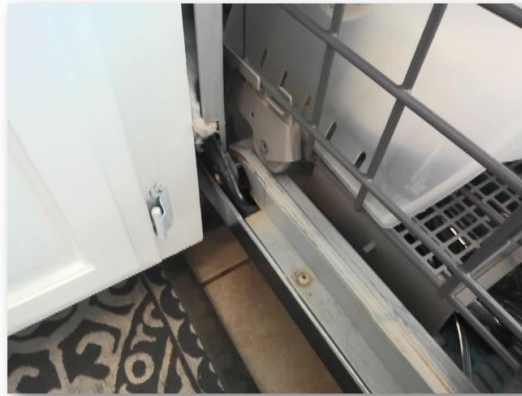
- Rust present in interior of unit

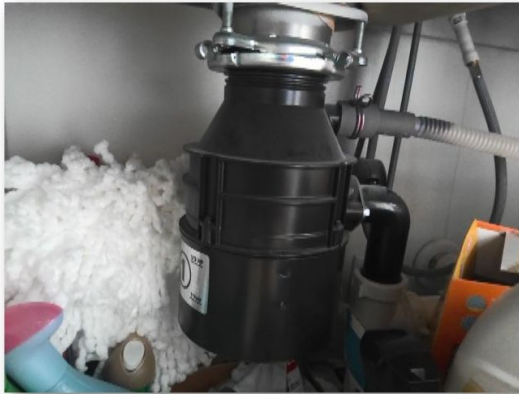
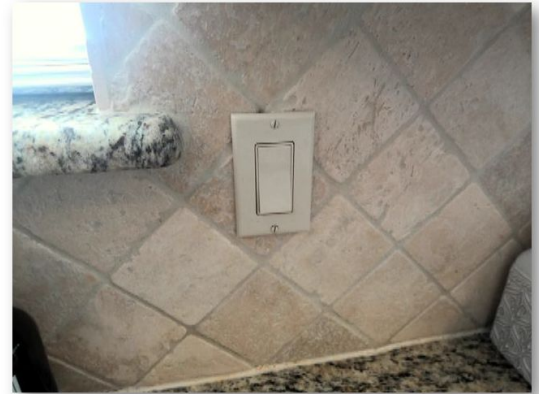
The food waste disposal was inspected to determine it was functional while also looking for leaks from the unit, an exposed power cord, heavy rust, or other deficiencies. No reportable conditions were present at the time of inspection unless otherwise noted in this report.

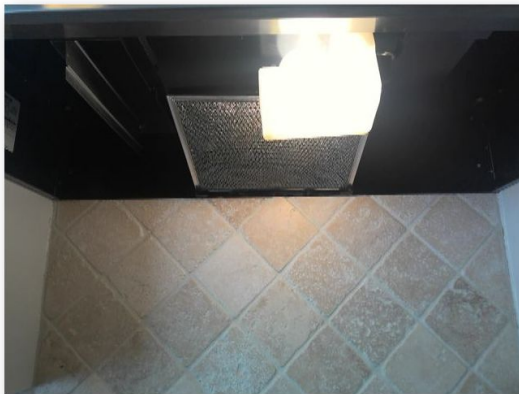
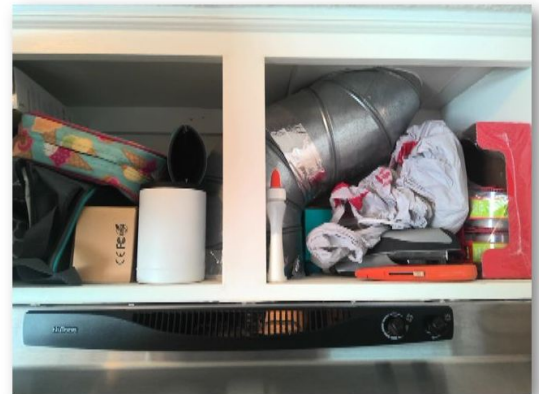
The following deficiencies (if any) with the range hood and exhaust system?were observed on the day of the inspection of this structure and are noted below.

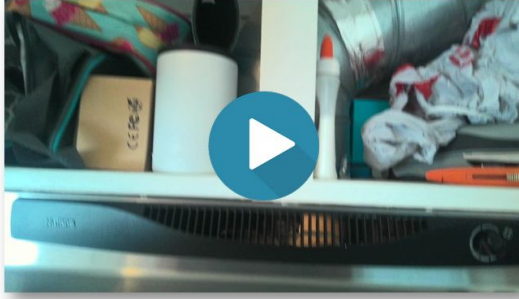
The fan noise of the exhaust hood is excessively loud. The hood uses an updraft system, but the airflow is circulating instead of functioning properly. A check by an appliance expert is needed to correct the system's operation.

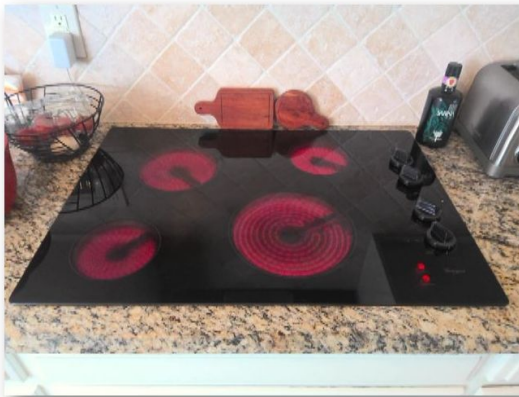
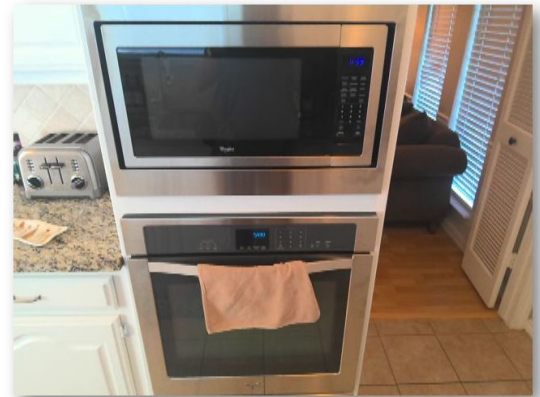
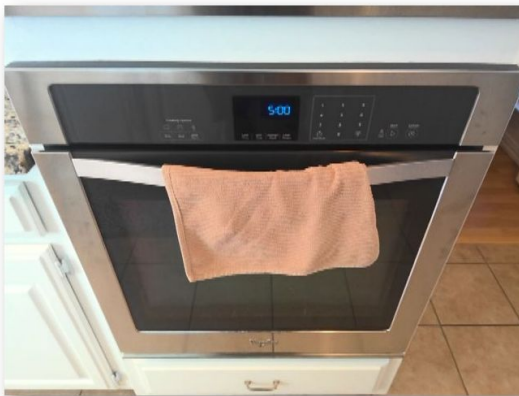
At the time of the inspection it is the Inspectors opinion that the **Cook top, Oven** appeared to be in **Operable Condition**.

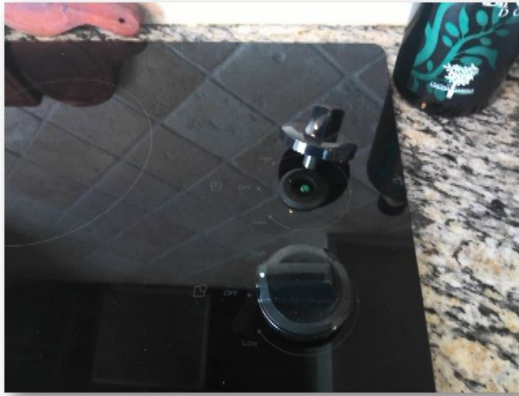
- Control knobs are loose and/or missing

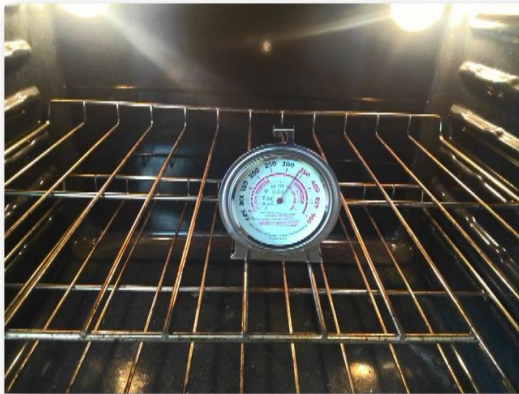
Tested at 350°F, Variance noted: 350°F (max 25°F)

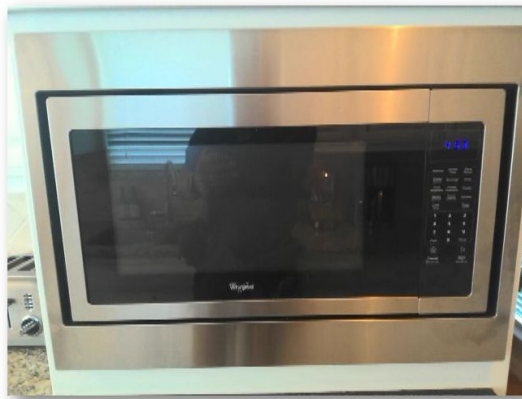
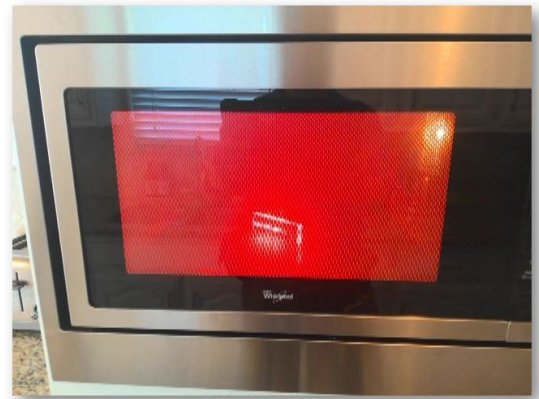
At the time of the inspection it is the Inspectors opinion that the **Microwave** appeared to be in **Good Condition**.

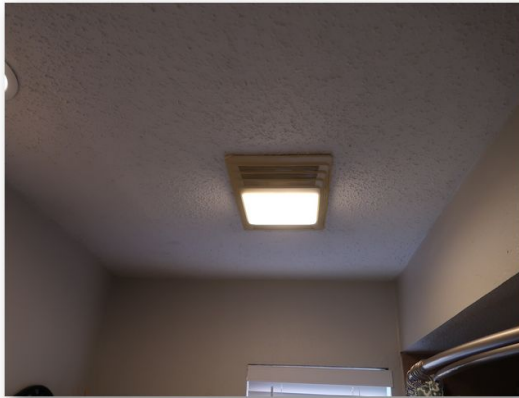
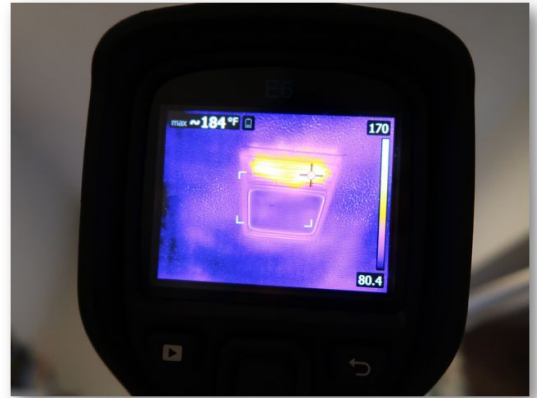
I	NI	NP	D
---	----	----	---

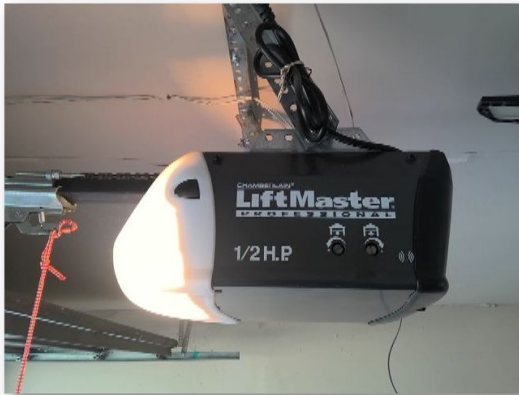
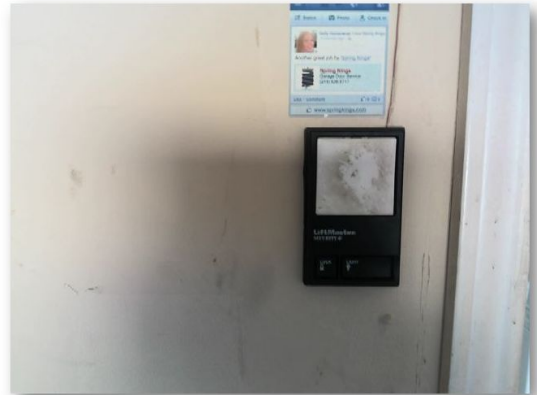
The garage door operator(s) were tested by operating the wall-mounted transmitter and checking for proper operation. The door(s) were examined for significant damage or installation-related deficiencies. No reportable conditions were present at the time of inspection unless otherwise noted in this report.

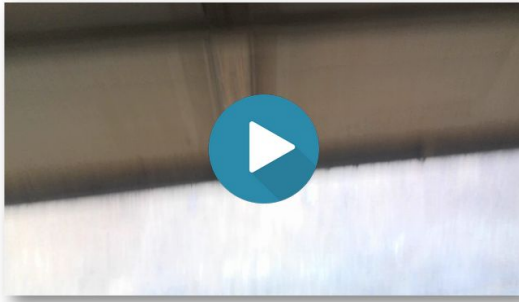
The overhead garage door was equipped with a photoelectric sensor. Photoelectric sensors are devices installed to prevent injury by raising the vehicle door if the sensor detects a person on a position in which they may be injured by the descending door. Installation of photo sensors in new homes has been required by generally-accepted safety standards since 1993.

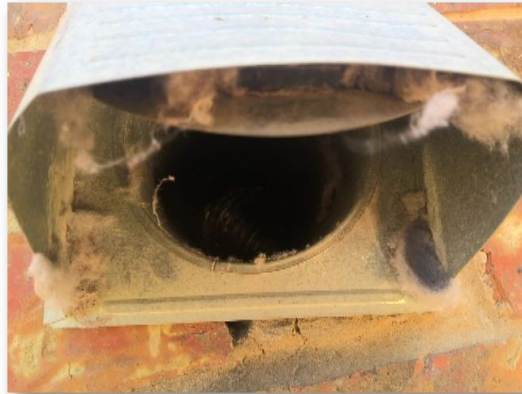
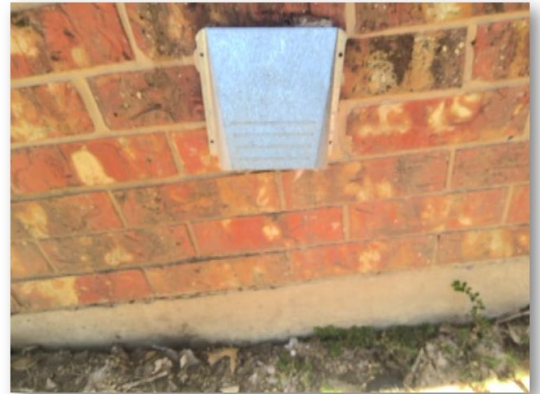
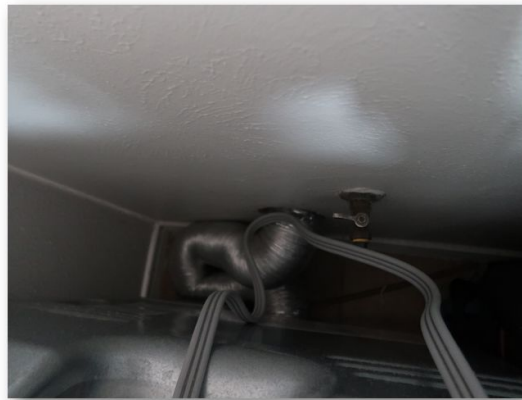
The dryer vent should be cleaned at least annually if not more frequently. Cleaning your dryer vent piping will allow the dryer to vent properly and work more efficiently. Dryer vents that are not cleaned regularly can be a fire hazard.

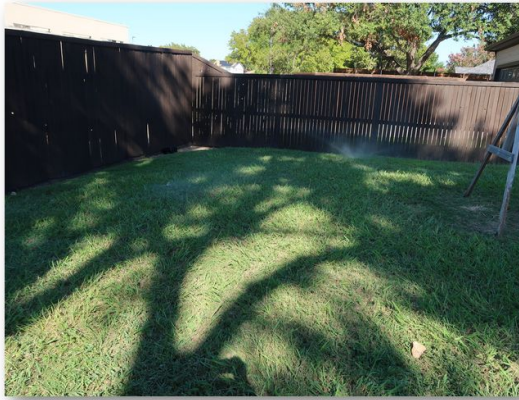
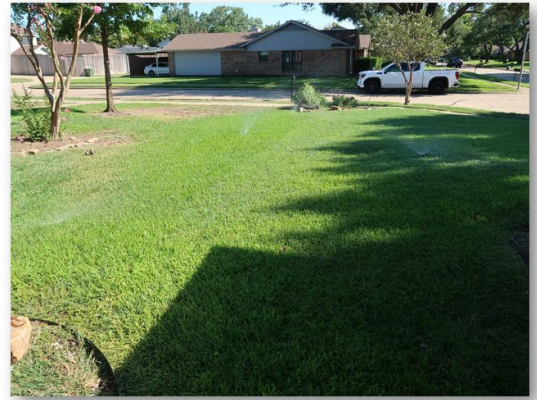
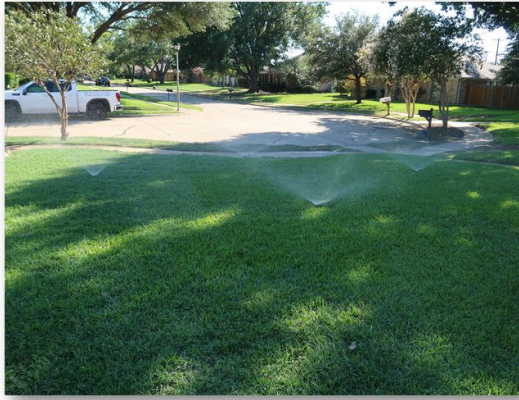
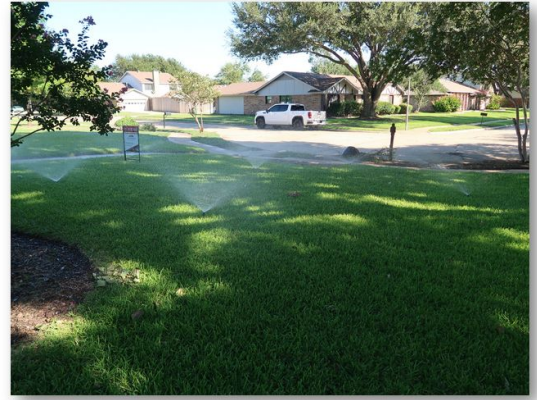
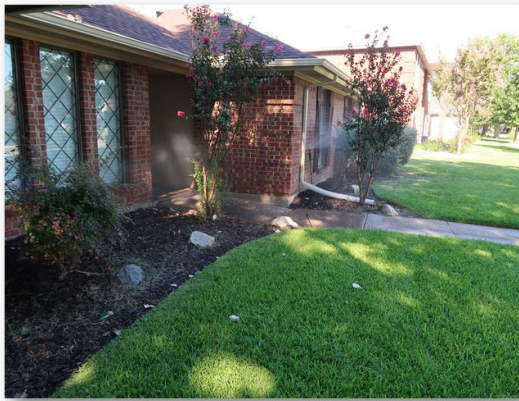
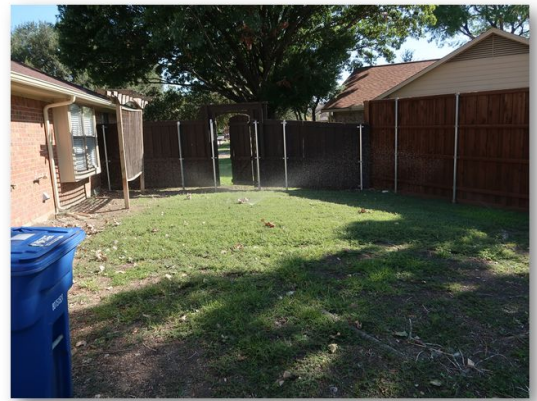
I	NI	NP	D
---	----	----	---

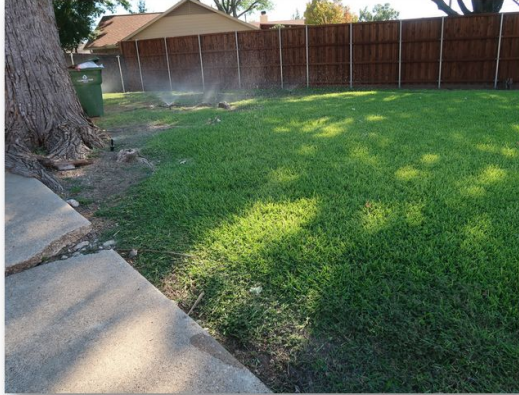
The items listed below are the Inspectors observations of deficiencies and/or exceptions if any associated with the **Landscape irrigation** that were noted on this house at the Time of the Inspection:

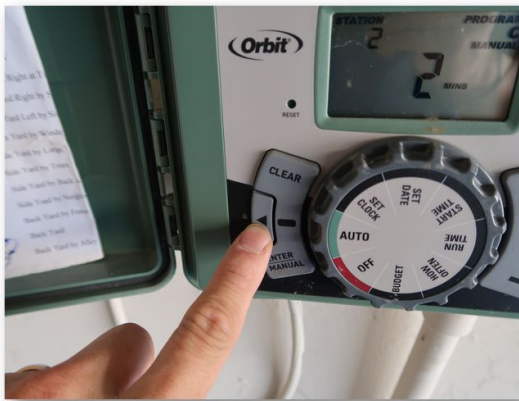
The 'Back' button on the landscape sprinkler controller is unresponsive.

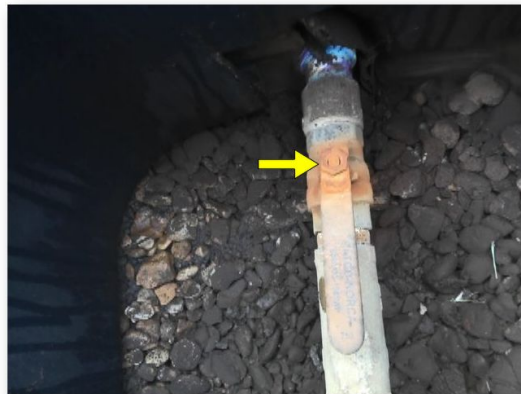
The city backflow prevention valve handle has rust on it. Replacement is recommended.
