PrimeVue
HOME INSPECTIONS

Inspected by Jude Hwang TREC #25266

SUMMARY

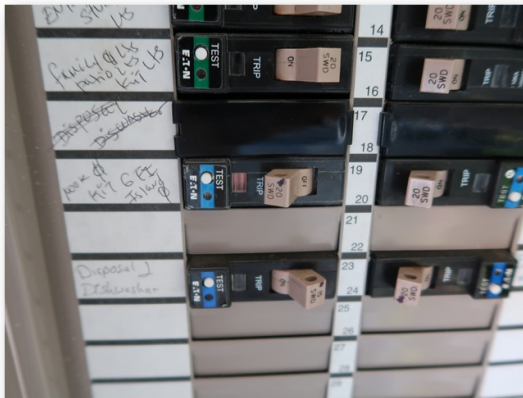
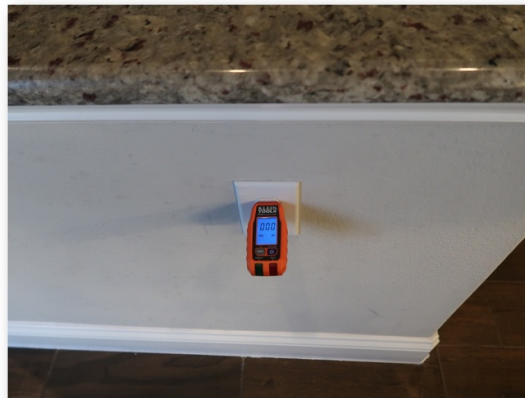
4.

D-The GFCI outlet associated with the kitchen island sink receptacle is frequently tripping, which could indicate an issue with the outlet itself or a potential underlying electrical problem; it is recommended to have this outlet evaluate and, if necessary, replaced by a certified electrician to ensure safety and consistent functionality.

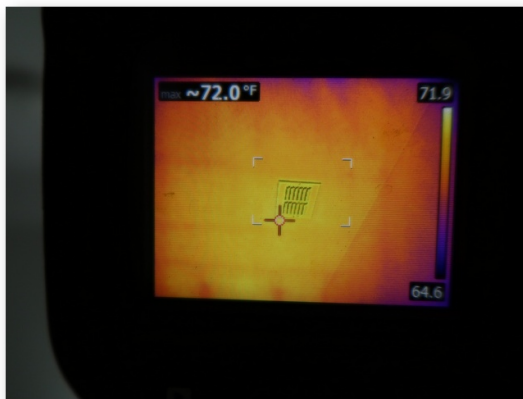
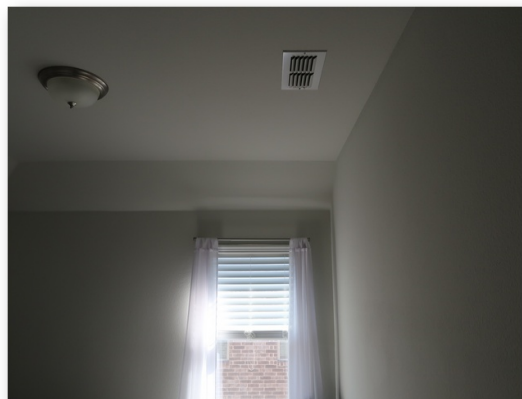
5.

D-The HVAC supply in the second-floor guest room is not delivering air from the air handler, potentially due to a blockage or system malfunction; observation and evaluation by a certified HVAC technician are recommended to diagnose and restore proper airflow and functionality.

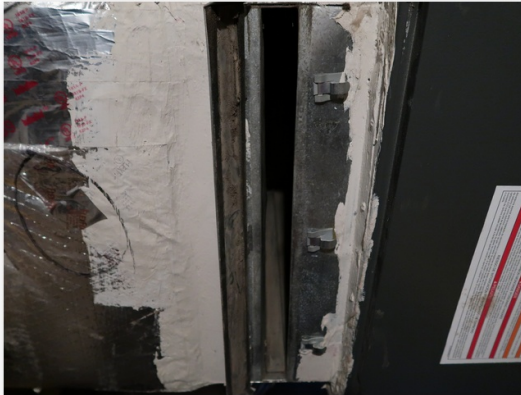
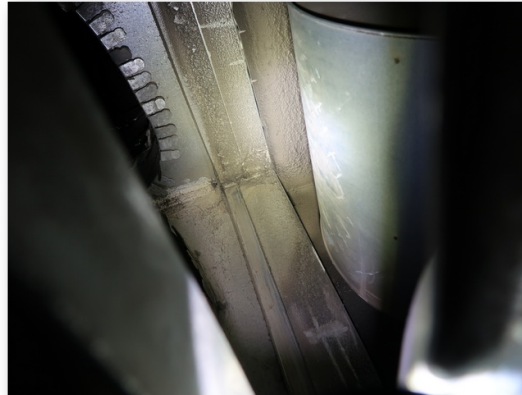
7.

D-The furnace is currently missing an air filter, which can lead to decreased efficiency and potential buildup of dust and debris within the system; installing the appropriate filter is recommended to ensure optimal performance, protect internal components, and maintain air quality.

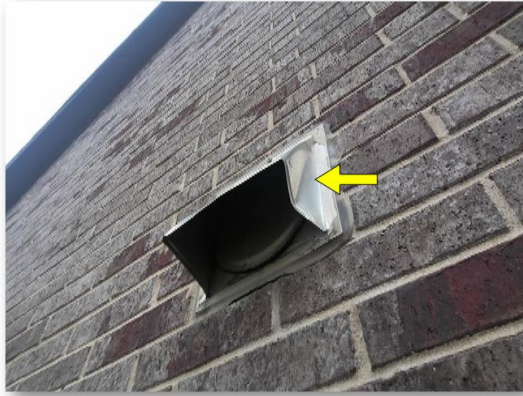
8.

D-The exterior hood fan cover is dented, which may affect its appearance and functionality; repair or replacement is recommended to maintain proper ventilation and aesthetics.

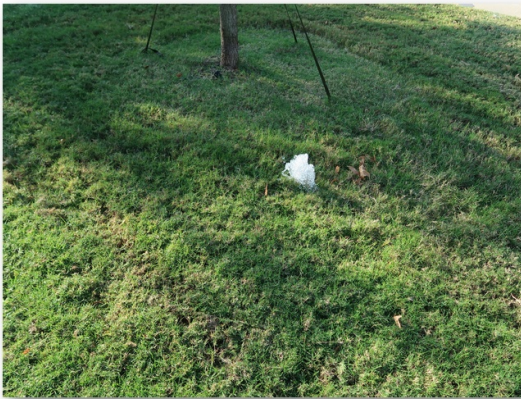
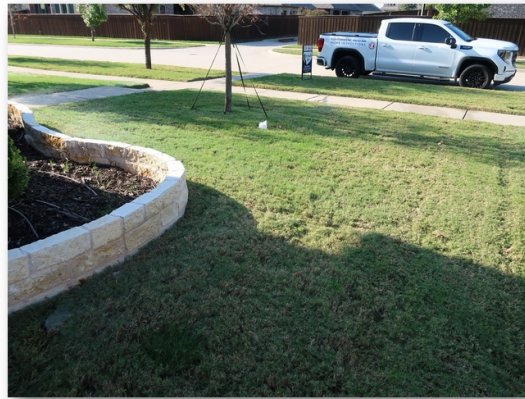
9.

D-In sprinkler zones 2, 4, and 7, one of the heads is damaged, causing water to spray around the lawn area; repair or replacement of the affected sprinkler heads is recommended to ensure efficient water distribution.

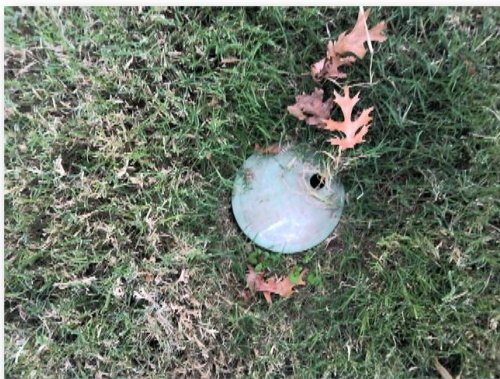
10.

D-The main valve next to the irrigation backflow prevention box is buried in the ground, making it difficult to access in case of emergency; it is recommended to keep the valve visible at all times for easy access and quick shutoff if needed.

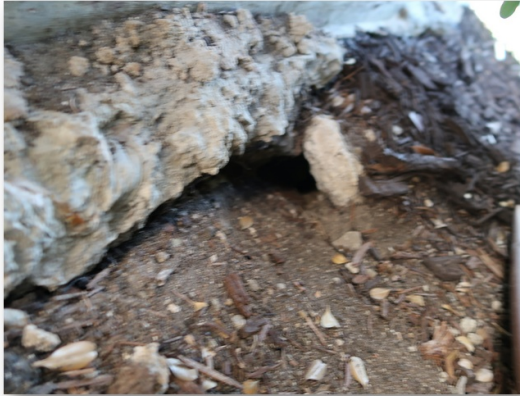
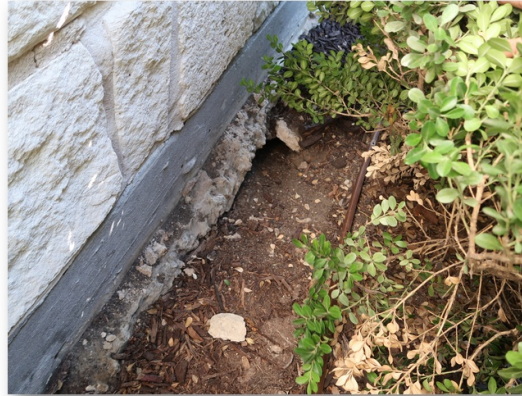
3.

M-Sinkholes are observed around the front of the house. These depressions in the soil indicate poor drainage management, which can lead to water pooling near the foundation. Left unaddressed, these areas can attract vermin and potentially compromise the integrity of the foundation. It is recommended to fill these sinkholes with soil to prevent further erosion and to enhance the foundation's protection against moisture intrusion.

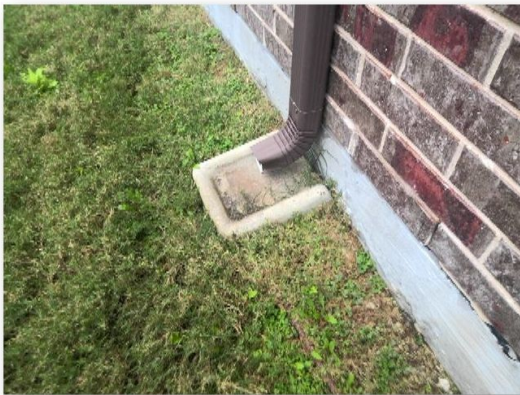
4.

M- A complete gutter system with extensions is recommended on this structure. The gutter system is designed to expedite the drainage of water away from the property. Splash plates located under the down spouts can help direct water away from the foundation and reduce soil erosion, which can reduce the effectiveness of the termite chemicals placed in the soil.

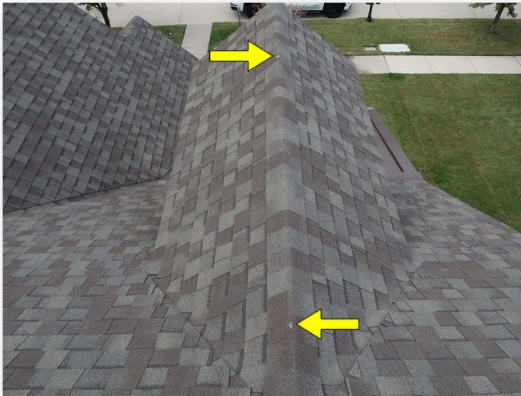
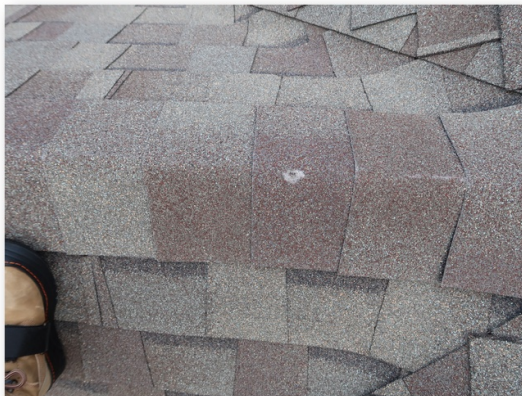
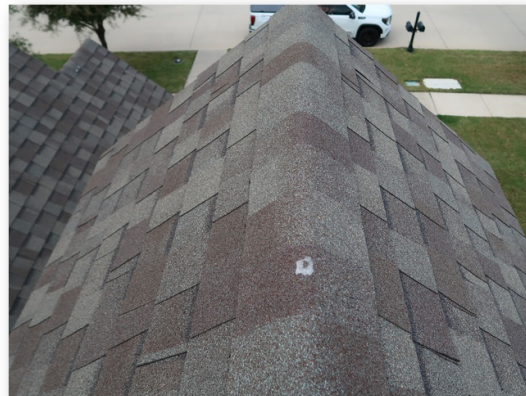
6.

M-Mechanical damage refers to any damage caused Installing shingles or equipment, cleaning gutters, making repairs, or performing construction work of other types can put people on the roof with tools or equipment capable of damaging shingles.

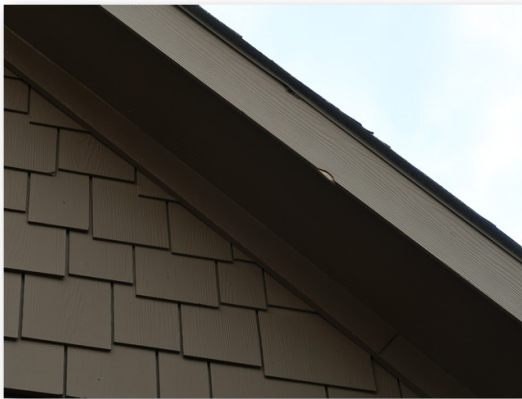
11. M-Chip damage was observed on the front eave of the house. Repair is recommended to prevent potential worsening of the damage and to maintain the integrity of the eave.

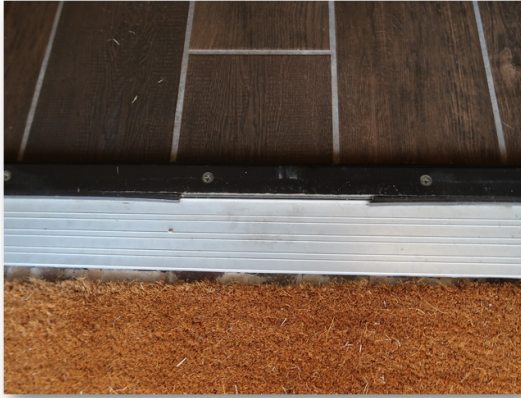
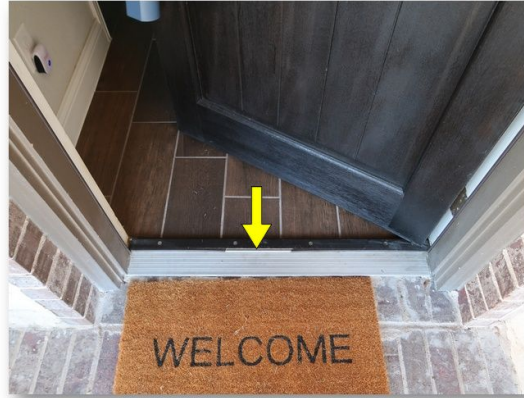
14.

M-The weather seal at the bottom threshold of the exterior door at the house entrance is damaged, which may allow air and moisture intrusion; repairing or replacing the seal is recommended to ensure proper insulation and protection against weather elements.

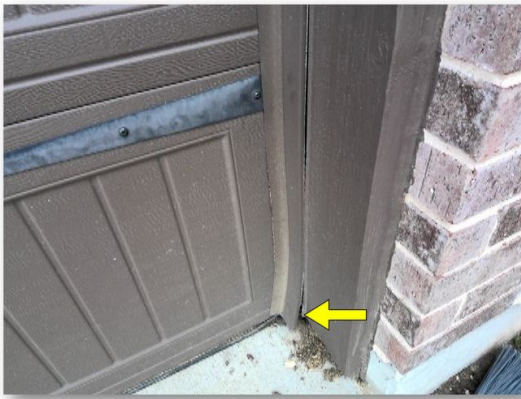
15.

M-The weather seal at the bottom of the exterior trim on the garage door has come loose, which could lead to moisture intrusion and reduced insulation; reattaching or replacing the seal is advised to maintain protection and efficiency.

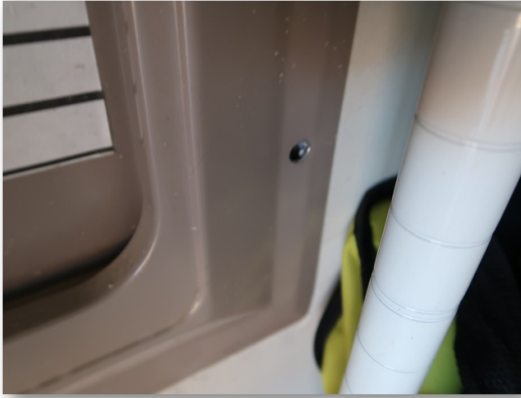
20.

M-A bolt is missing from the electrical dead cover, which may compromise safety; it is recommended to replace the missing bolt to secure the cover properly.

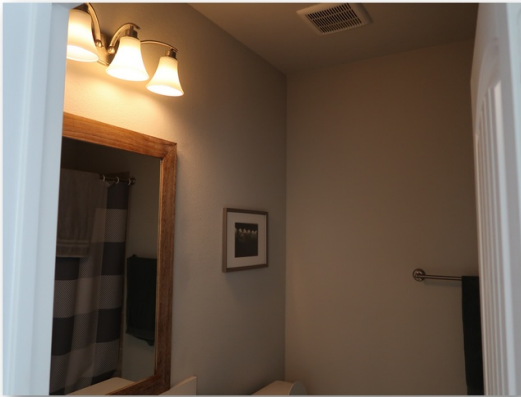
21.

M-The lighting in the second-floor bathroom is noticeably dim, which may affect visibility and usability; it is recommended to assess the lighting fixtures and consider upgrading or replacing them to improve illumination in the space.

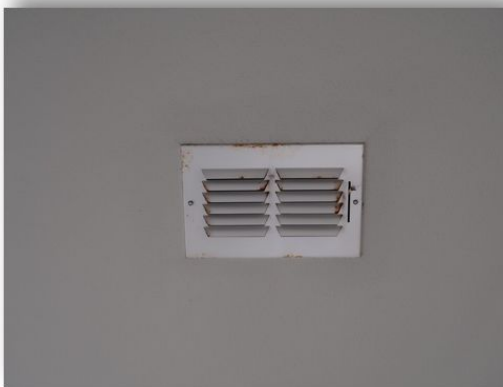
24.

M-Rust was found on the mesh cover of the supply vent in the master bathroom, which may affect air quality and appearance; cleaning or replacing or paint the cover is recommended to maintain functionality and aesthetics

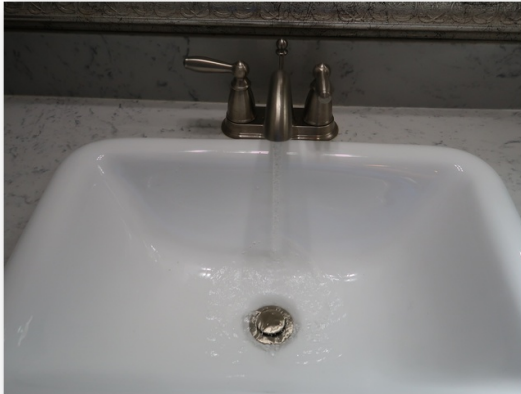
25.

M-One of the bathroom drain stoppers was not functioning properly, preventing effective operation; adjustment or replacement is recommended to restore full functionality.

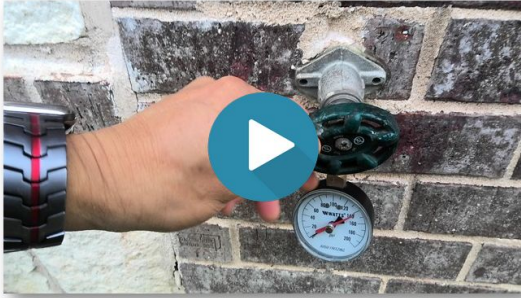
27.

M-The handle on the exterior faucet on the right side of the house is loose, which may affect its operation; securing or repairing the handle is recommended to ensure proper functionality and prevent potential leaks.

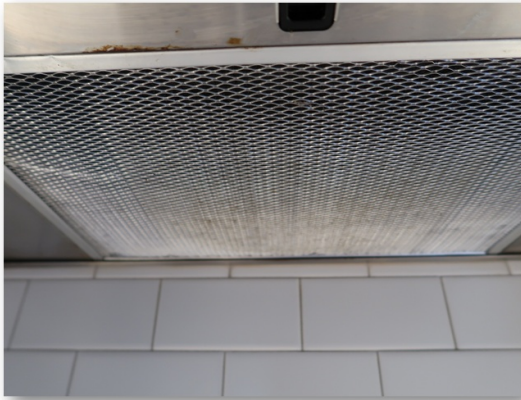
28.

M-The hood filter is dirty, which may reduce its efficiency and airflow; cleaning or replacing the filter is recommended to maintain optimal performance and air quality.

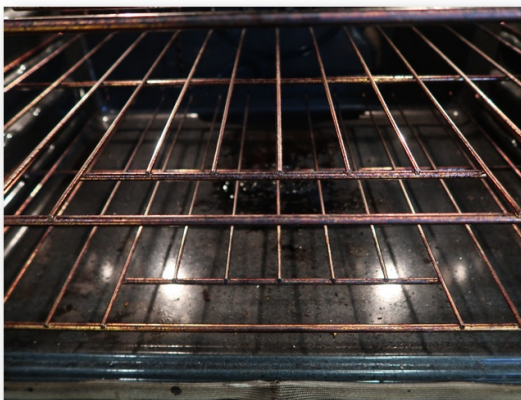
29.

M-The interior of the oven is dirty, which may impact its performance and efficiency; a thorough cleaning is recommended to maintain functionality and hygiene.

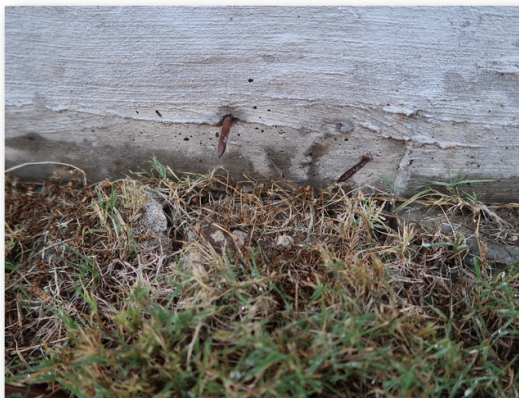
D-Nails are embedded in the foundation wall. If they rust, the surrounding area may expand, and rust stains may run down the wall, negatively impacting its appearance. Additionally, there is a potential safety risk, as the rusted nails could cause injury. It is recommended that they be removed.

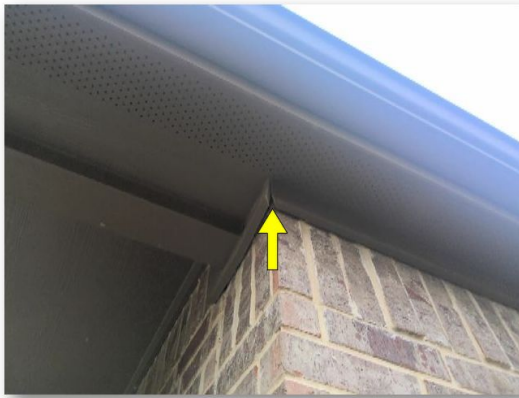
M-A gap was observed in the frieze board at the corner of the house. Sealing this area is recommended to prevent potential moisture intrusion and pest entry.

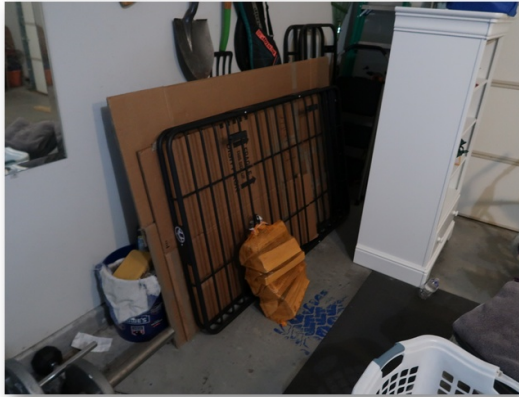
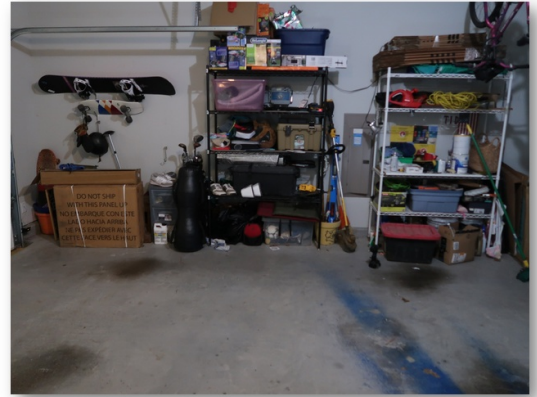
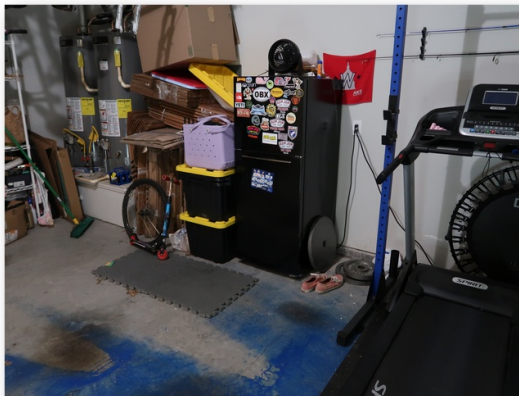
During the inspection of the property, it was noted that the some of garage space was obstructed by the owner's personal items. The presence of these items limited the ability to fully assess the condition and functionality of the garage.

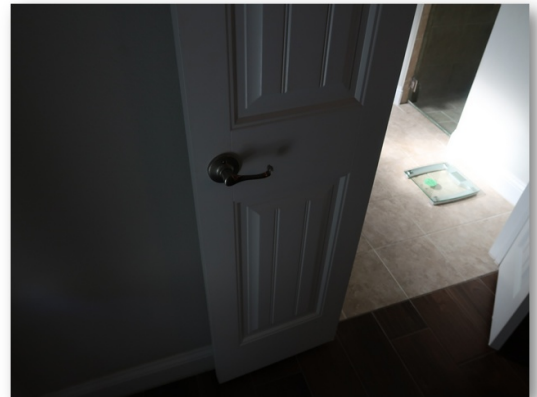
D-An interior doors were missing or pull off a stop. This condition is may result in wall and door damage. A stop be installed to protect the wall.

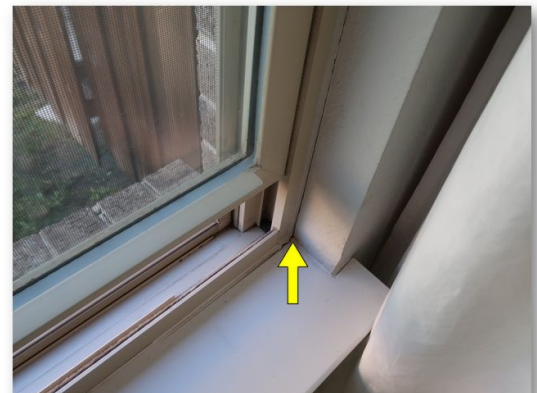
M-There is a gap in the silicone sealant at the corner of the exterior window frame on the front of the house, as well as at the bottom corner of one of the interior window frames. Sealing these gaps is recommended to prevent potential air and moisture intrusion.

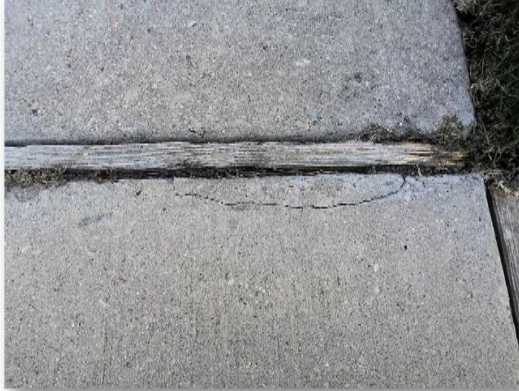
M-A small common hairline crack was observed at the corner of the walkway in front of the house. Monitoring is recommended to ensure it does not expand or worsen.

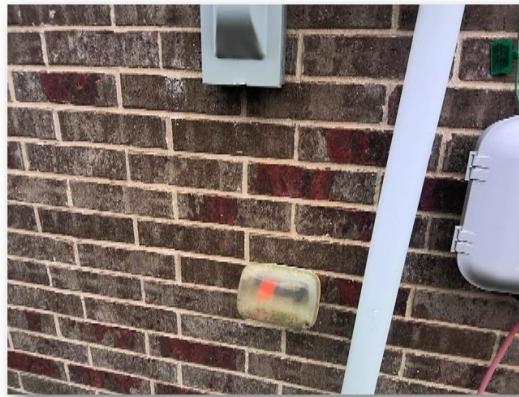
S-An open ground error was detected in the GFCI outlet near the electric meter, which can pose a safety risk. Evaluation and correction by a licensed electrician are recommended to ensure proper grounding and electrical safety.

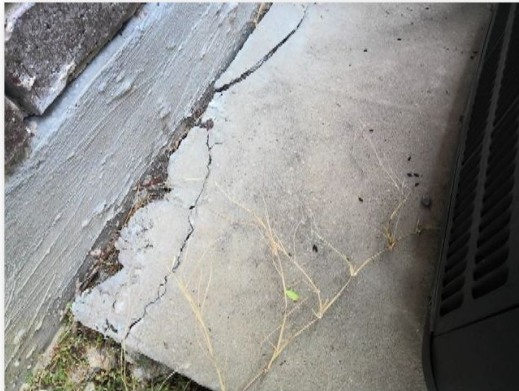
M-A crack was observed at the junction where the concrete pad of the outdoor air conditioning unit meets the wall; this crack does not indicate a foundation issue.

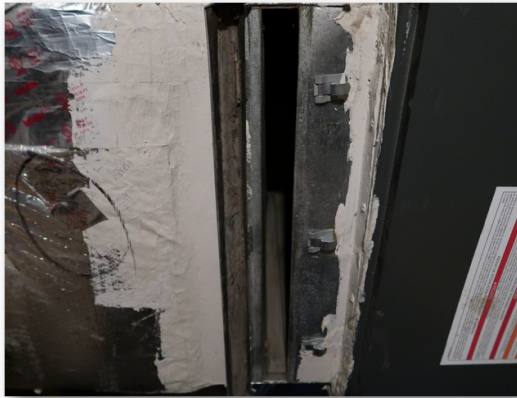
D-The furnace is currently missing an air filter, which can lead to decreased efficiency and potential buildup of dust and debris within the system; installing the appropriate filter is recommended to ensure optimal performance, protect internal components, and maintain air quality.

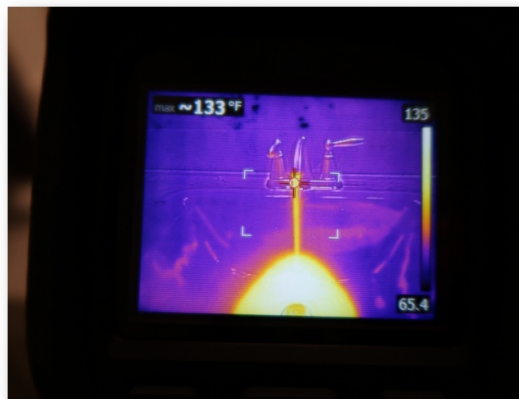
Water Temp: 133 °F Recommended Hot Water setting should between 115°F – 120°F

Water heater tanks (if applicable) should be flushed annually to prevent sediment built-up inside tanks and maintain energy efficiency. Recommend a plumbing contractor to service and flush the tank when the opportunity is right. Typical life expectancy for conventional water heaters is 16-18 years (hard water and poor maintenance of the unit may diminish its service life).

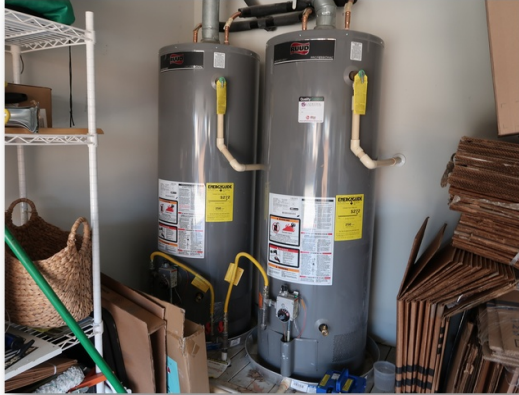
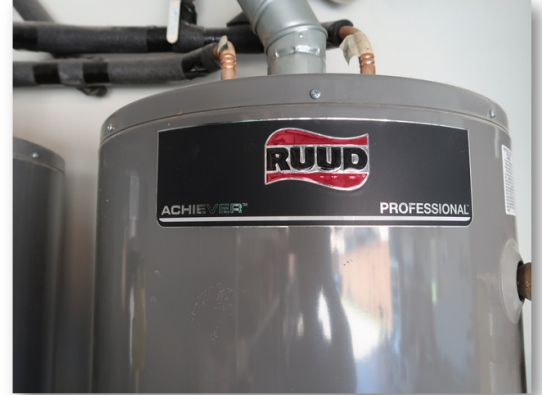
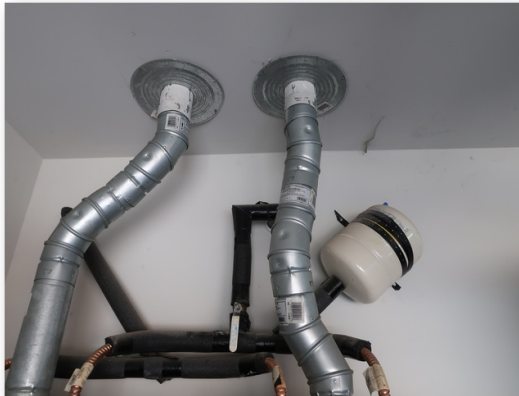
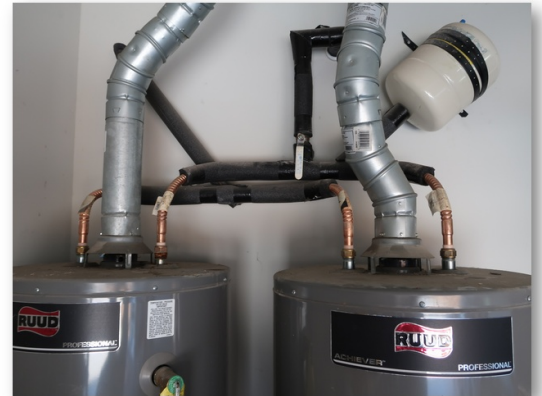
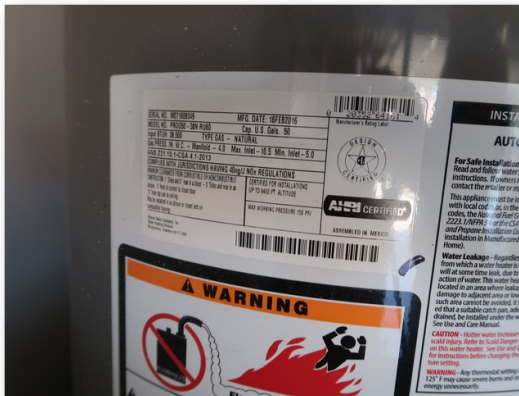
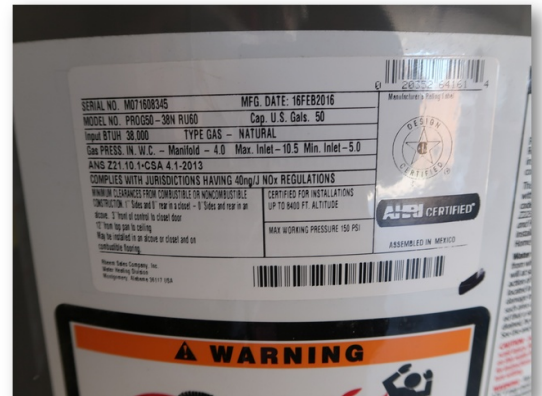
The Water Heater appeared to be in Operable Condition on the Day of the Inspection.

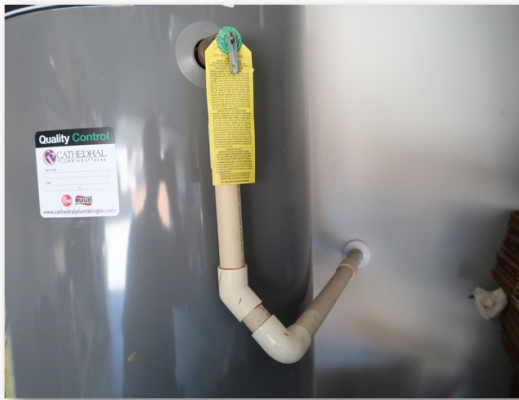
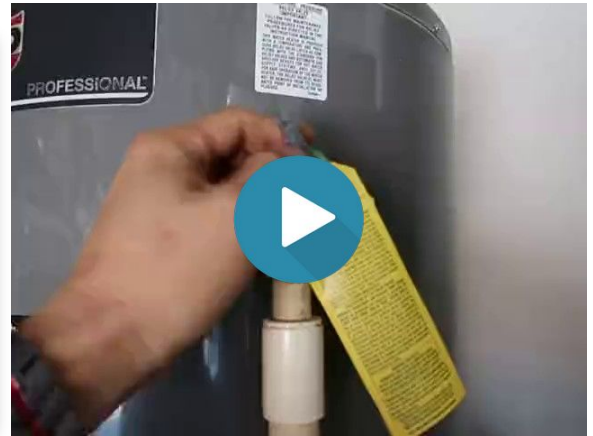
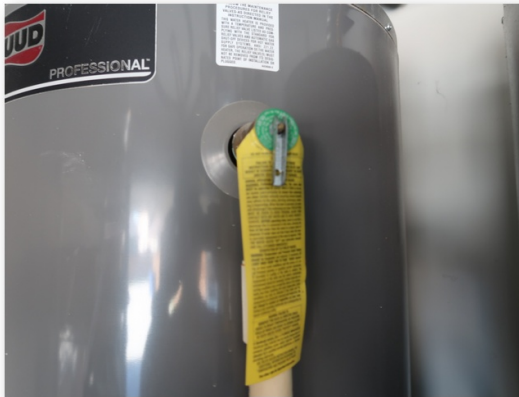
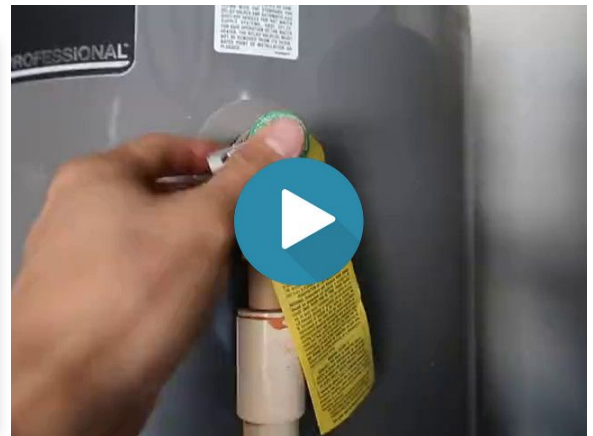
T/P valve inspected / verified, TESTED

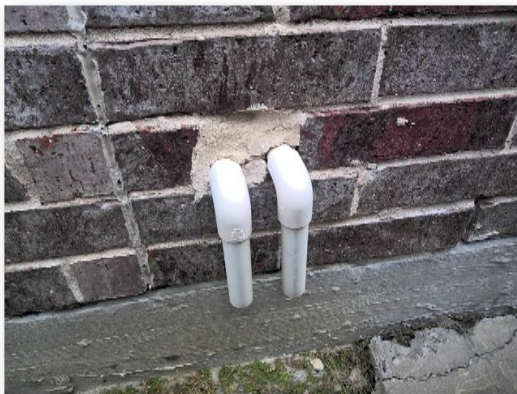
TPR Valve Drain Line

NOTE: We did not operate the TPR (Temperature and Pressure Relief) valve during the inspection to avoid potential damage to the resident's property or the valve mechanism. These valves are typically not used frequently, and operating them during an inspection can sometimes cause leaks. Manufacturers generally recommend monthly testing of this valve. If a further evaluation of the valve is desired, we recommend contacting a licensed plumbing contractor.

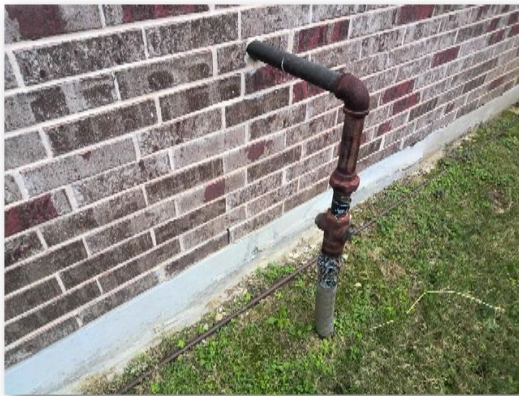
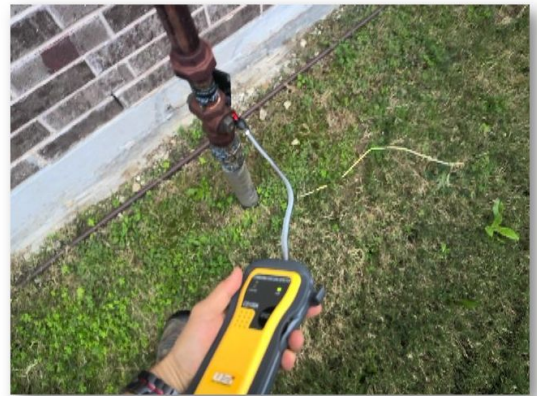
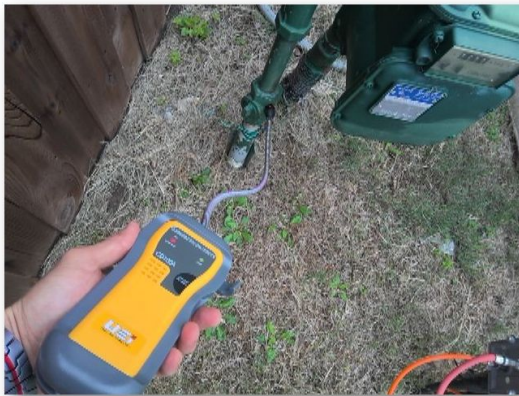
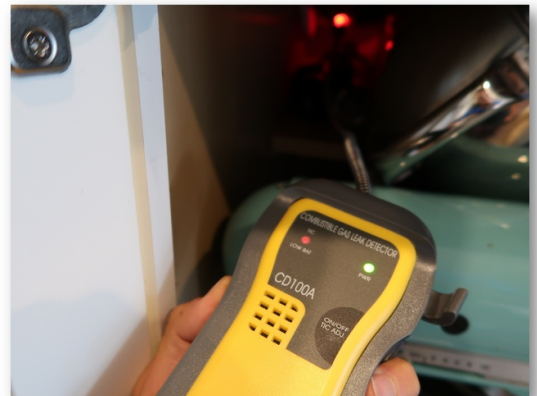
On the day of the inspection it was the Inspectors opinion the **Gas Distribution System & components** appeared to be in **Operable Condition** at the time of this inspection.

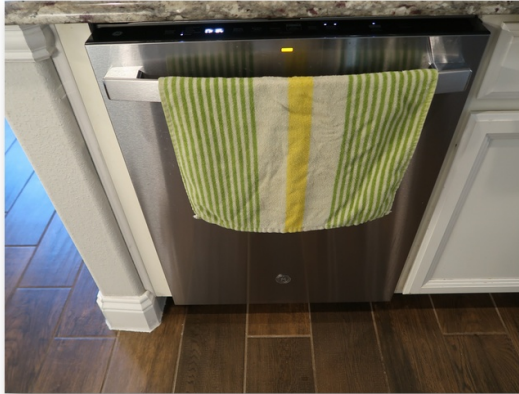
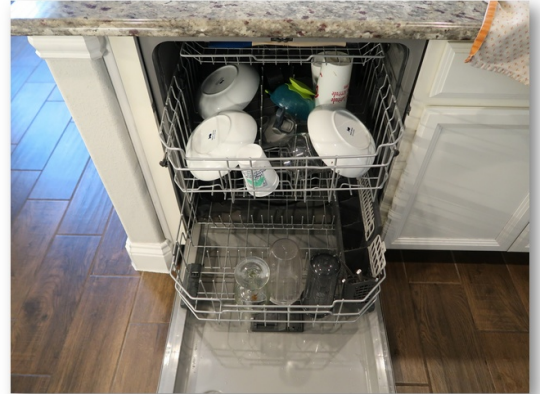
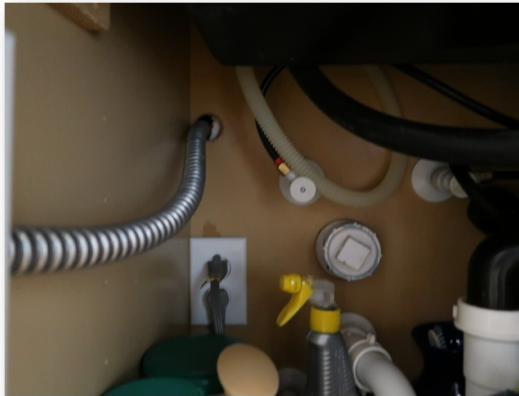
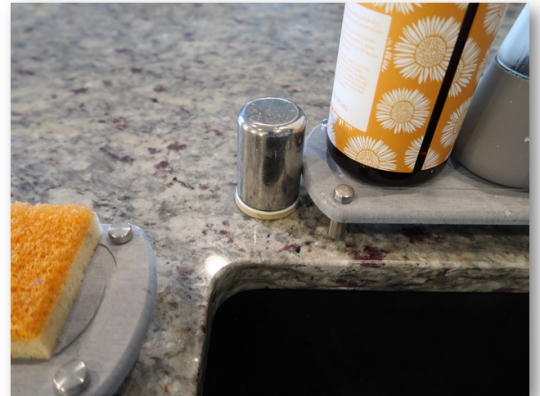
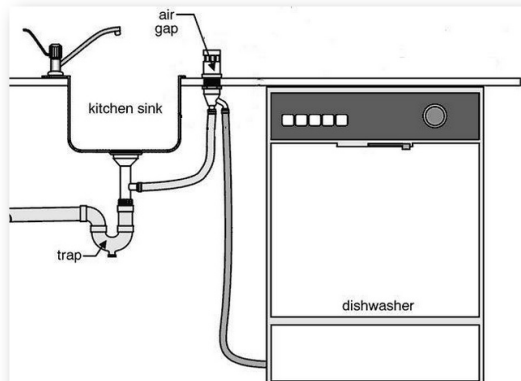
The Inspector observed no deficiencies in the condition and Operable Condition of the dishwasher. It was operated through a cycle.

The dishwasher was operated by running a wash cycle and was functional at the time of inspection. No leaks or water was present at the base of the unit at the completion of the cycle. The unit's efficiency of cleaning dishes is not tested. No deficiencies were observed with the unit unless otherwise noted in this report.

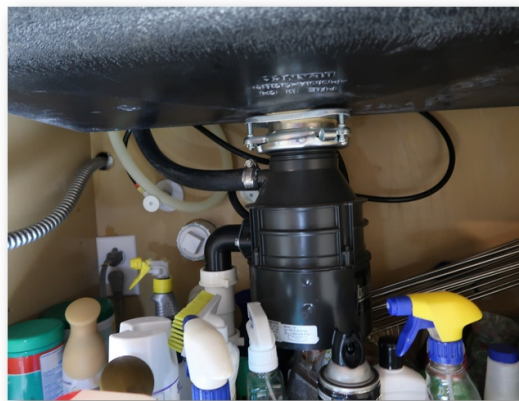
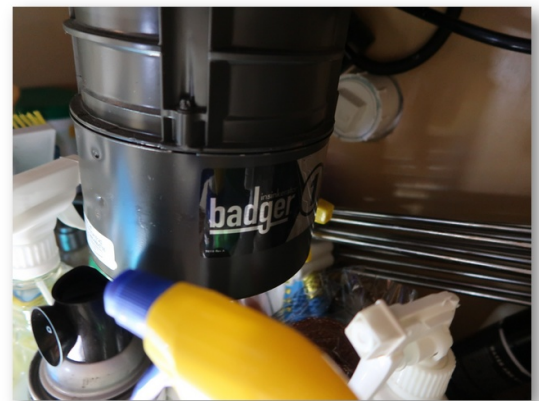
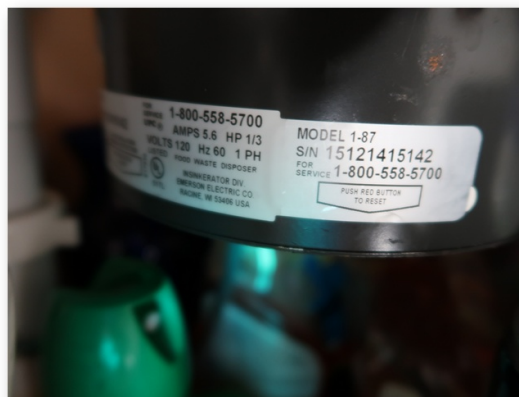
At the time of the inspection it is the Inspectors opinion that the **Waste Disposer System** appeared to be in **Operable Condition** with the following observations.

The food waste disposal was inspected to determine it was functional while also looking for leaks from the unit, an exposed power cord, heavy rust, or other deficiencies. No reportable conditions were present at the time of inspection unless otherwise noted in this report.

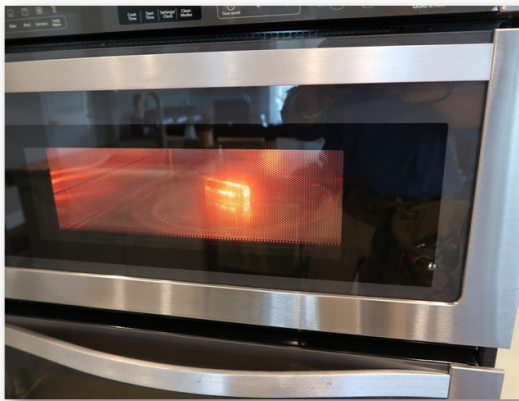
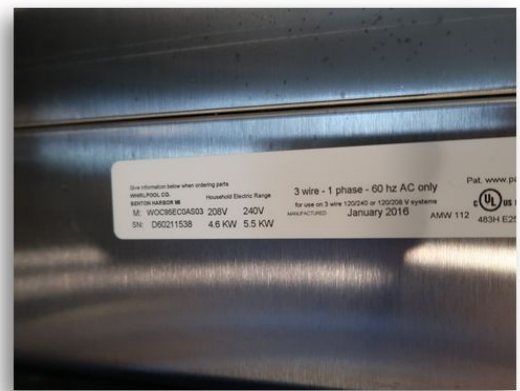
At the time of the inspection it is the Inspectors opinion that the **Microwave** appeared to be in **Operable Condition**.

The inspector observed no deficiencies in the condition and operation of the built-in microwave oven. Built-in microwave ovens are tested using normal operating controls. Unit was tested and appeared to be serviceable at time of inspection. Leak and/or efficiency testing is beyond the scope of this inspection. If concerned, you should seek further evaluation by qualified technician prior to closing.

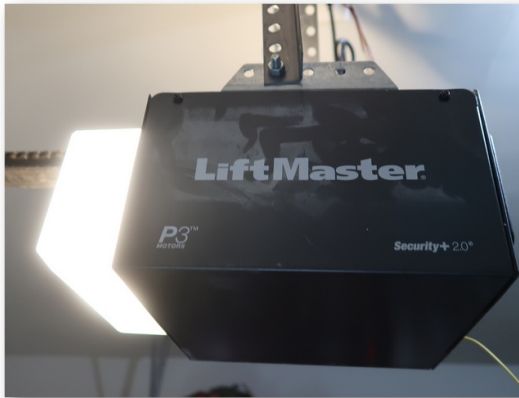
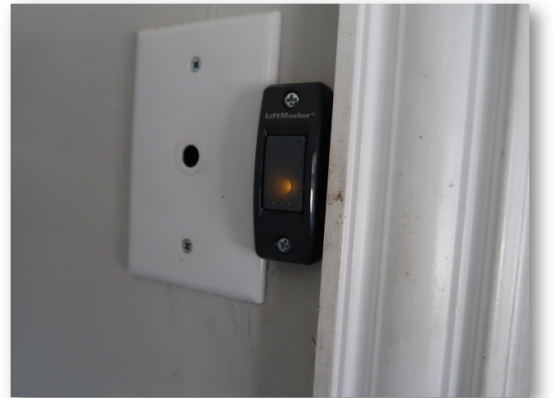
At the time of the inspection it is the Inspectors opinion that the **Garage Door Operator** appeared to be in **Operable Condition**.

The garage door operator(s) were tested by operating the wall-mounted transmitter and checking for proper operation. The door(s) were examined for significant damage or installation-related deficiencies. No reportable conditions were present at the time of inspection unless otherwise noted in this report.

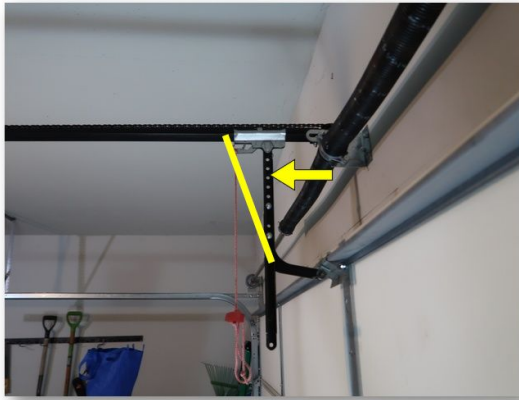
M-To ensure smooth operation of the garage door, it is recommended that the hockey stick part be adjusted to the 1 o'clock position.

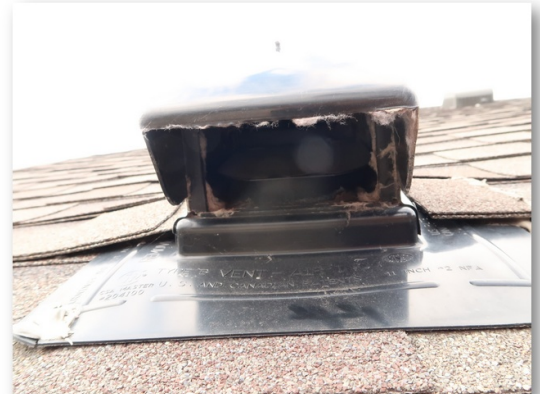
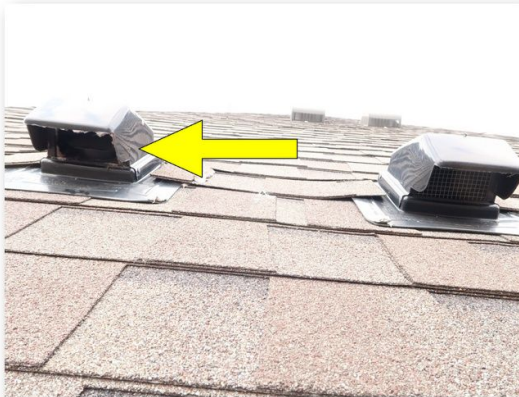
A dryer vent connection was installed in the laundry room. Although the inspector operated the dryer briefly, the dryer vent was examined visually only. A visual examination will not detect the presence of lint accumulated inside the vent, which is a potential fire hazard. You have the dryer vent cleaned at the time of purchase and annually in the future to help ensure that safe conditions exist.

The dryer vent should be cleaned at least annually if not more frequently. Cleaning your dryer vent piping will allow the dryer to vent properly and work more efficiently. Dryer vents that are not cleaned regularly can be a fire hazard.

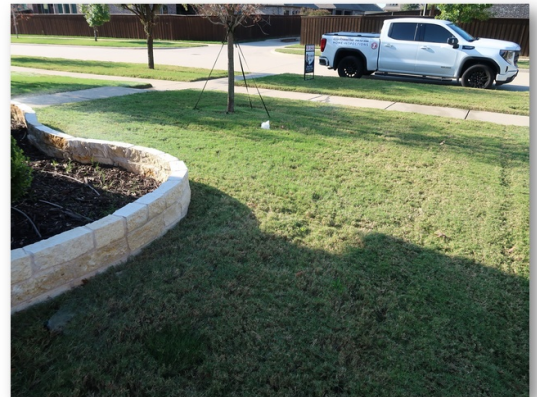
D-In sprinkler zones 2, 4, and 7, one of the heads is damaged, causing water to spray around the lawn area; repair or replacement of the affected sprinkler heads is recommended to ensure efficient water distribution.

Deficiencies in ZONE: 2,4,7

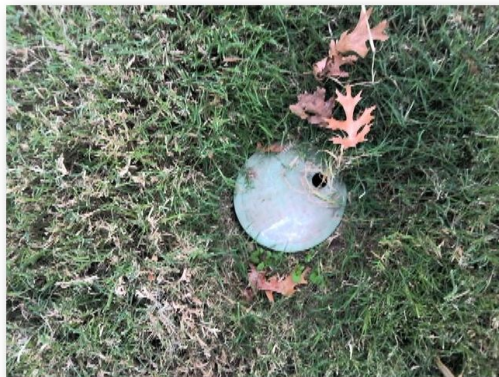
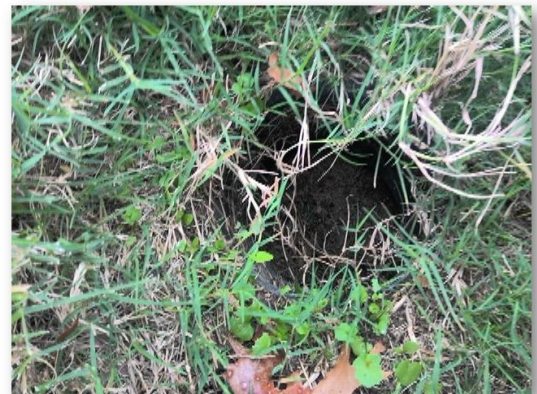
D-The main valve next to the irrigation backflow prevention box is buried in the ground, making it difficult to access in case of emergency; it is recommended to keep the valve visible at all times for easy access and quick shutoff if needed.
